Environmental and Social Monitoring First Report

Project Number: 48368-001
August 2017

MYA: Myingyan Natural Gas Power Project Part 2

APPENDIX 4 SITE VISIT PHOTO LOG

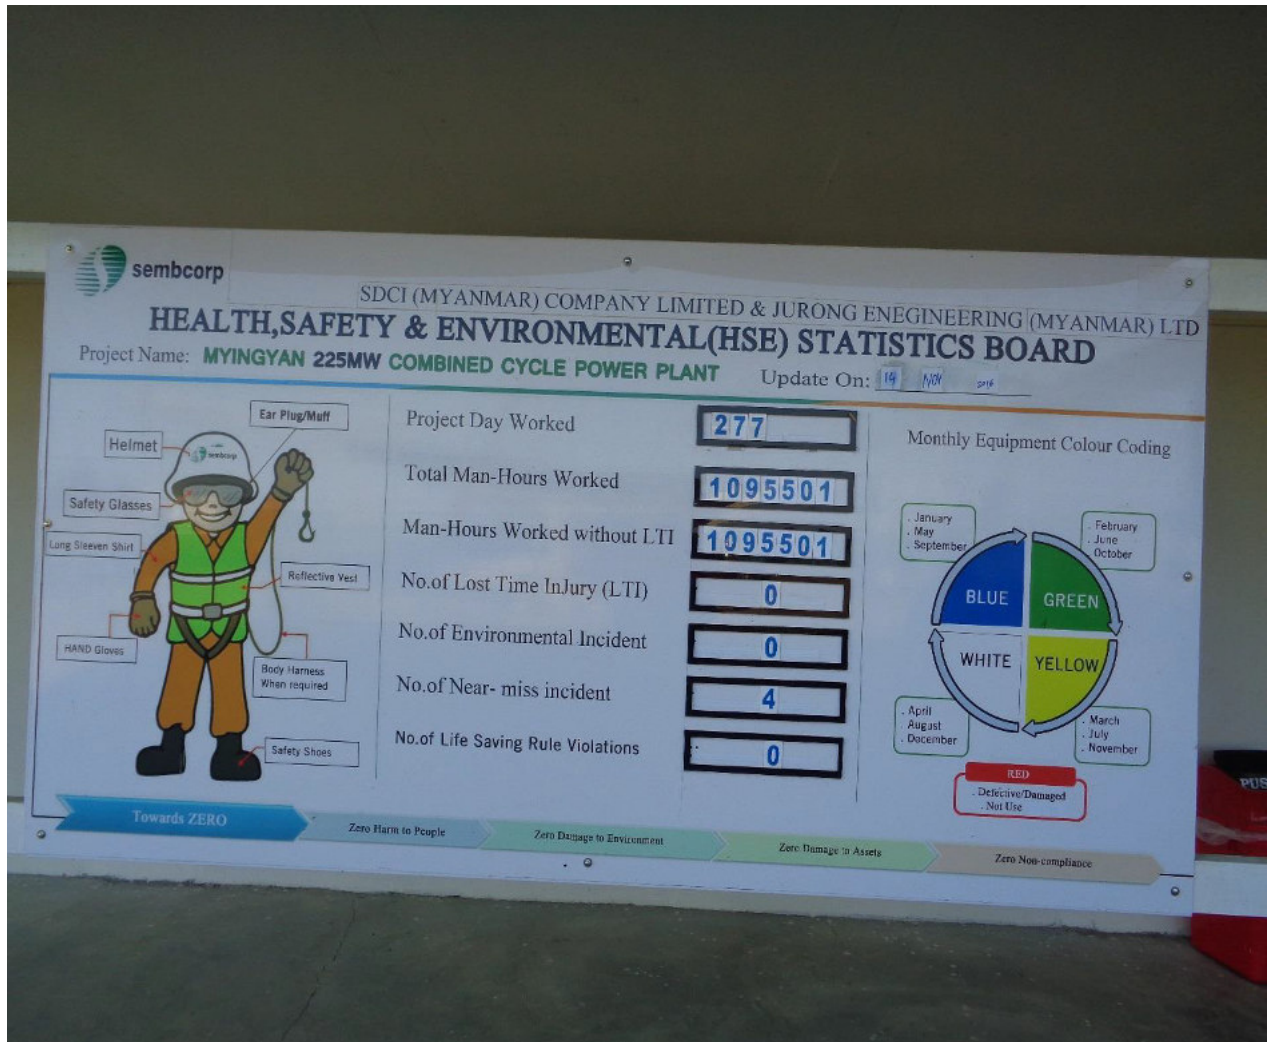
Photo No. 1. HSE Sign at the Myingyan 226 MW Gas fired Combined Cycle Project site (November 2016)

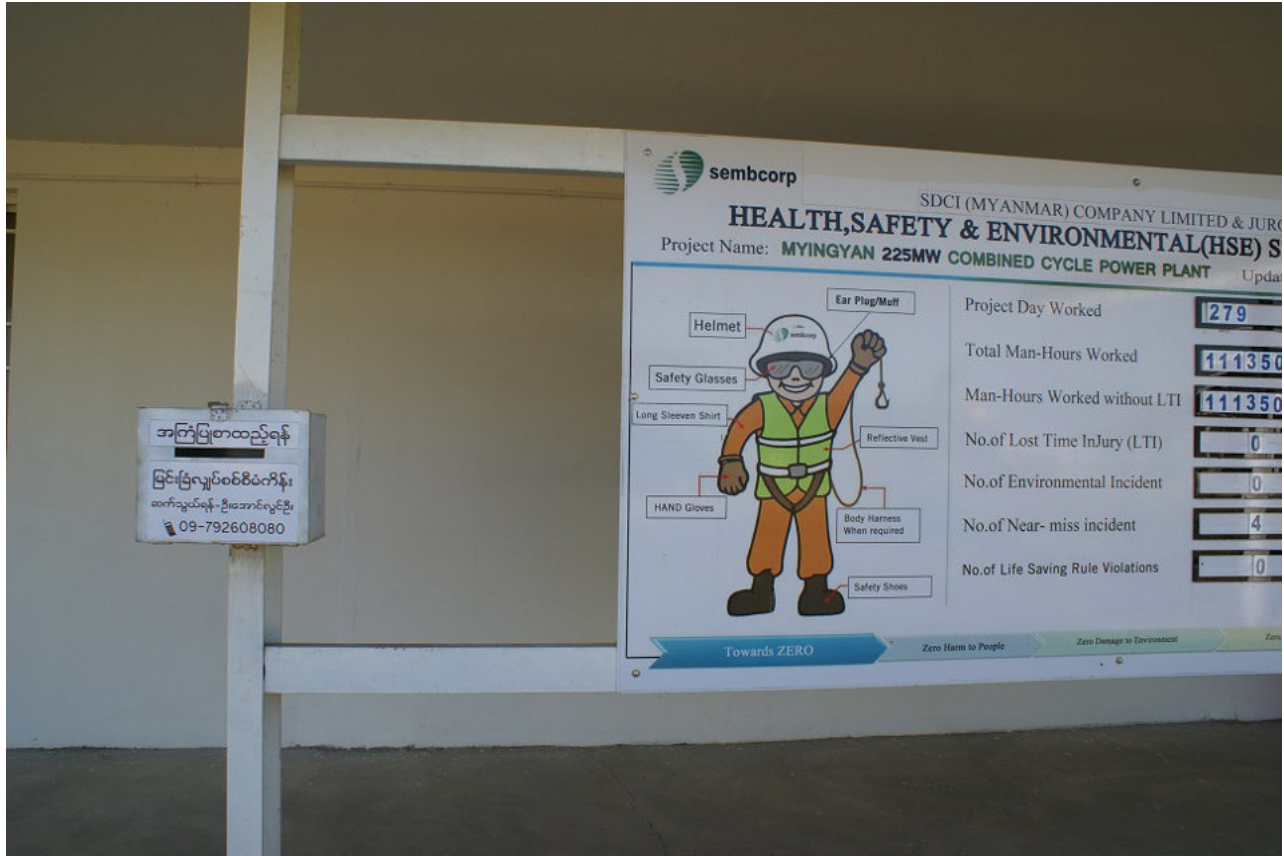
Photo No. 2. Grievance Mechanism suggestion box in front of the Semcorp office at the Project site

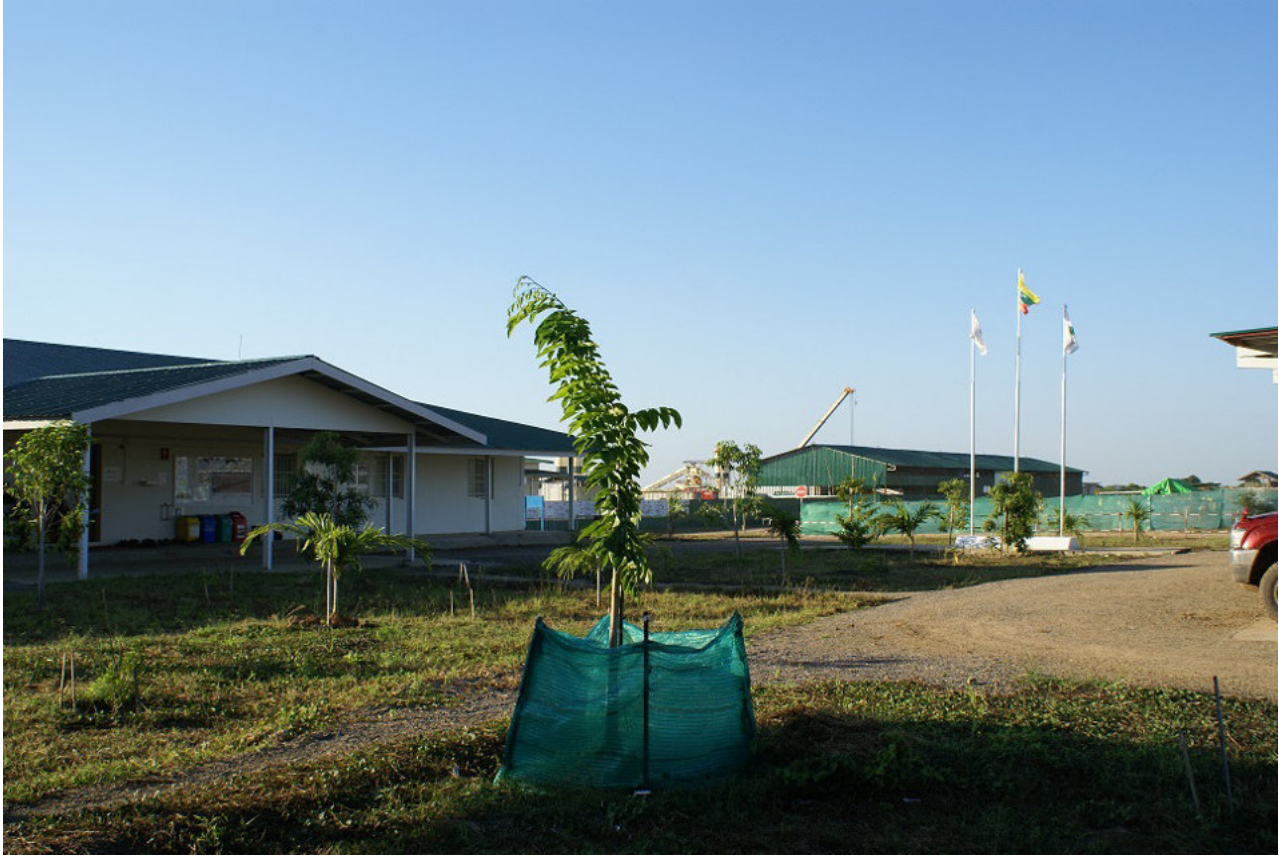
Photo No. 3. Offices and new trees planted at the Project site

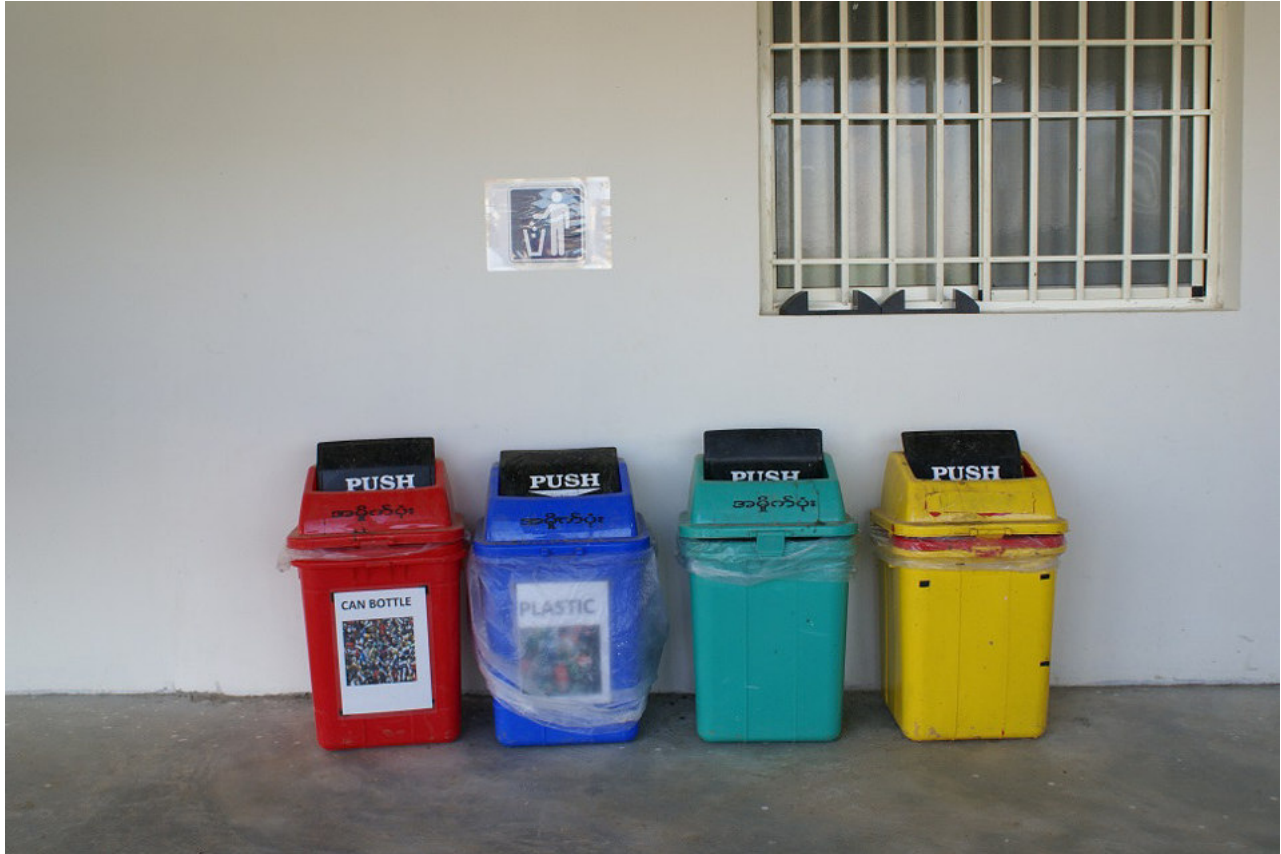
Photo No. 4. Waste Management at the Project site

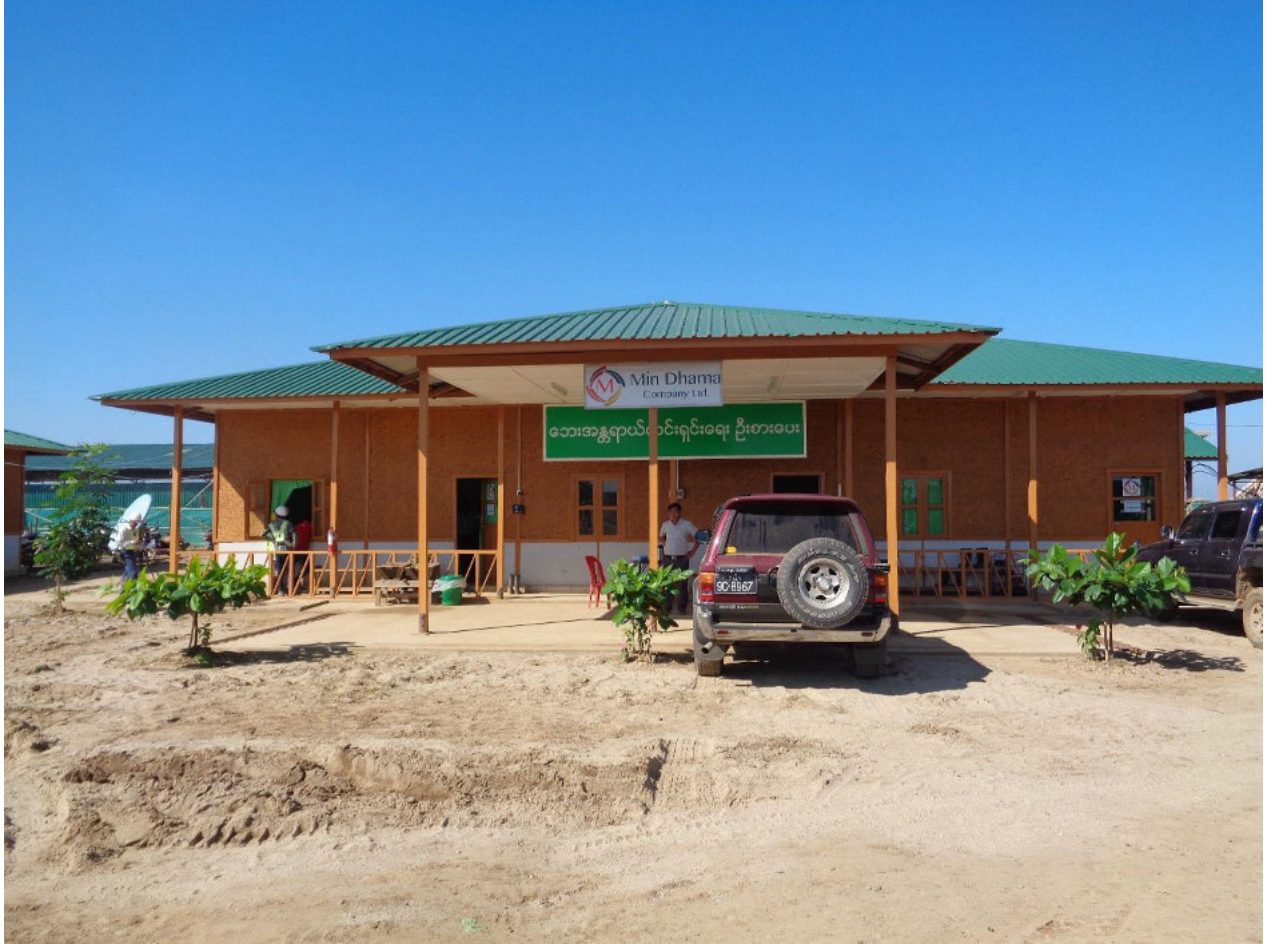
Photo No. 5. Contractor (Min Dhama) project office at the Project Construction site

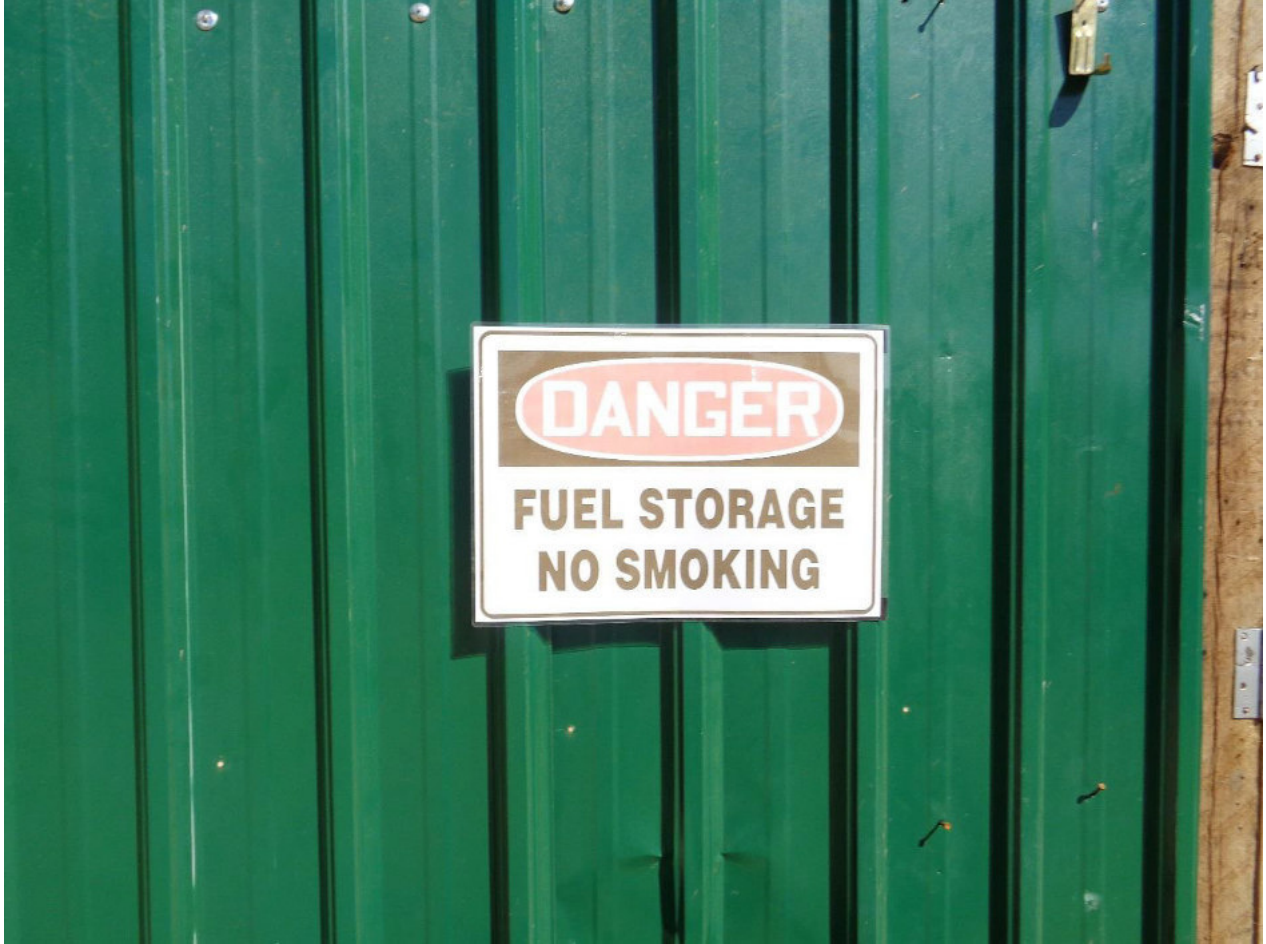
Photo No. 6. Sign at the fuel storage, as part of safety reminder, at the Project site

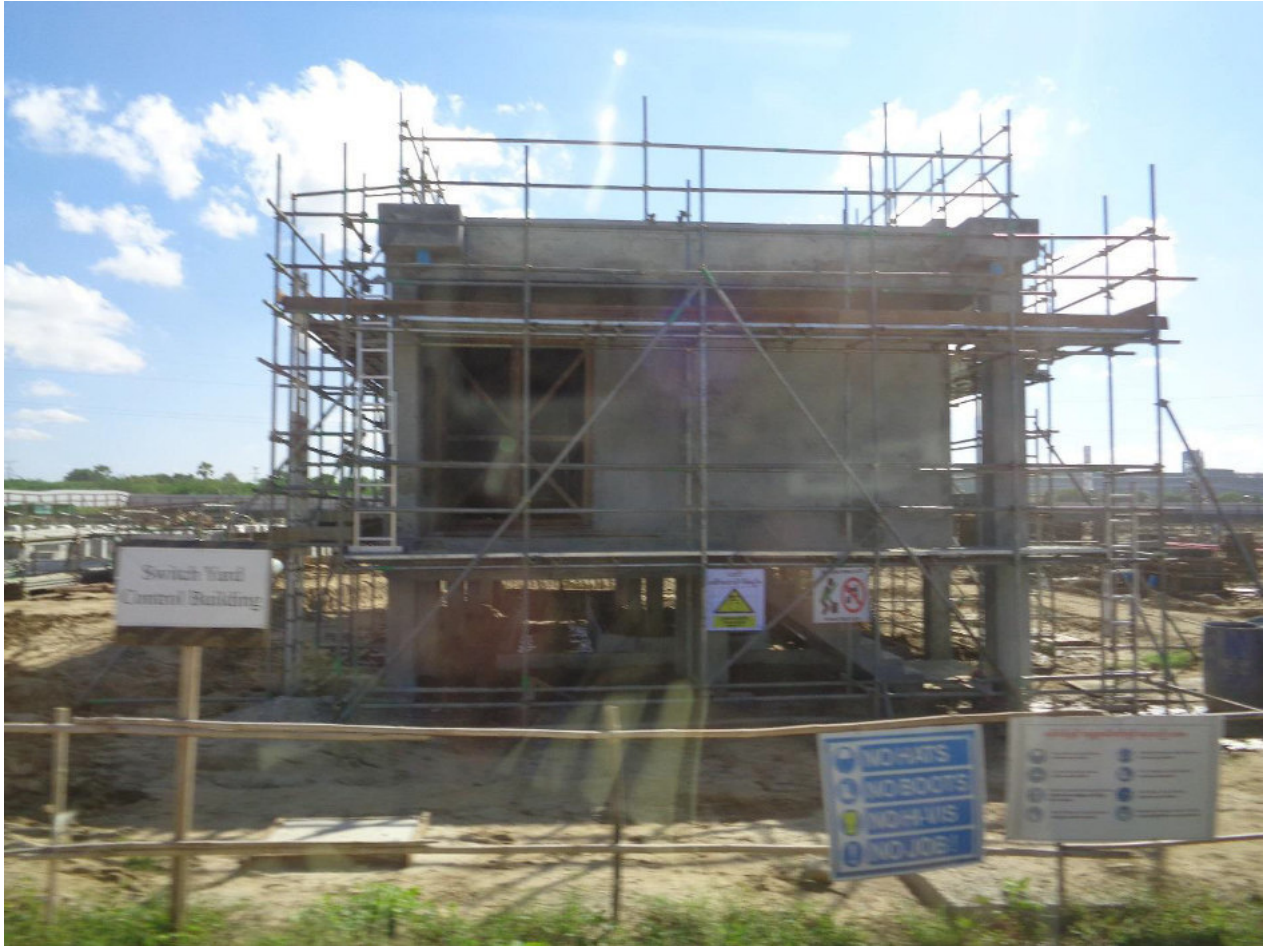
Photo No. 7. Strict reminder to wear PPE at the construction areas within the Project site

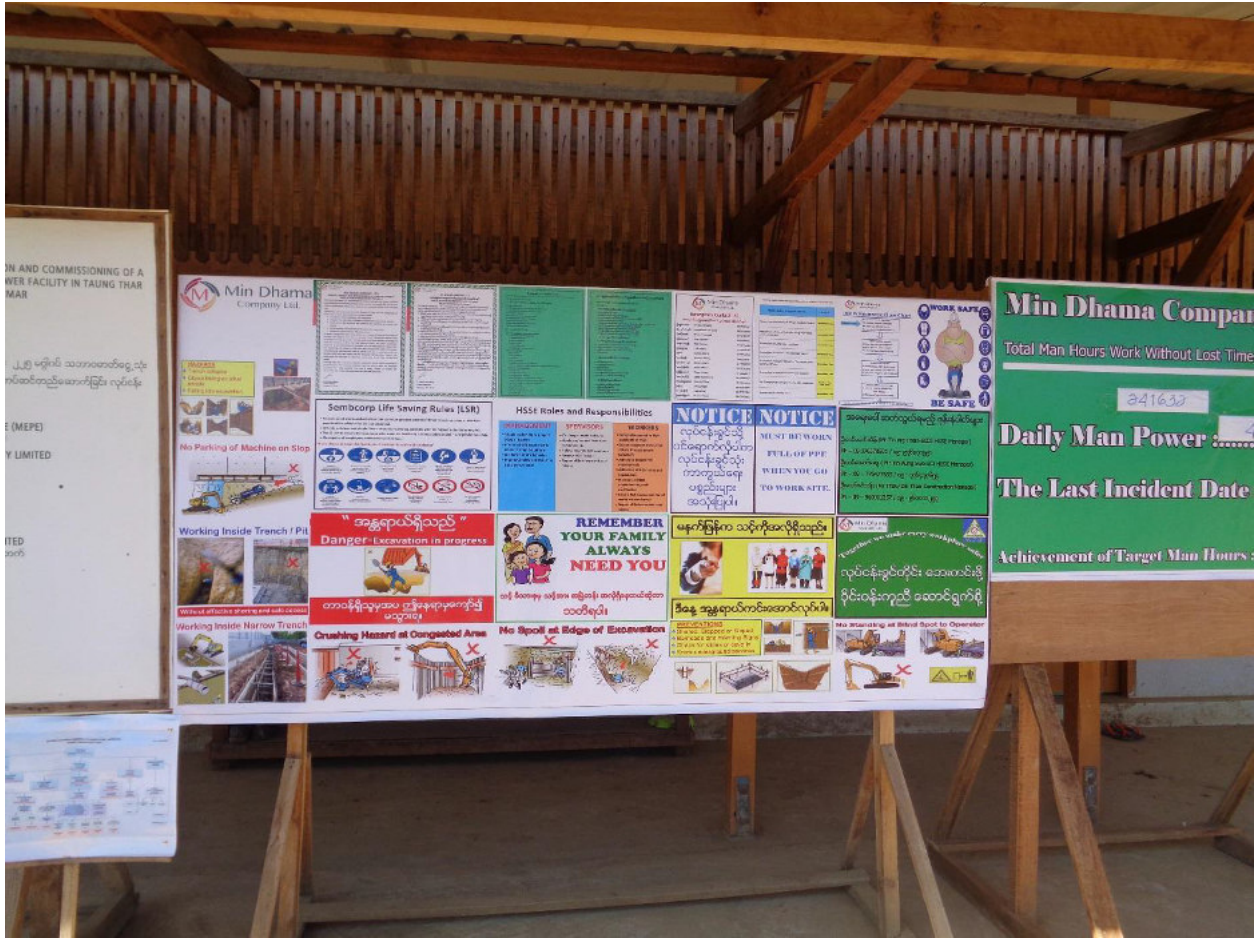
Photo No. 8. Safety reminders to workers outside the Min Dhama office at the Project site

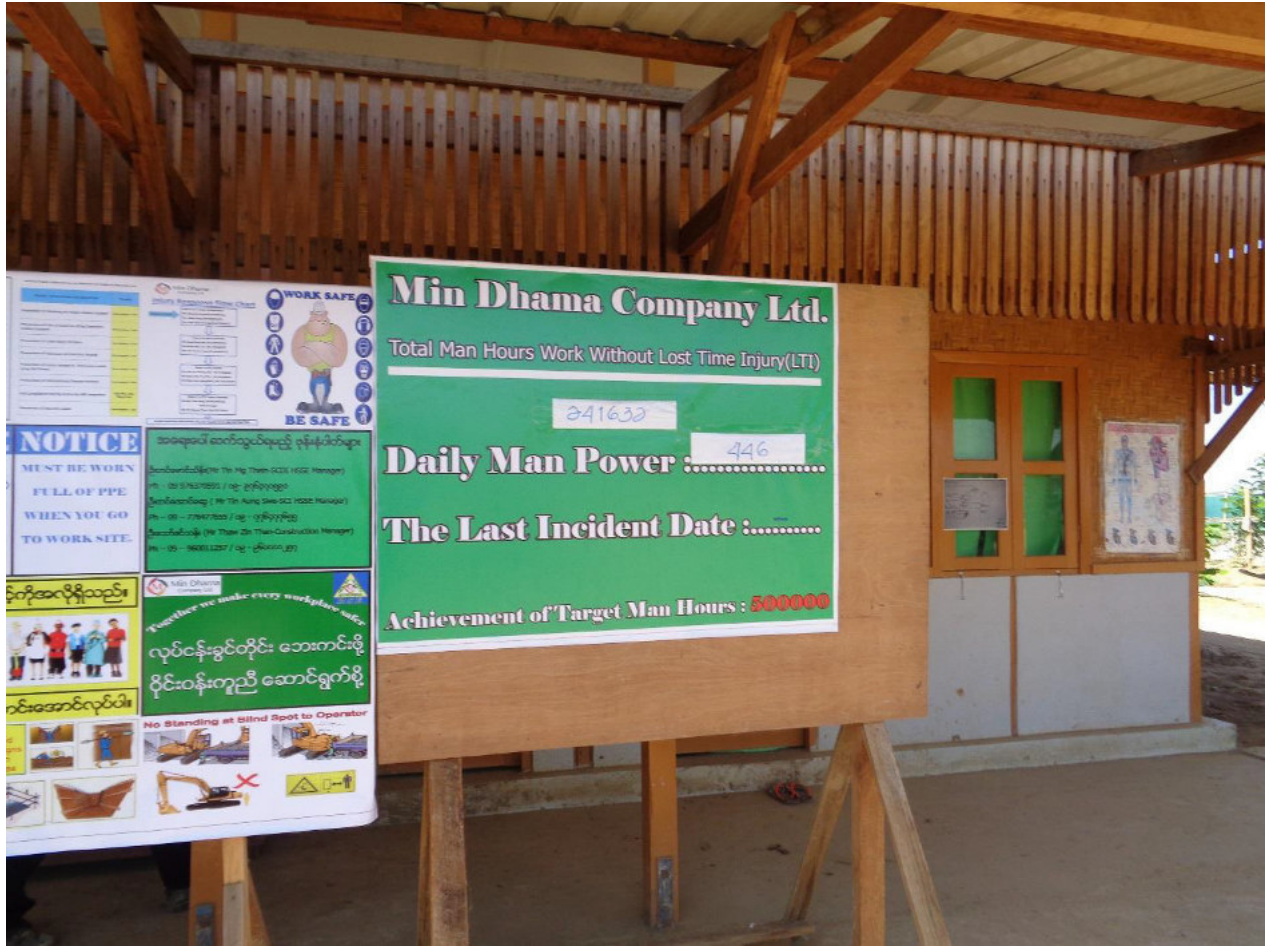
Photo No. 9. Daily log of Min Dhama Health & Safety incidents (zero to date) at the Project site.

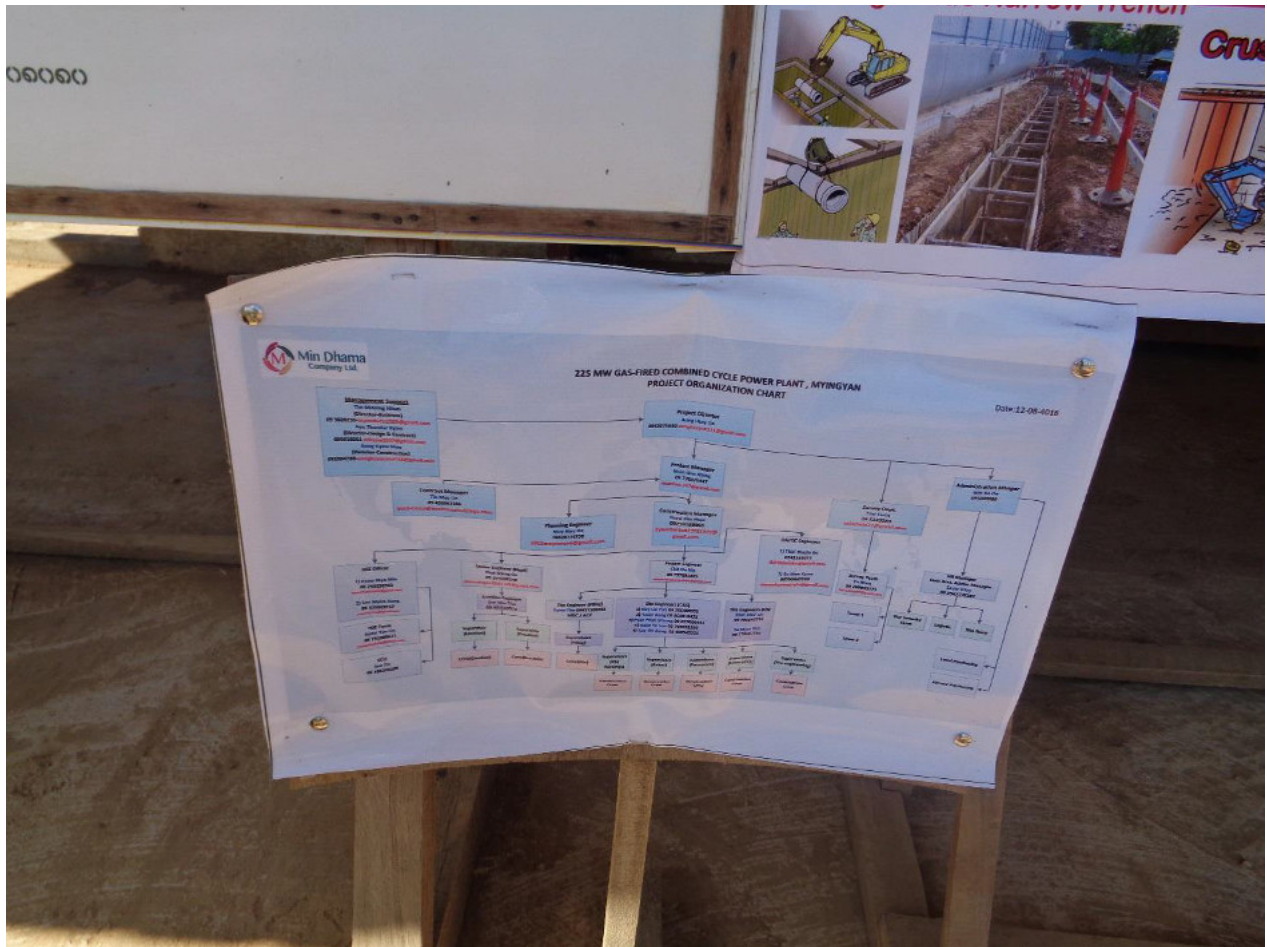
Photo No. 10. Organization Chart of Min Dhama Subcontractor at their Project office

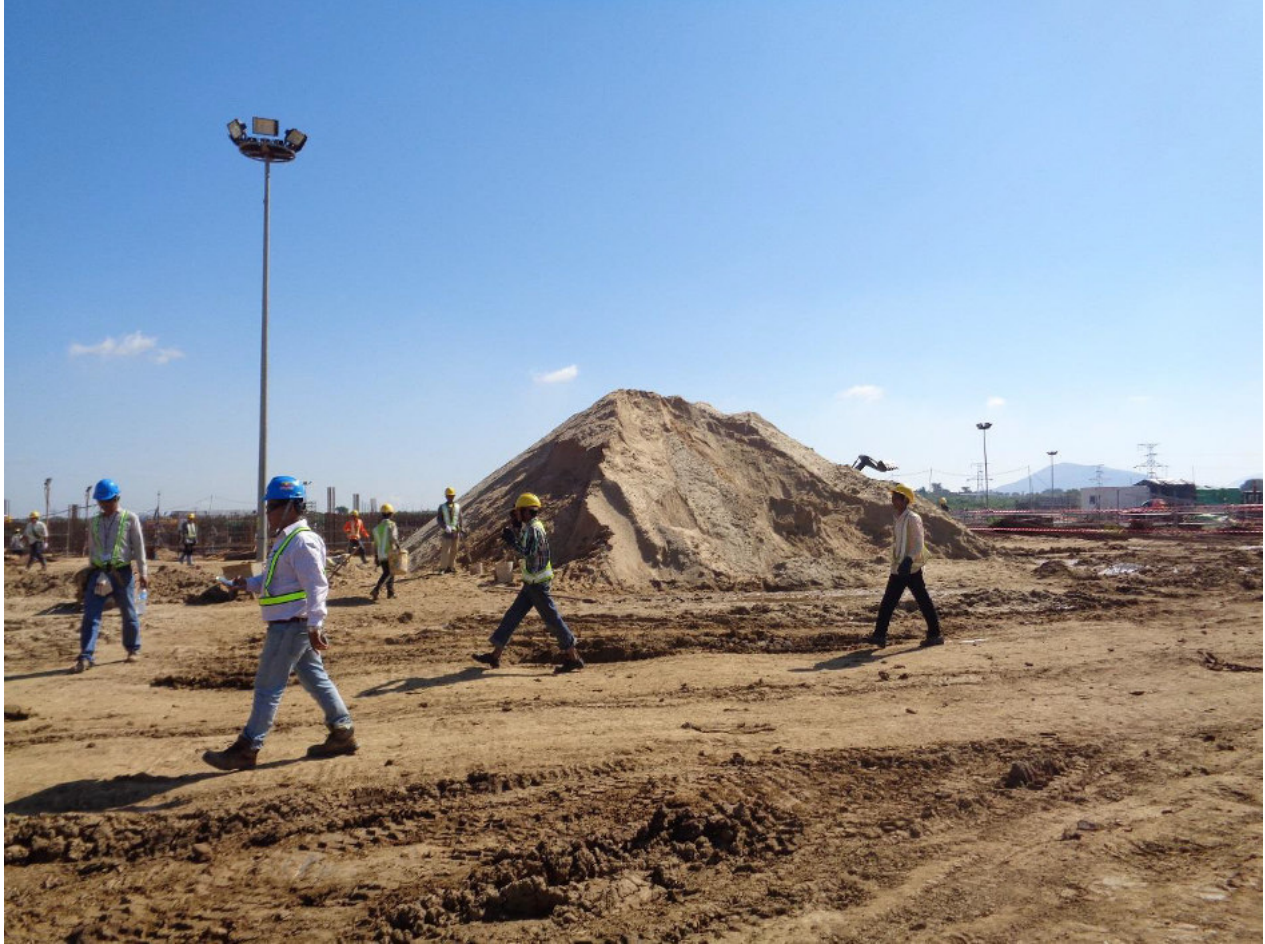
Photo No. 11. At the Project construction site, everyone is wearing proper PPE

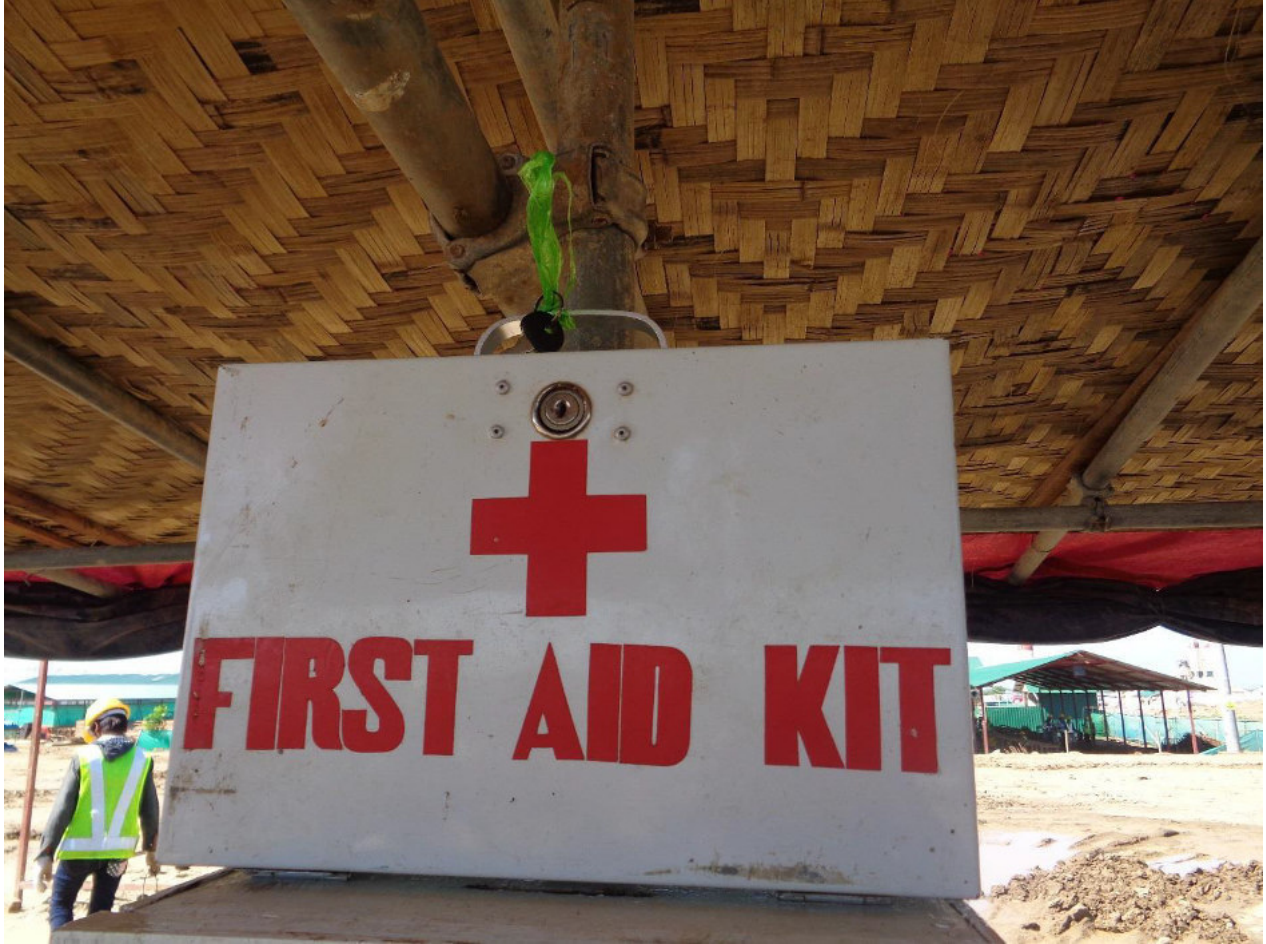
Photo No. 12. First Aid station at the Project construction site

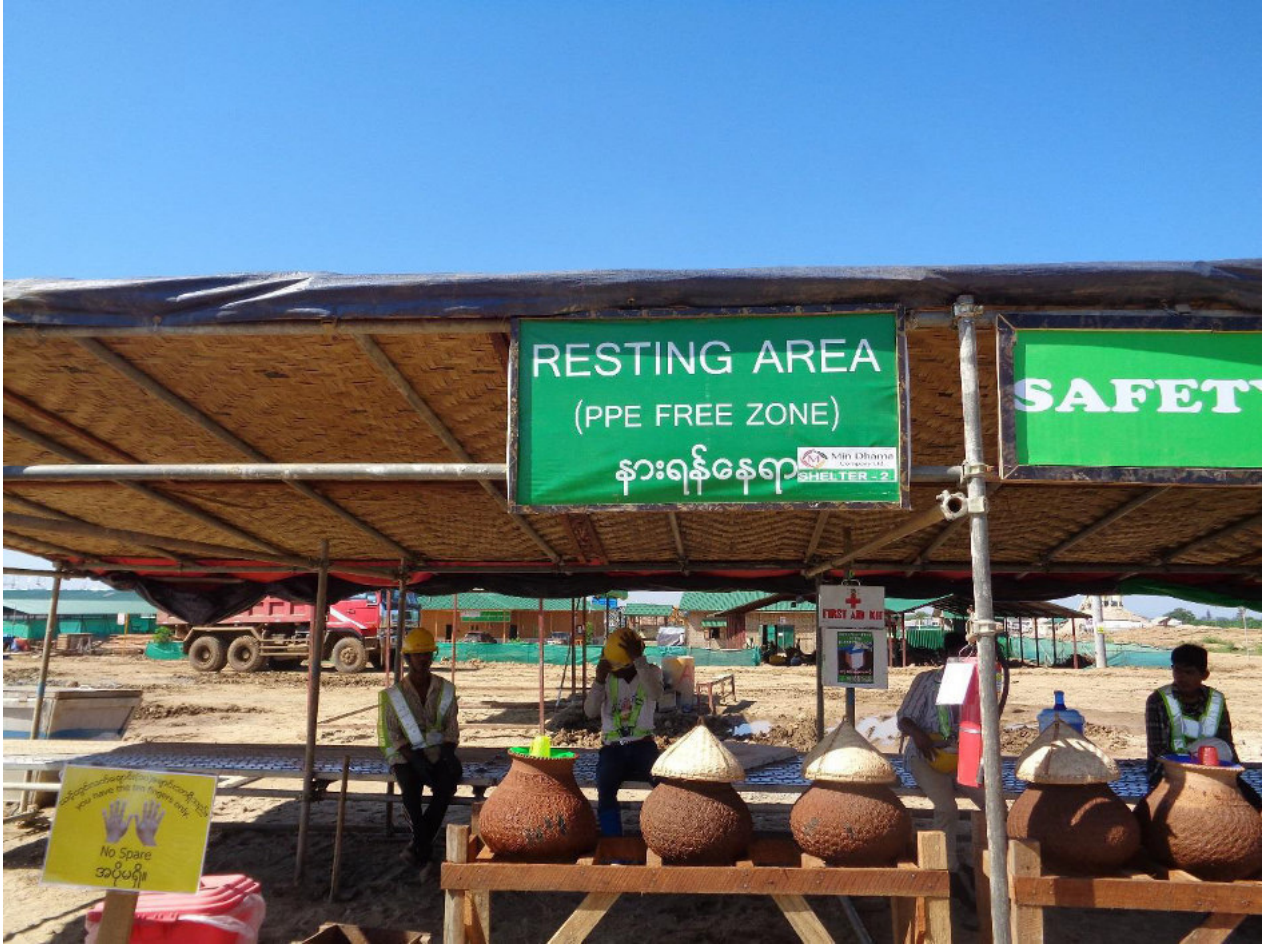
Photo No. 13. Workers rest area, Water drinking area, First Aid station at the Project construction site. The rest area is particularly beneficial to the workers during the summer months.

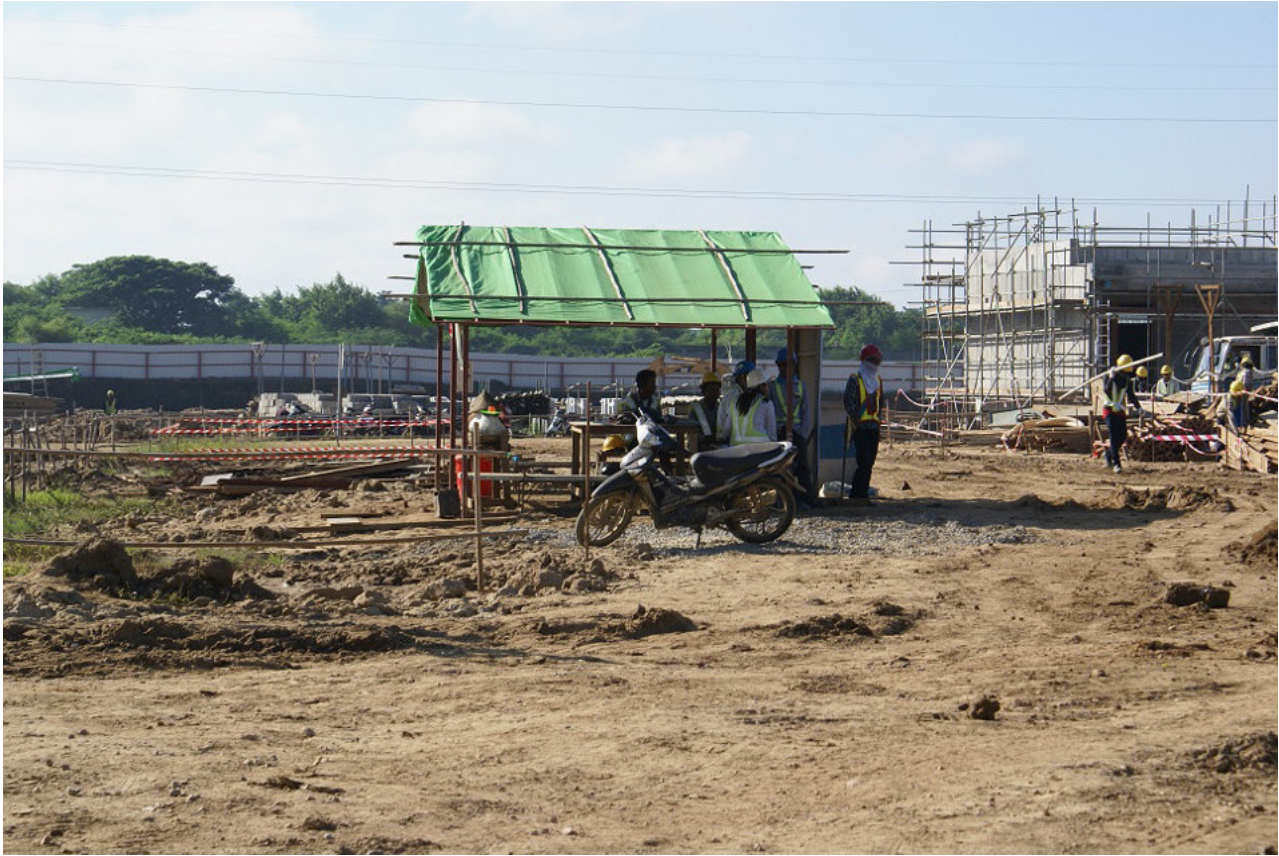
Photo No. 14. Another workers rest area at the Project construction site

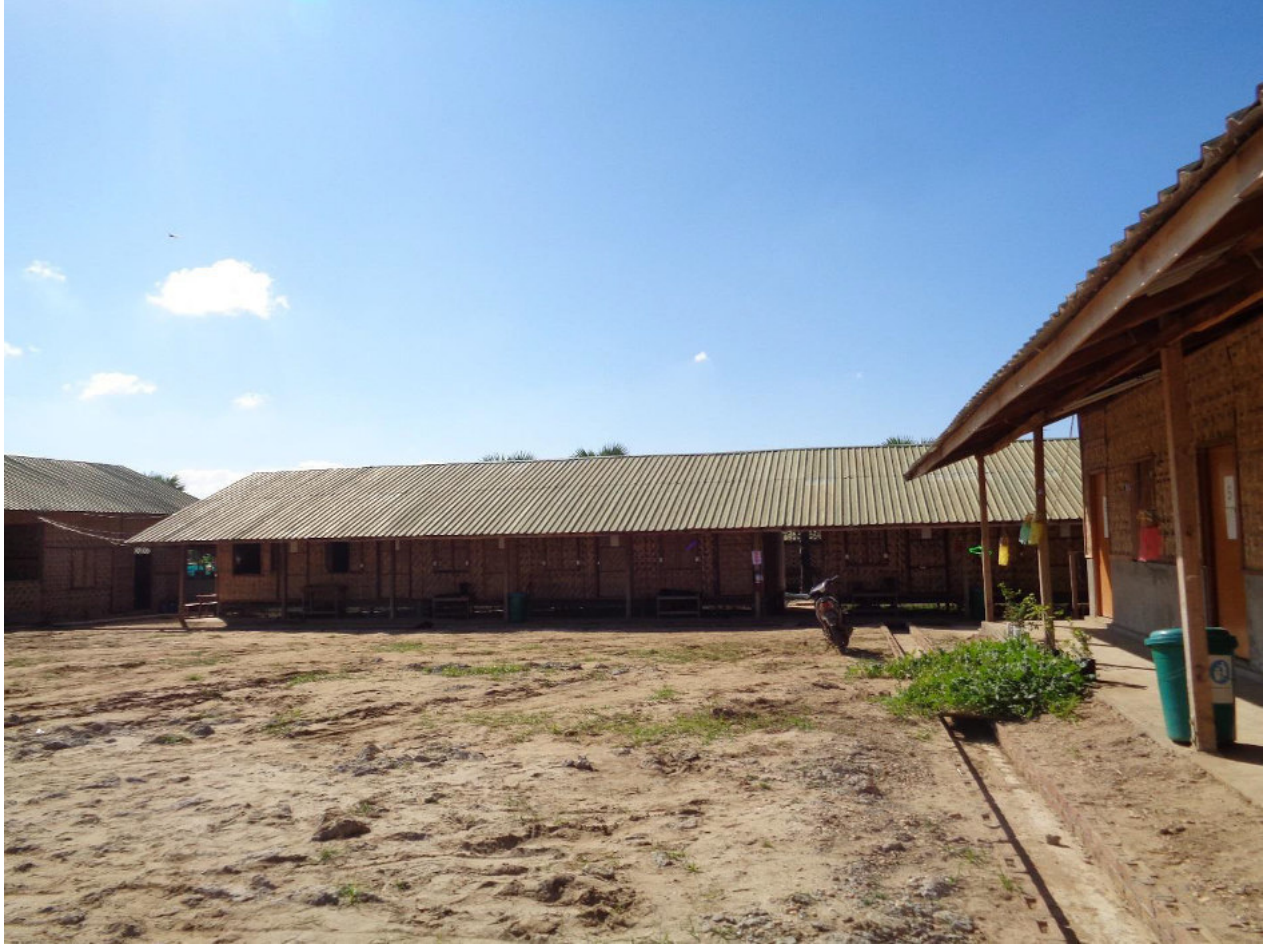
Photo No. 15. Workers accommodation camp for Min Dhamma workers (and families)

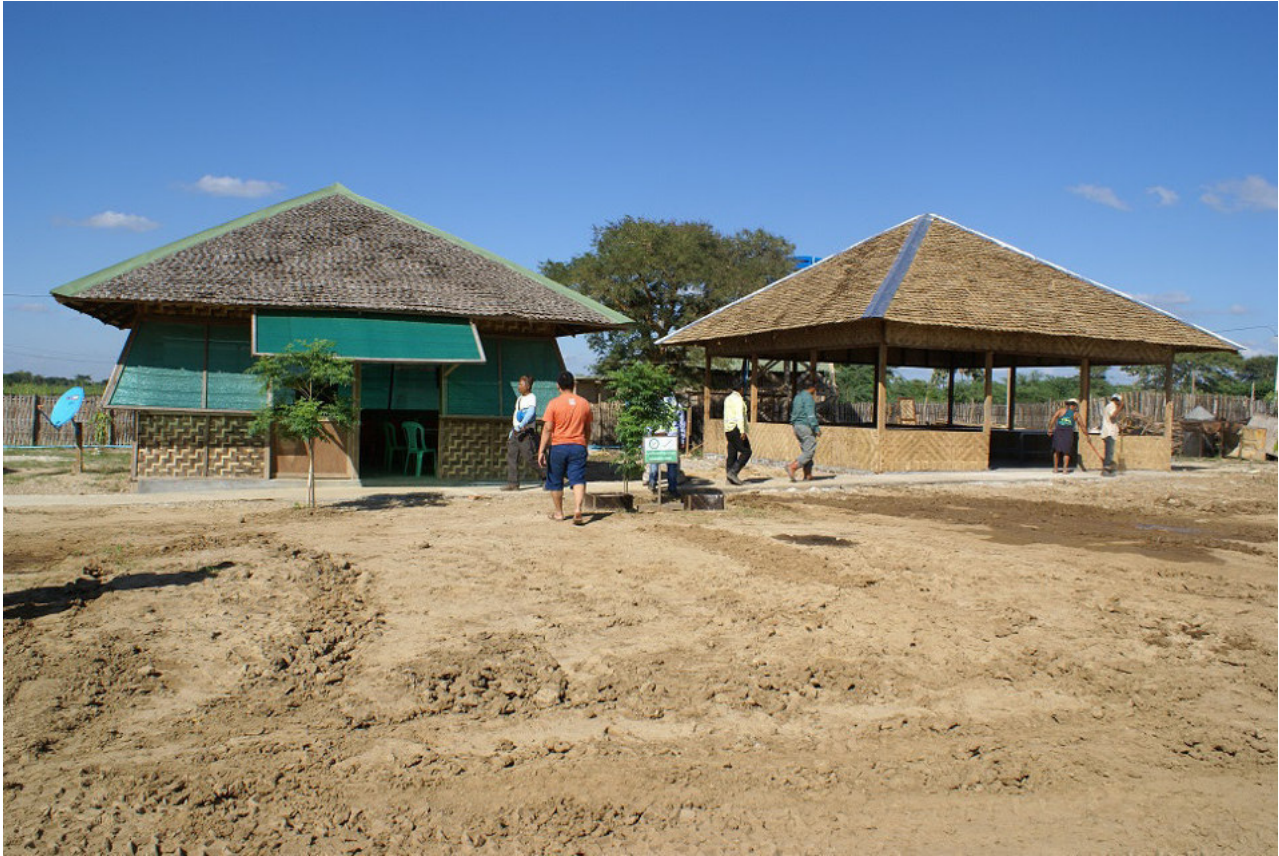
Photo No. 16. Recreation areas at the Min Dhama workers' accommodation camp

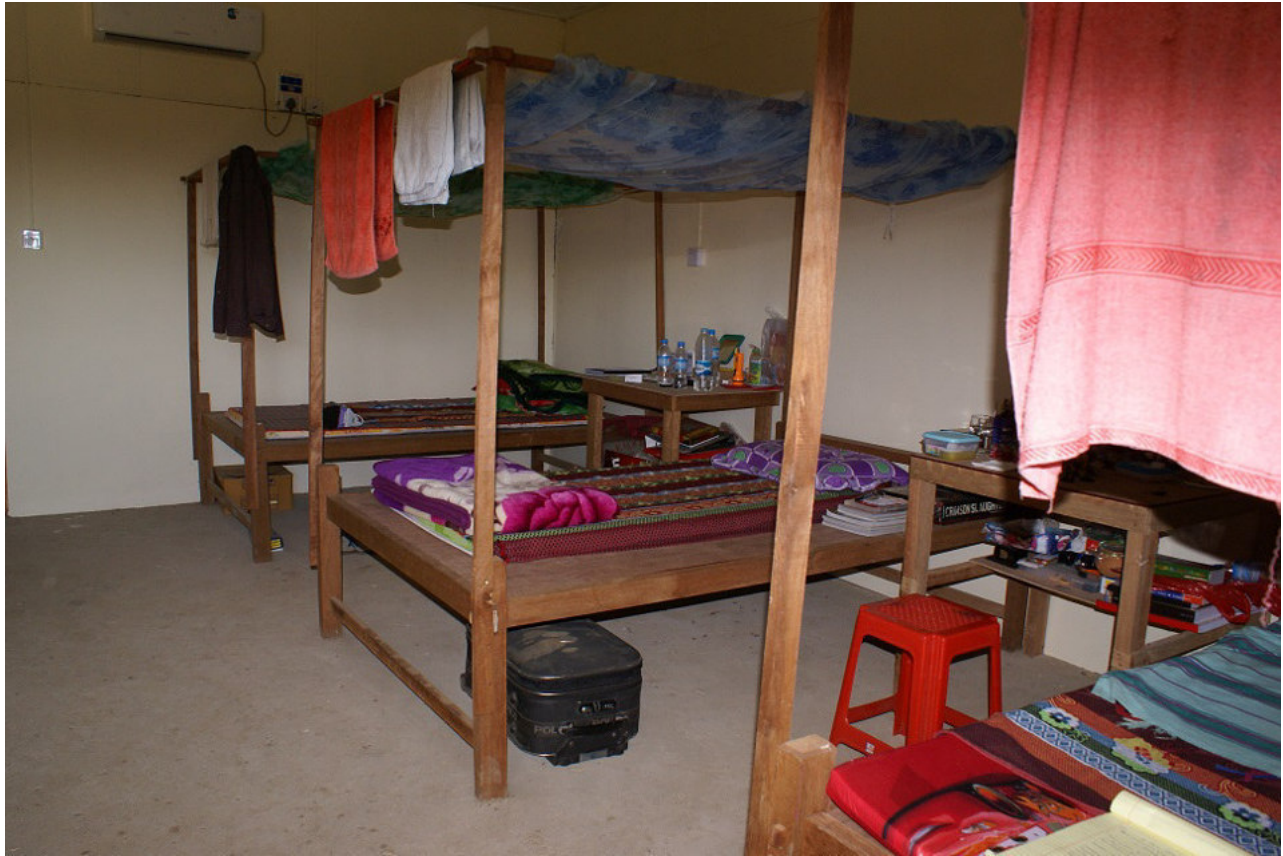
Photo No. 17. Womens skilled labor accommodations at the Min Dhama workers' accommodation camp

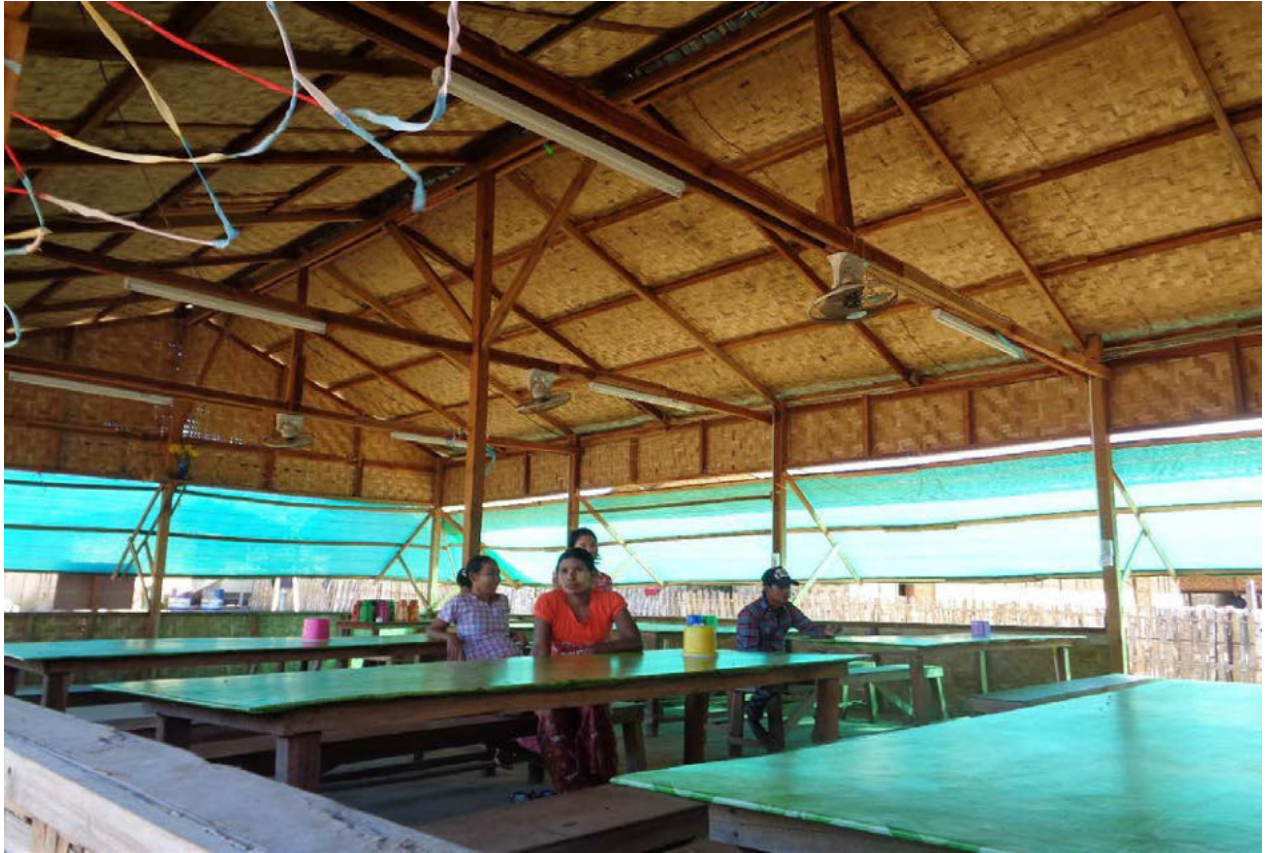
Photo No. 18. Dining area for Min Dhama workers at their workers' accommodation camp

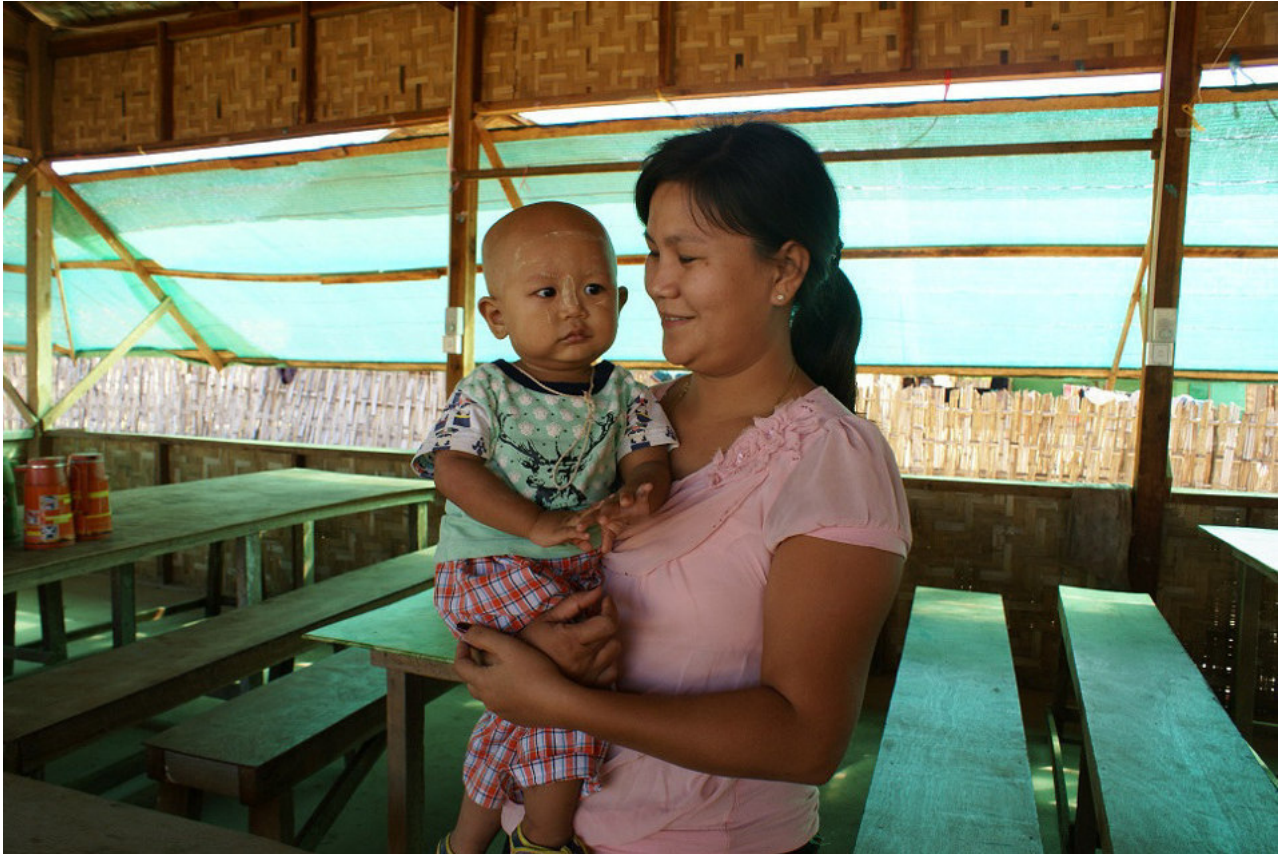
Photo No. 19. Worker's family that is living at the Min Dhama workers' accommodation camp
