Environmental and Social Monitoring First Report

Project Number: 48368-001
August 2017

MYA: Myingyan Natural Gas Power Project Part 2

APPENDIX 4 SITE VISIT PHOTO LOG

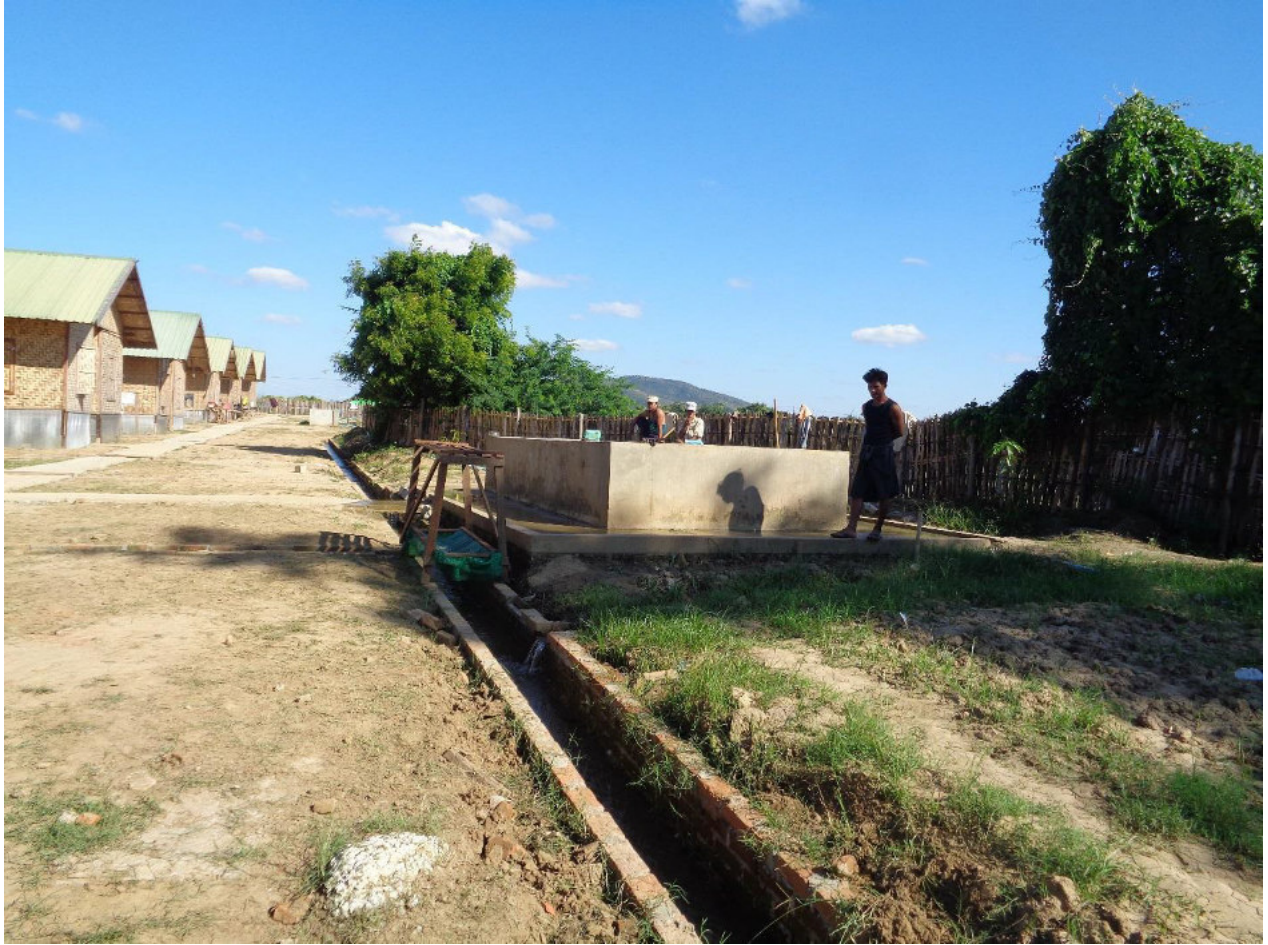
Photo No. 20. Water storage concrete tank for domestic use at the Min Dhama workers' accommodation camp

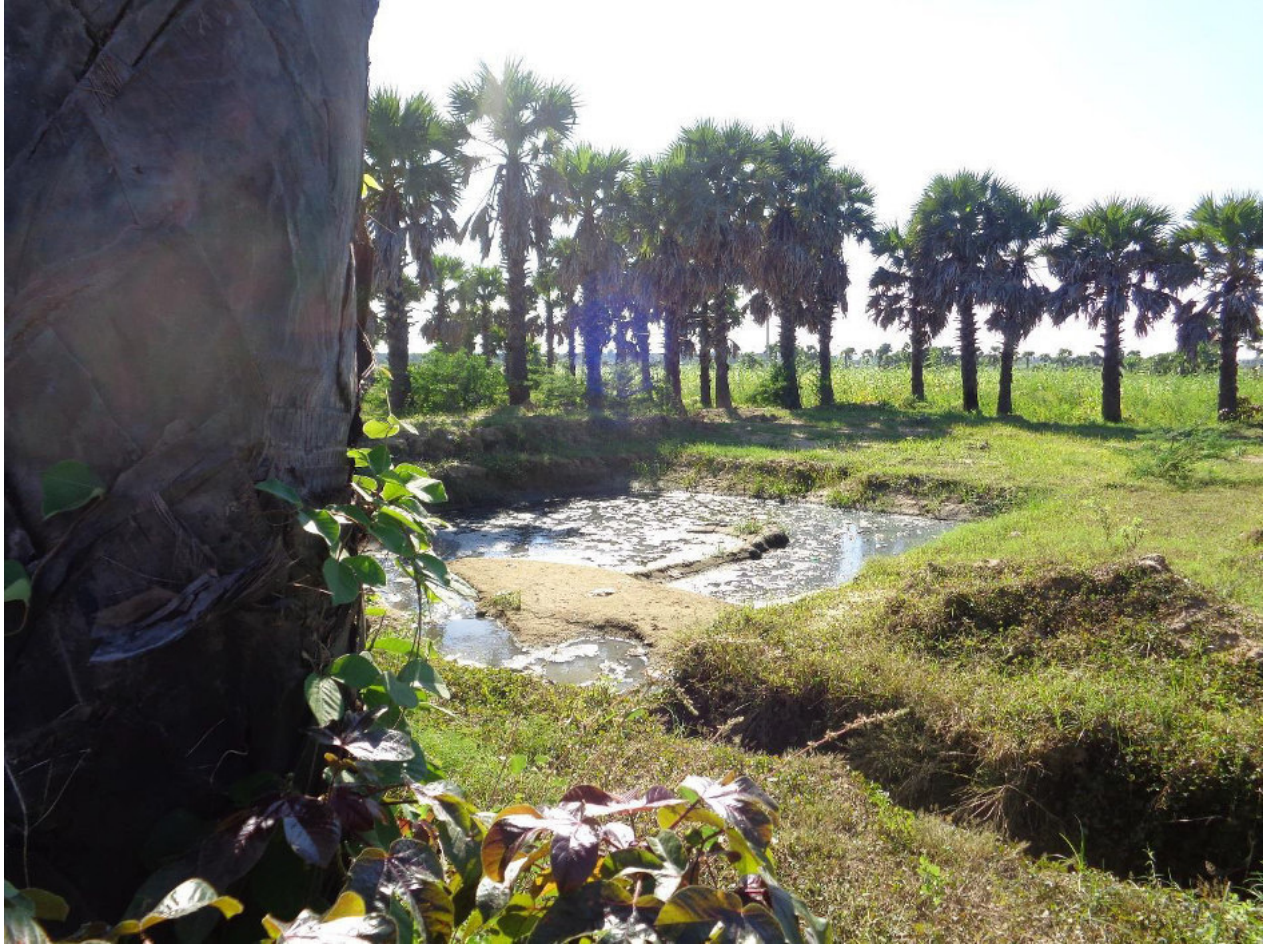
Photo No. 21. Domestic (sanitary) wastewater discharges into the adjoining farm land from the Min Dhama workers' accommodation camp. This was addressed and corrected by the Project immediately after this was noted during the inspection.

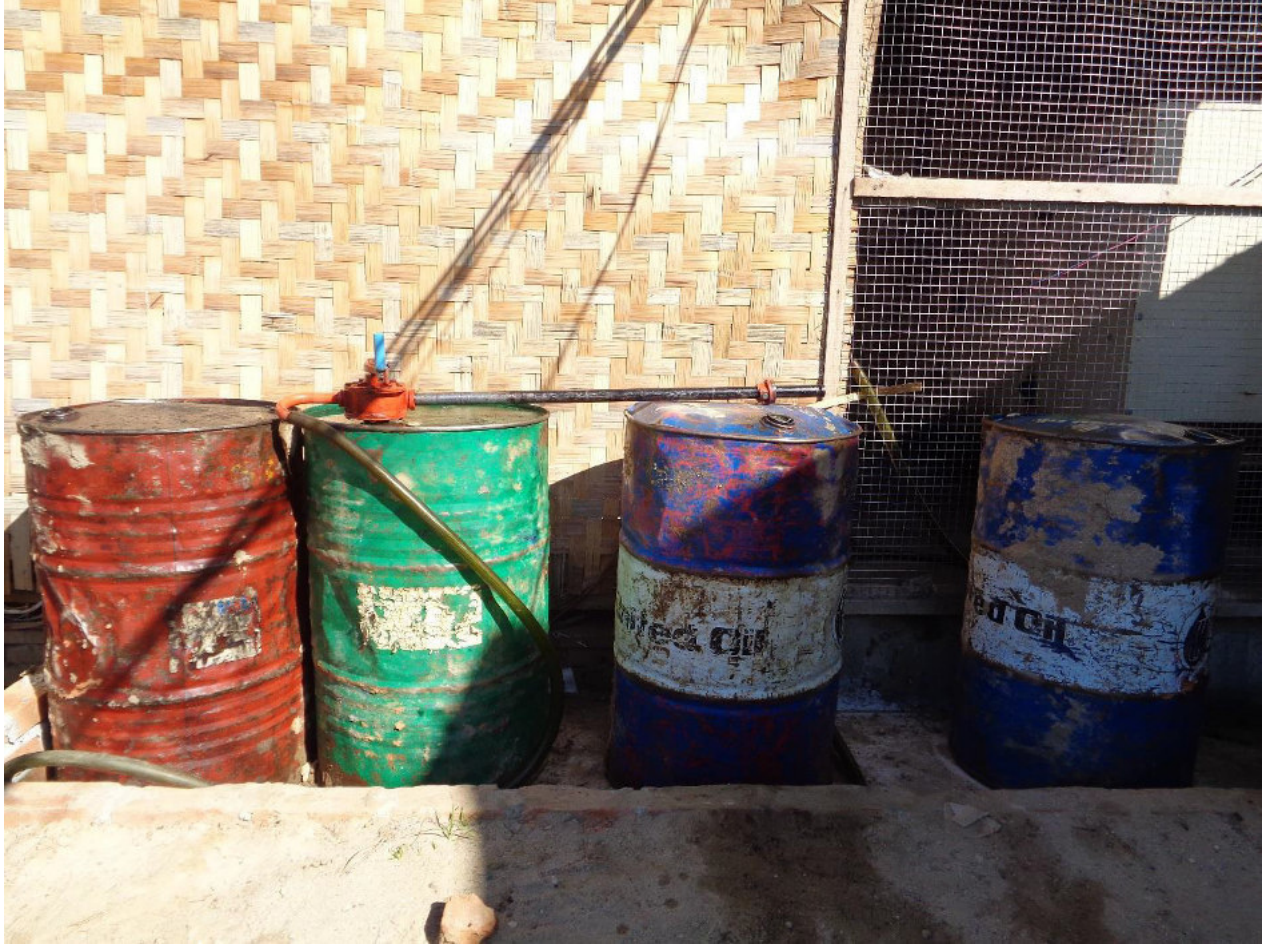
Photo No. 22. Fuel storage for the genset at the Min Dhama workers' accommodation camp. Needs improvement on the containment in case of leak or spills.

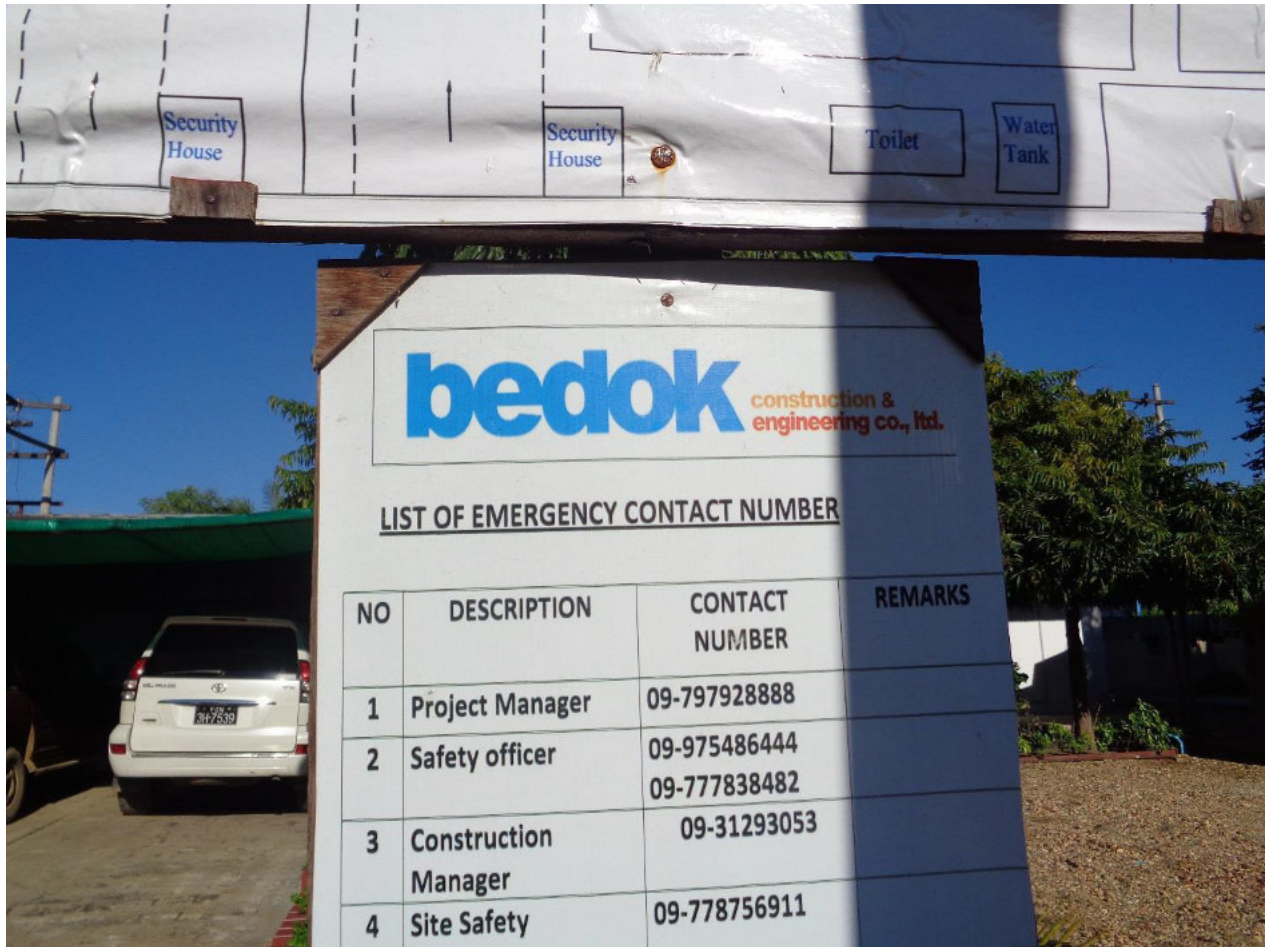
Photo No. 23. Emergency contact numbers at the Bedok workers' accommodation camp outside of the Project site.

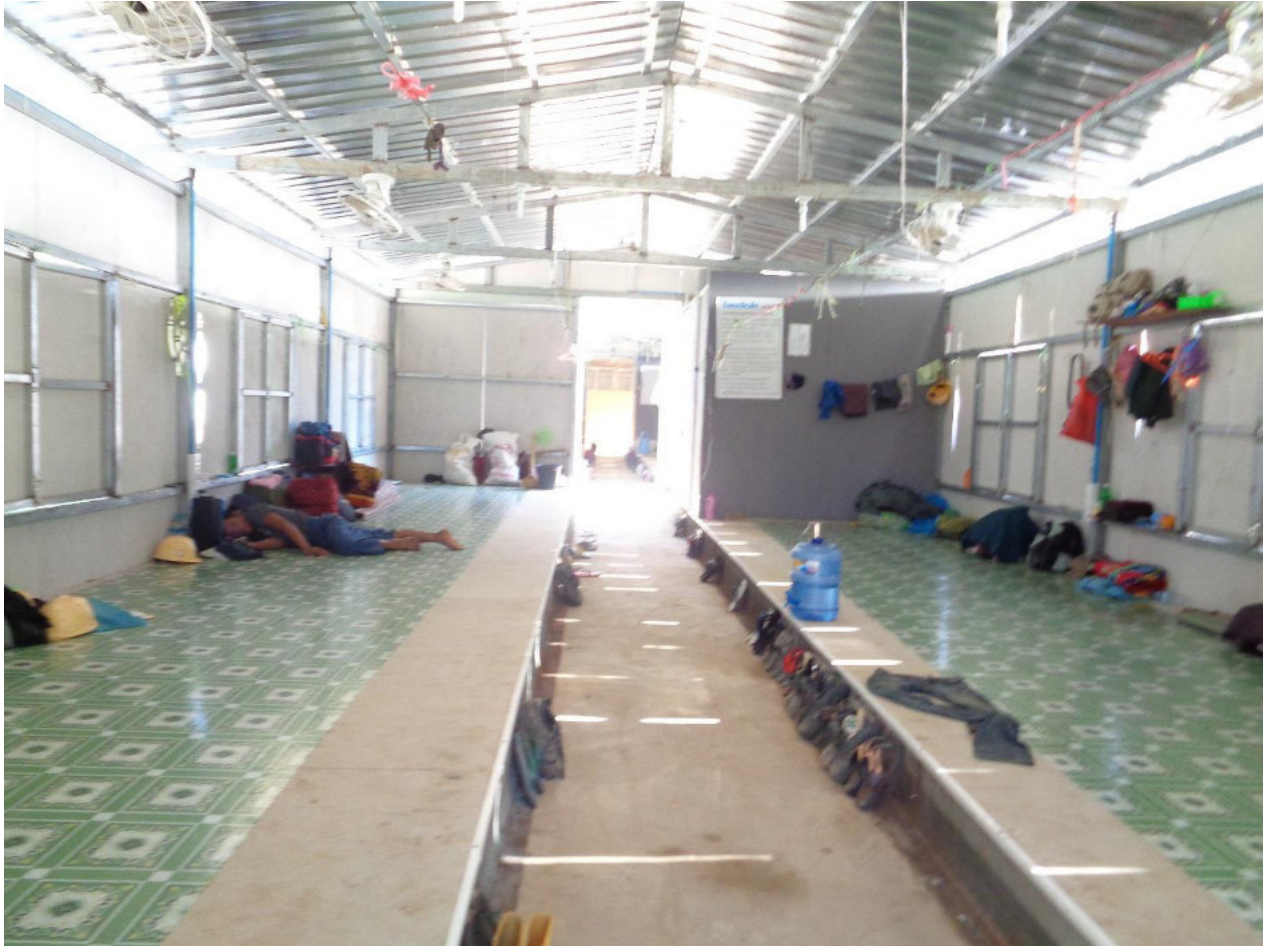
Photo No. 24. Sleeping area at the Bedok workers' accommodation camp, which is not in compliance with Lenders' standards.

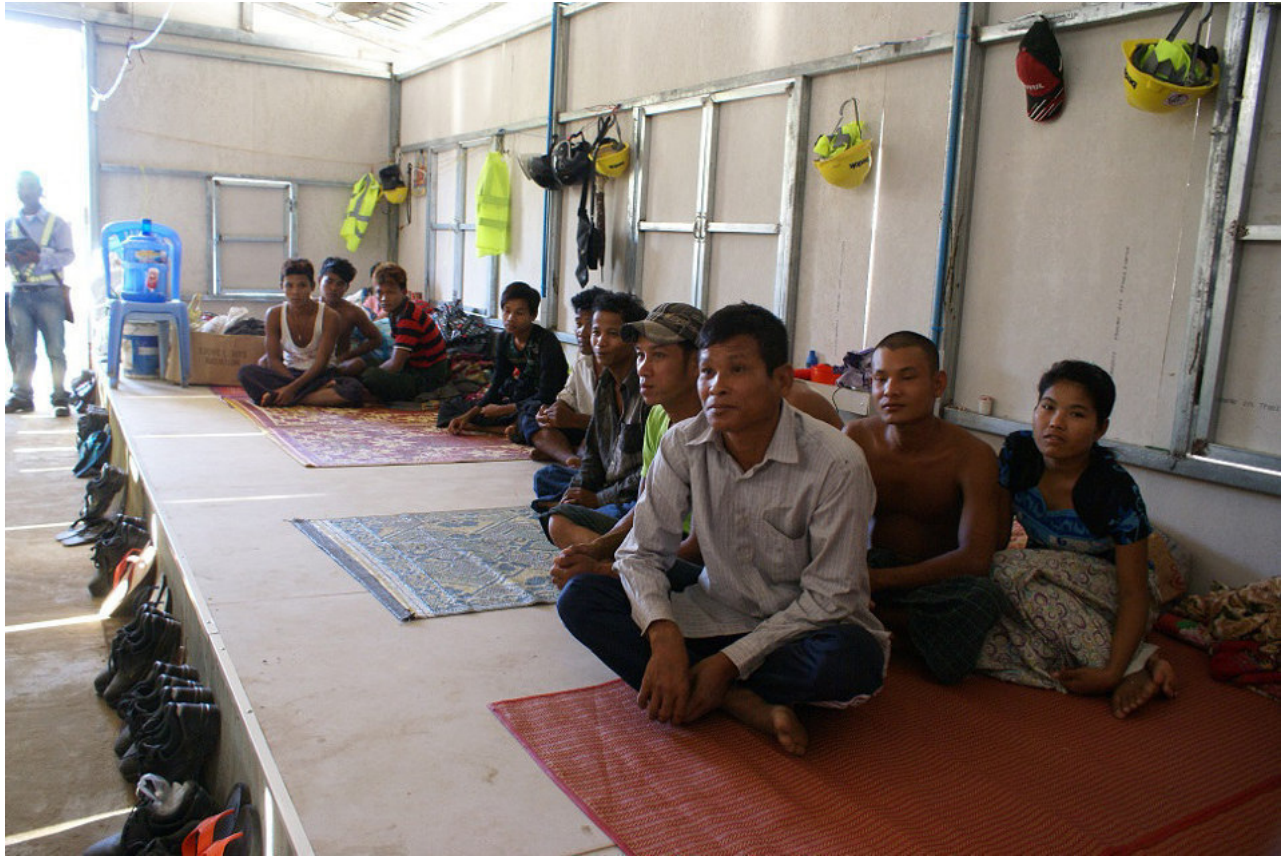
Photo No. 25. Workers relaxing and watching TV in a sleeping area at the Bedok workers' accommodation camp.

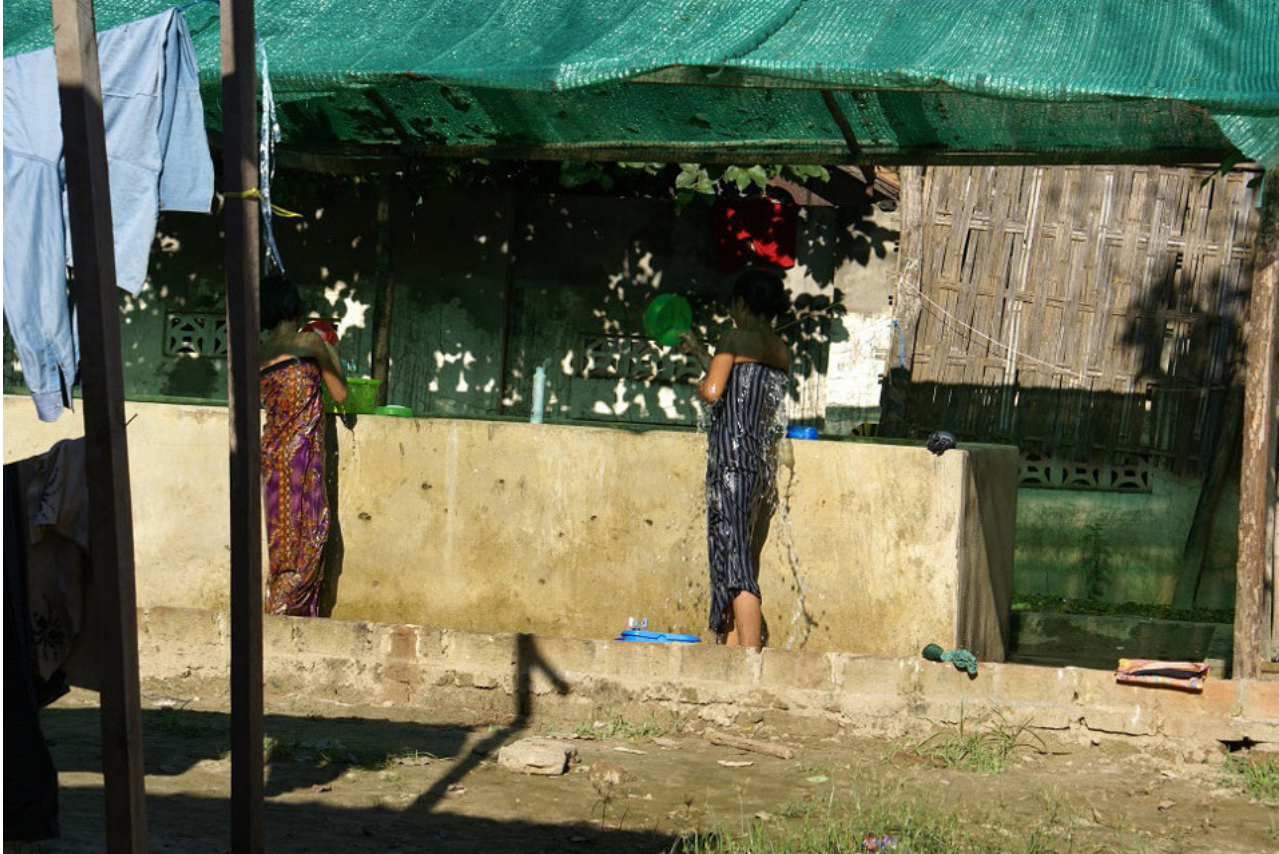
Photo No. 26. Outdoor bathing facility at the Bedok workers' accommodation camp

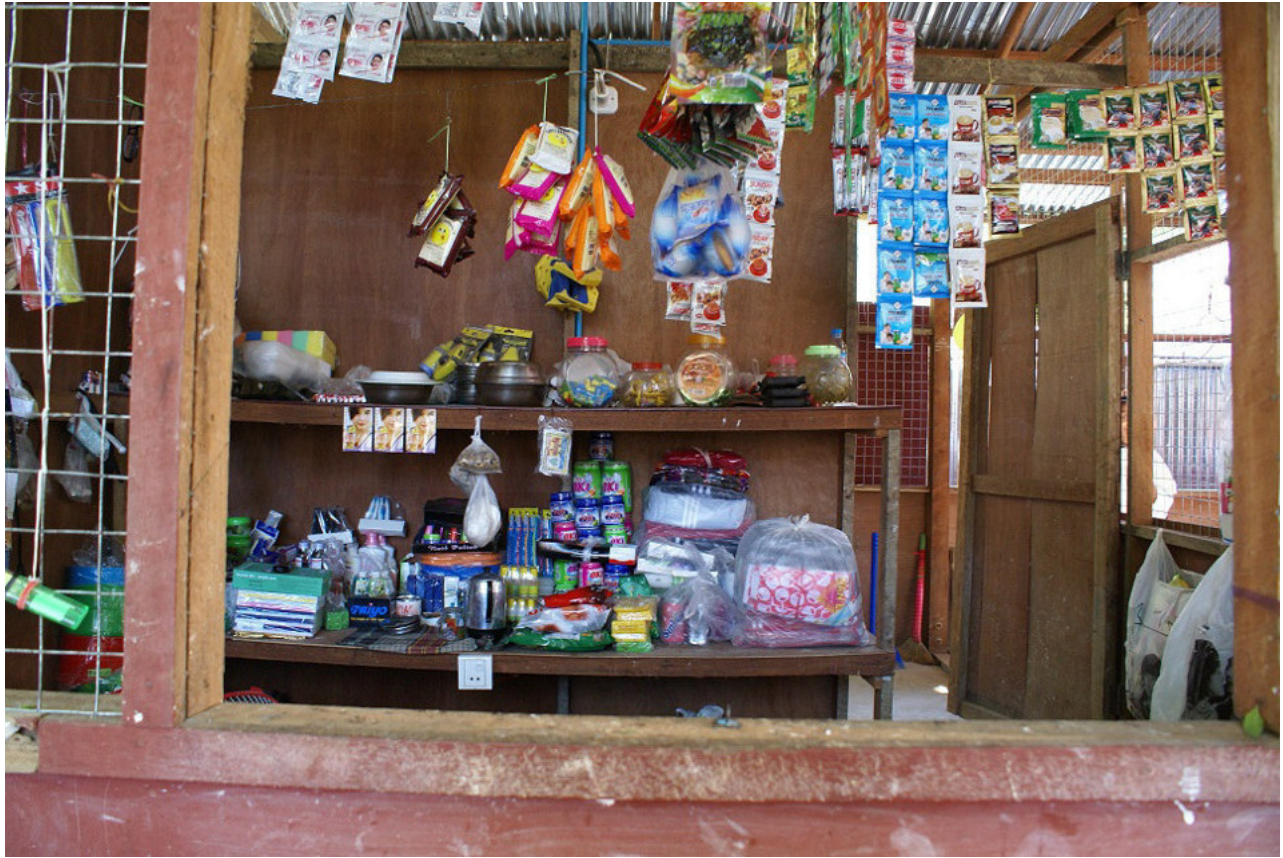
Photo No. 27. Shop at the Bedok workers' accommodation camp

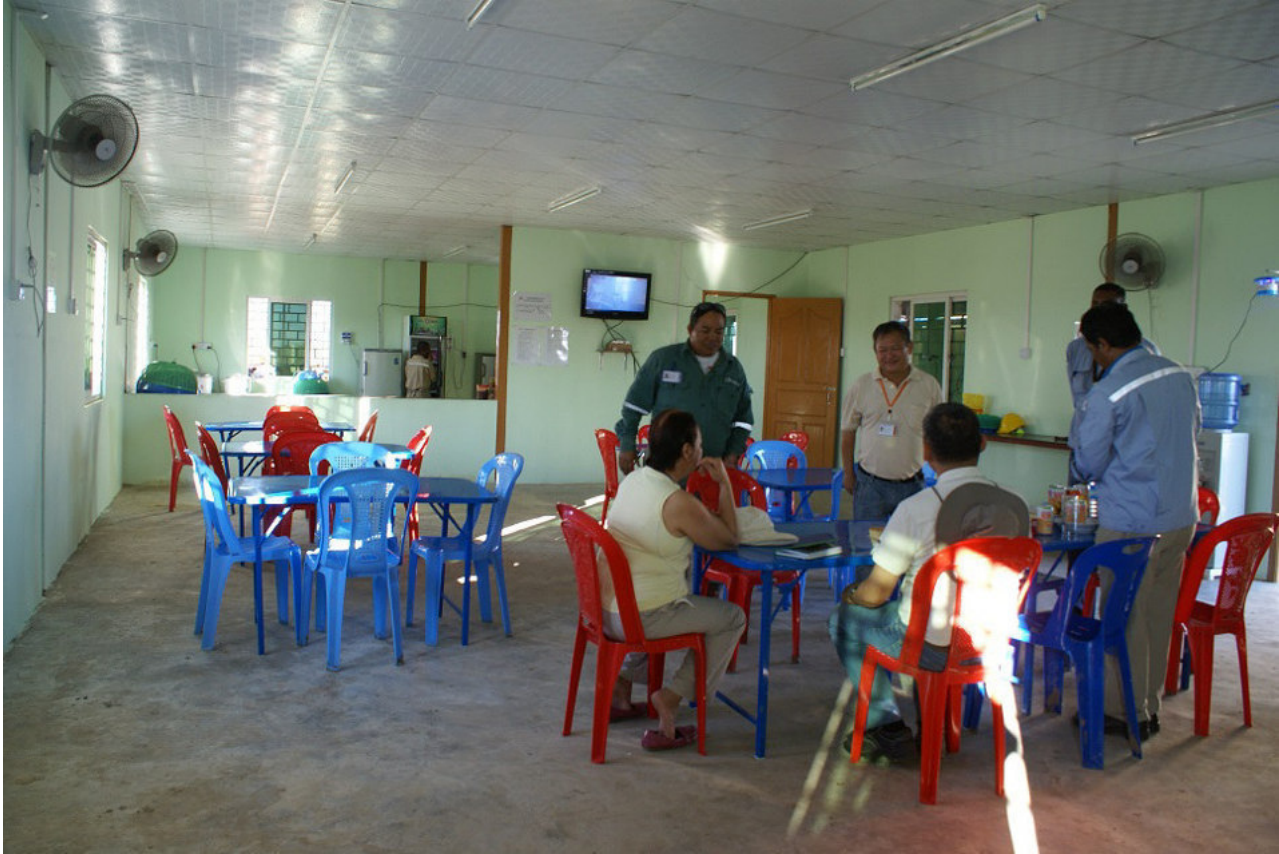
Photo No. 28. Dining area at the Jurong workers' accommodation camp

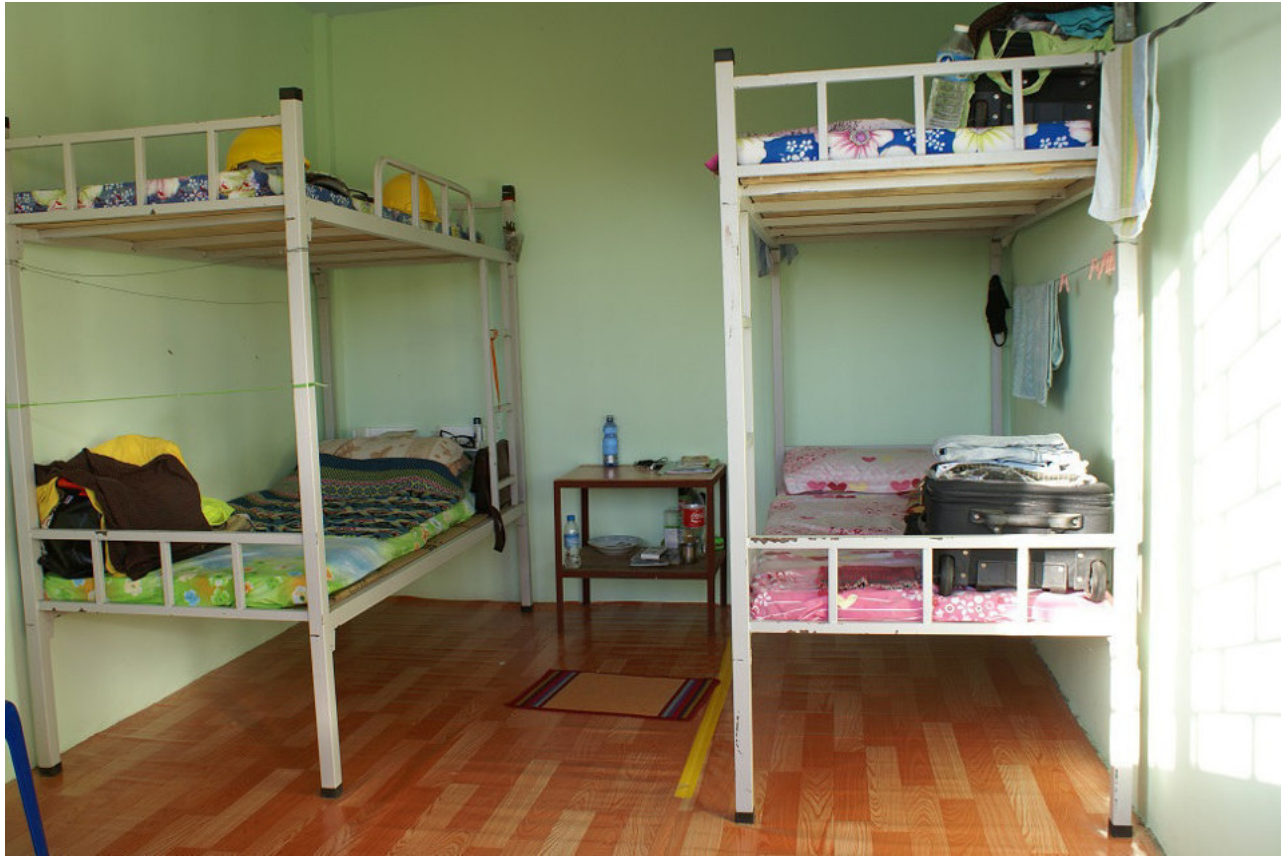
Photo No. 29. Womens skilled labor accommodations at the Jurong workers' accommodation camp

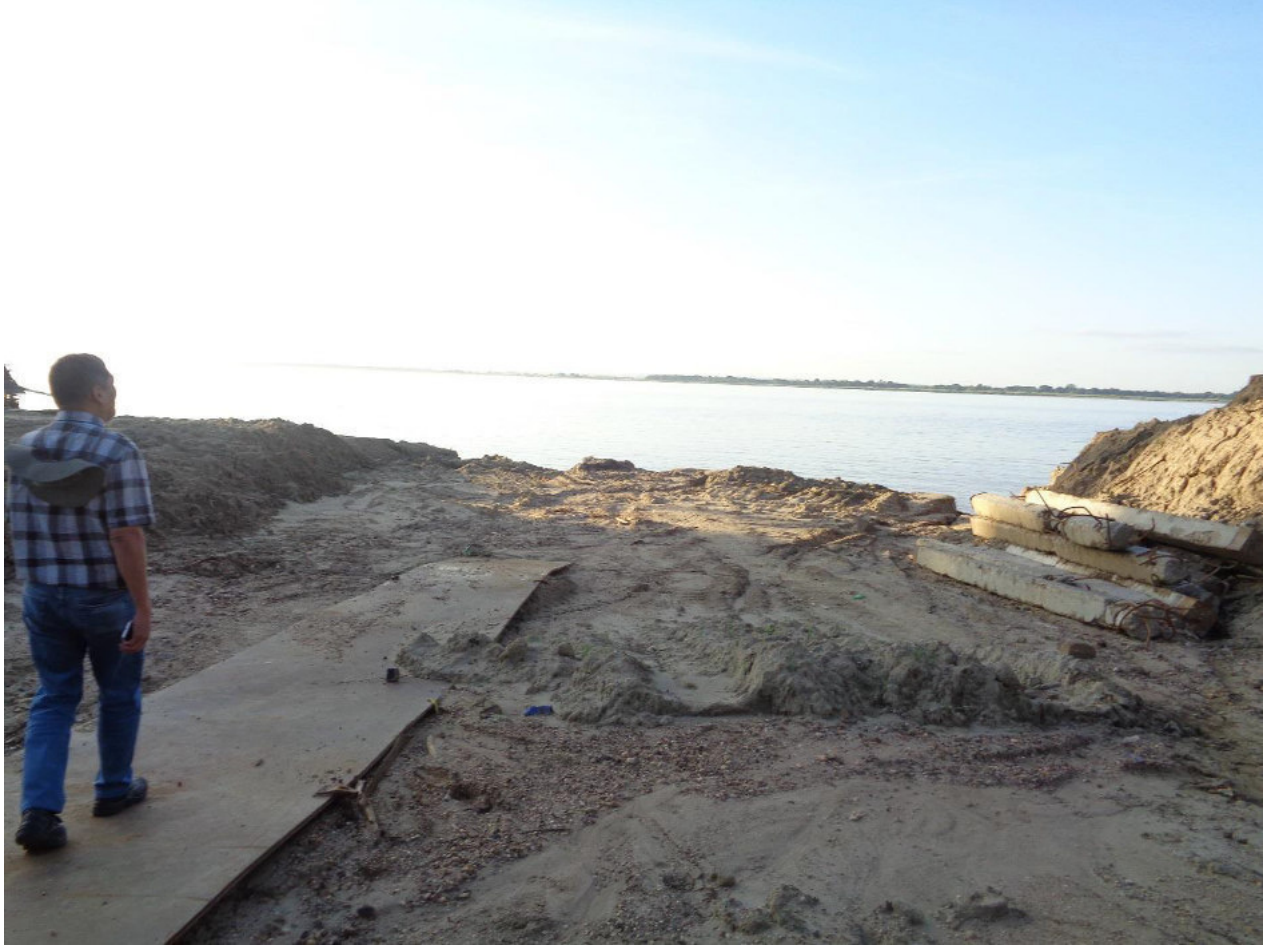
Photo No. 30. Private jetty at Nyaung Hla along the Ayeyarwaddy River. The jetty will be used to receive materials and supplies for the Project.

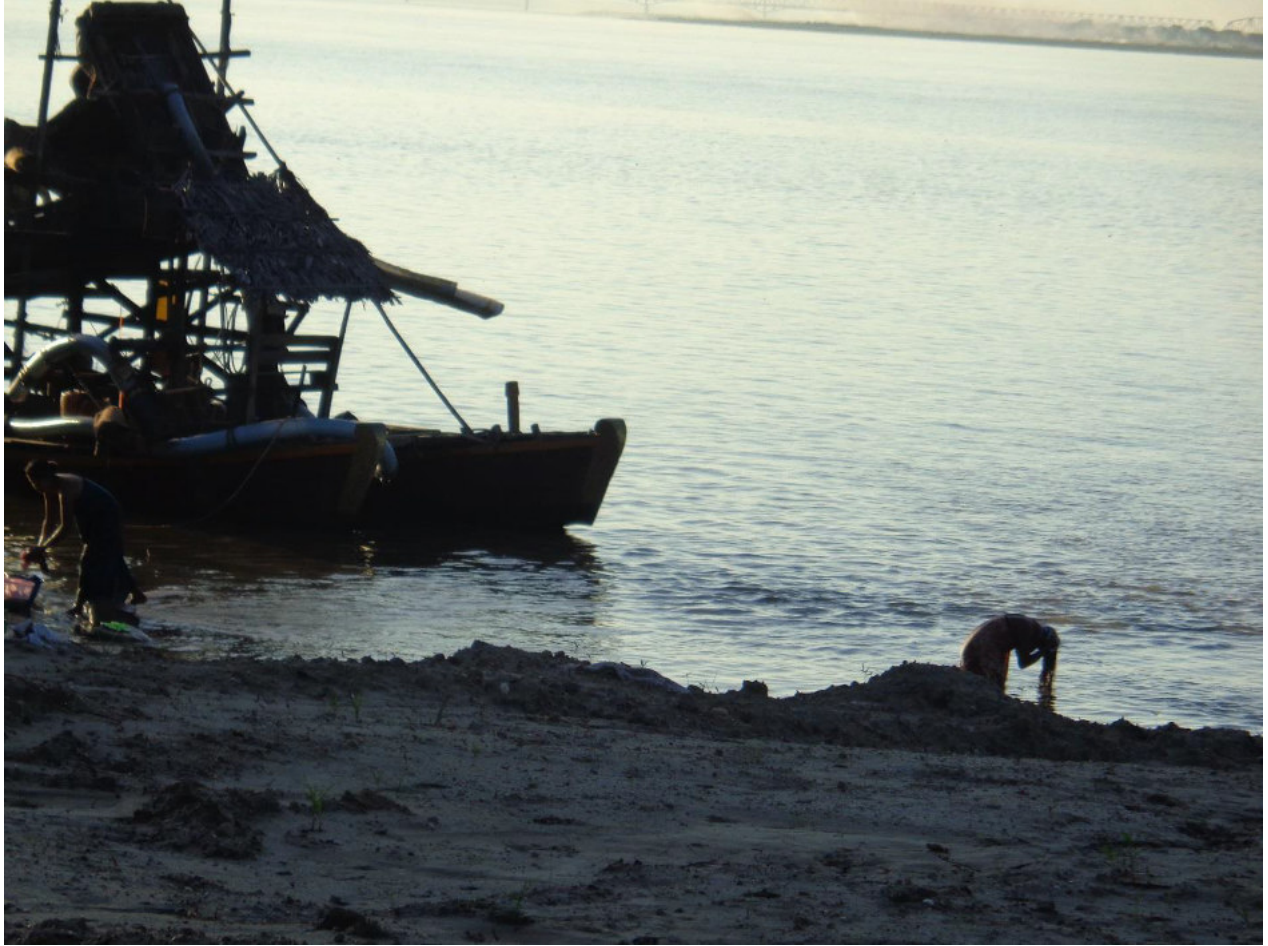
Photo No. 31. Other users of the jetty when not in use by the Project or the jetty owner.

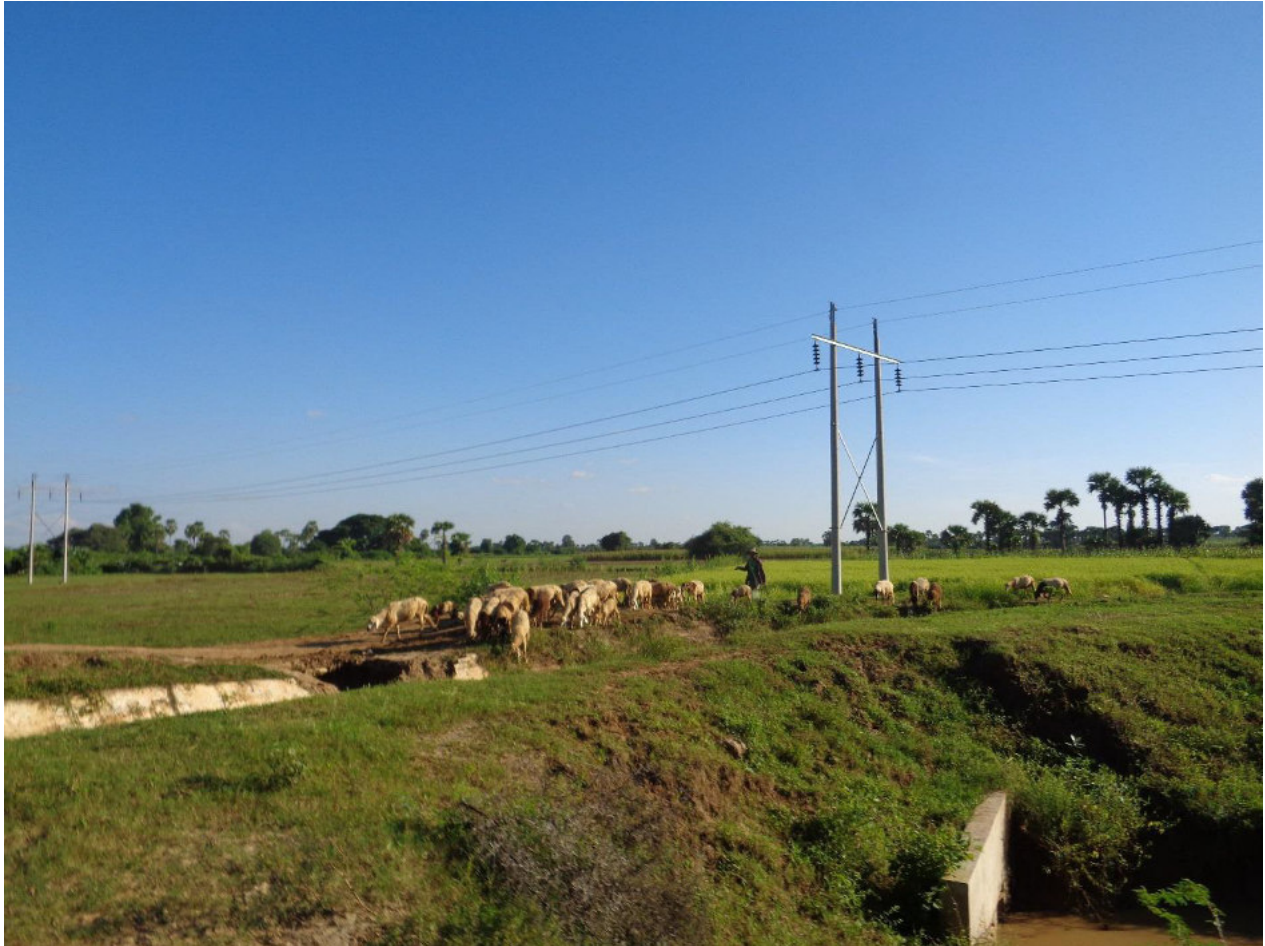
Photo No. 32. Villagers along the water supply pipeline route where farming and pasturing are the common means of livelihood.

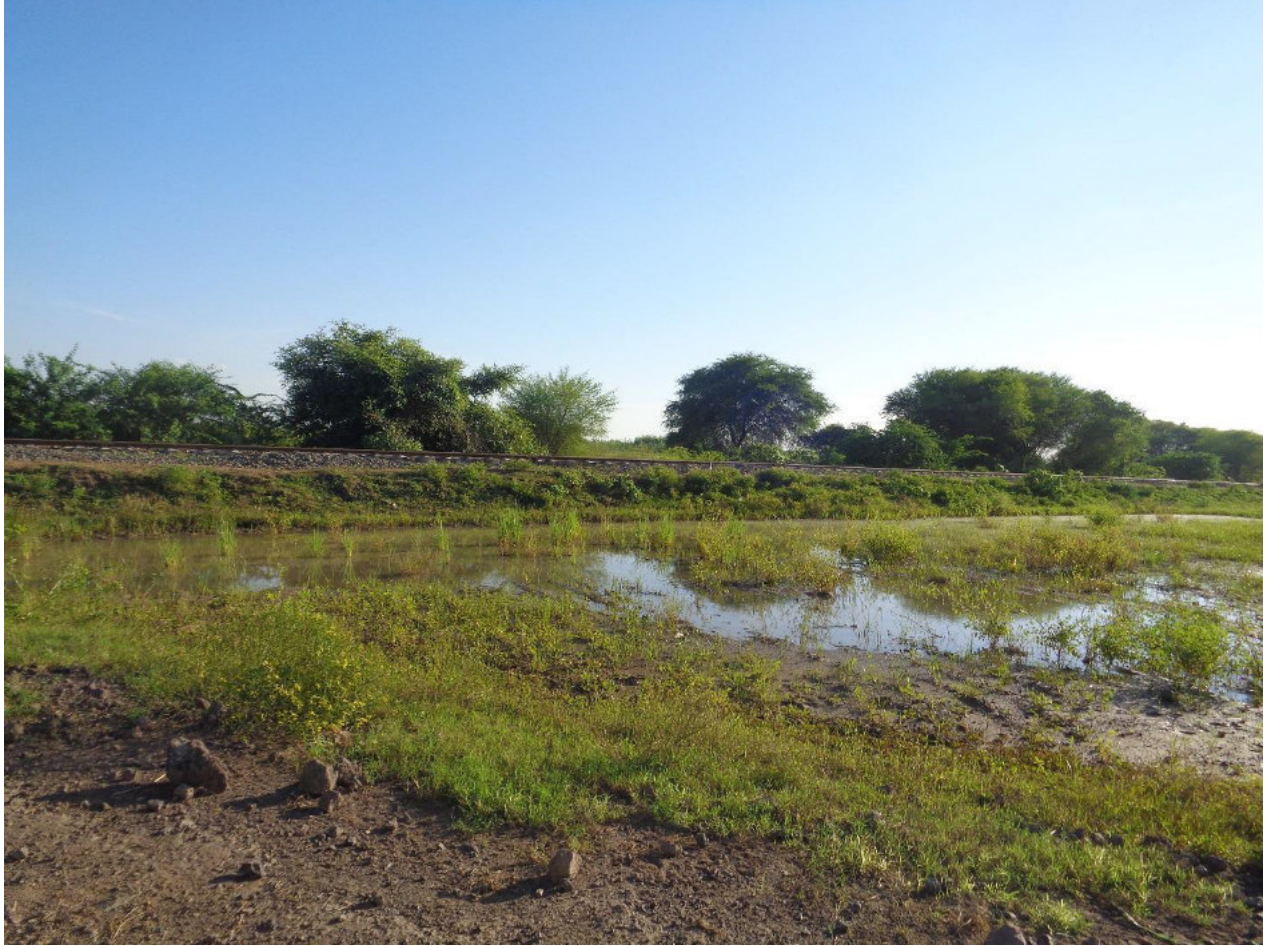
Photo No. 33. Along the access road to the Project site from the area where the water supply pipeline will be installed. Migratory birds and resident birds drink and feed in this area away from the village.

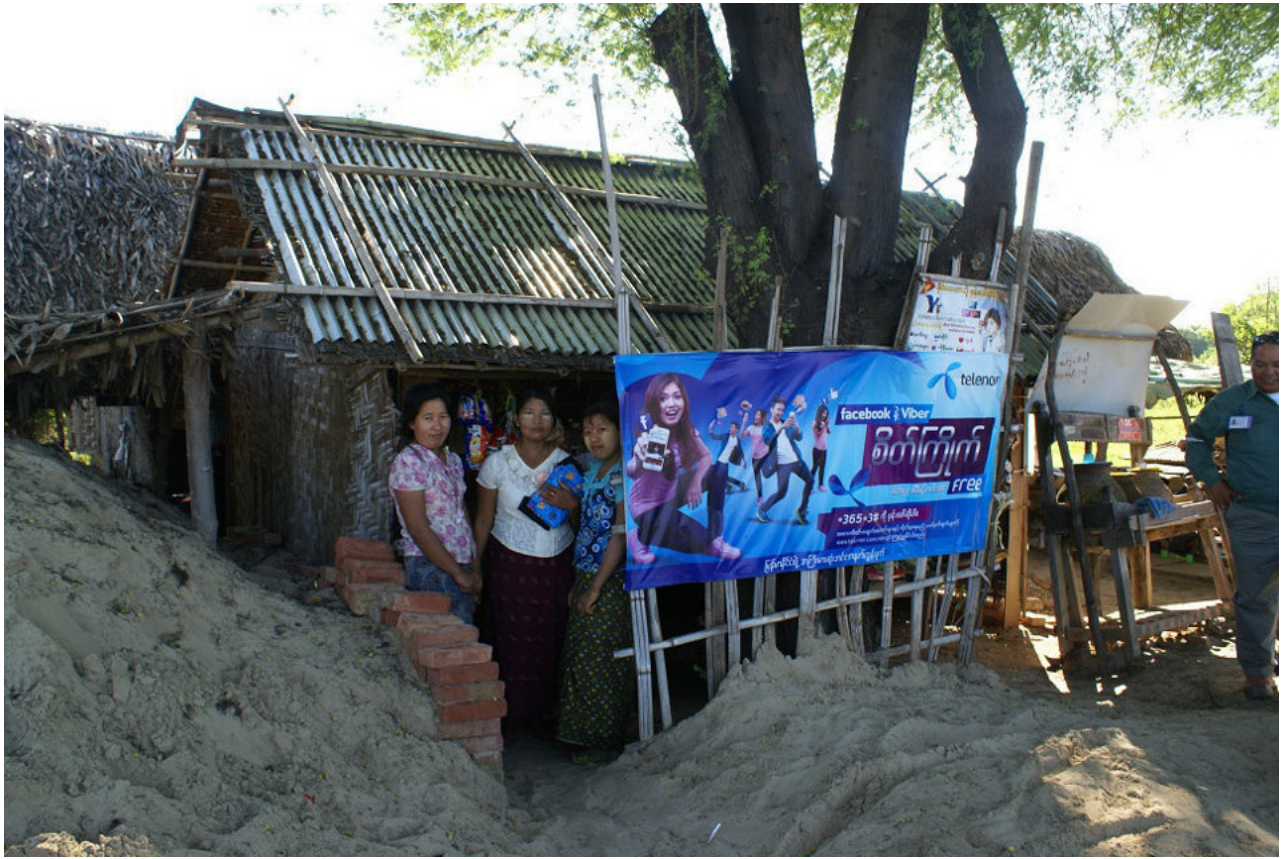
Photo No. 34. Young women we interviewed at a shop in Ayeywar along the water supply pipeline route
