Environmental and Social Monitoring Second Report

Project Number: 48368-001
August 2017

MYA: Myingyan Natural Gas Power Project Part 2

Title: Second Lenders' IESC Monitoring Report
Site: Myingyan CCPP, Myanmar

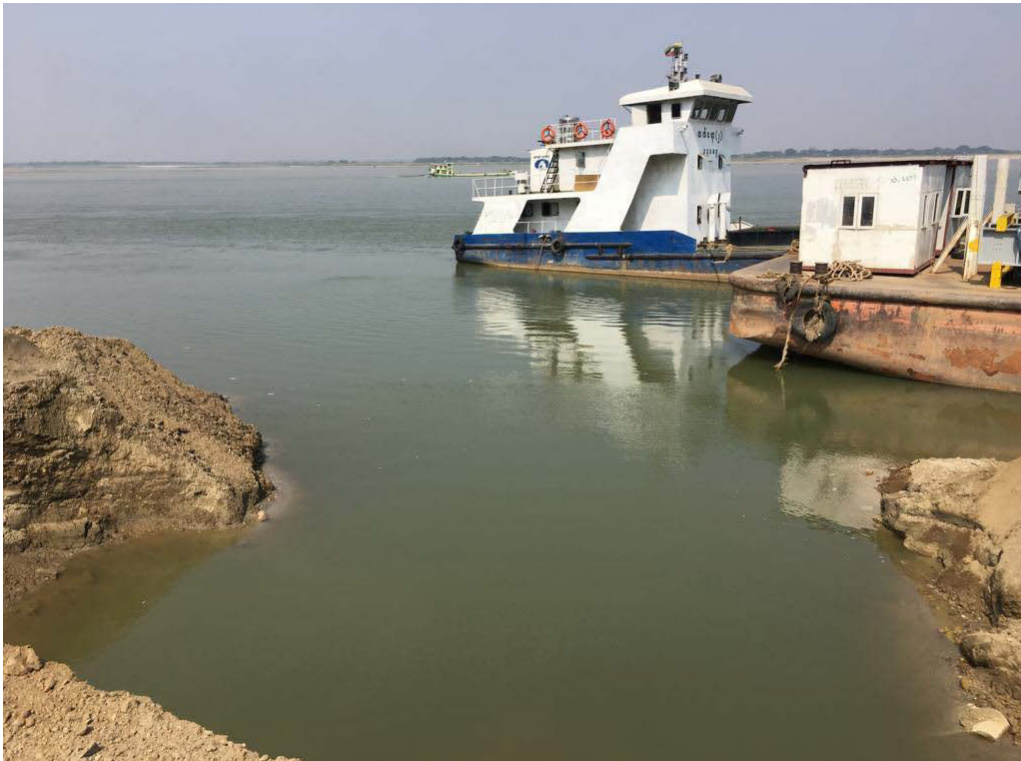
Photo 1: Nyaung Hla “jetty”, which is no longer used by the Project

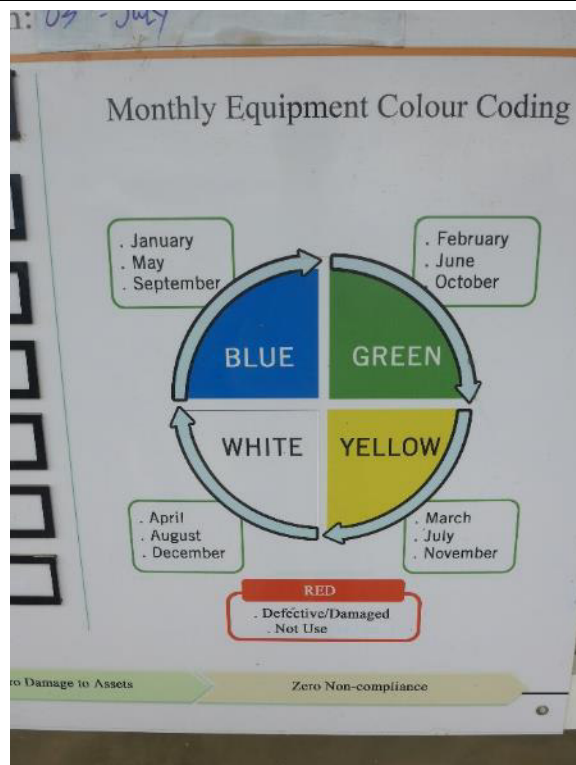
Photo 2: Equipment colour-coding to demonstrate maintenance and fitness-for-use

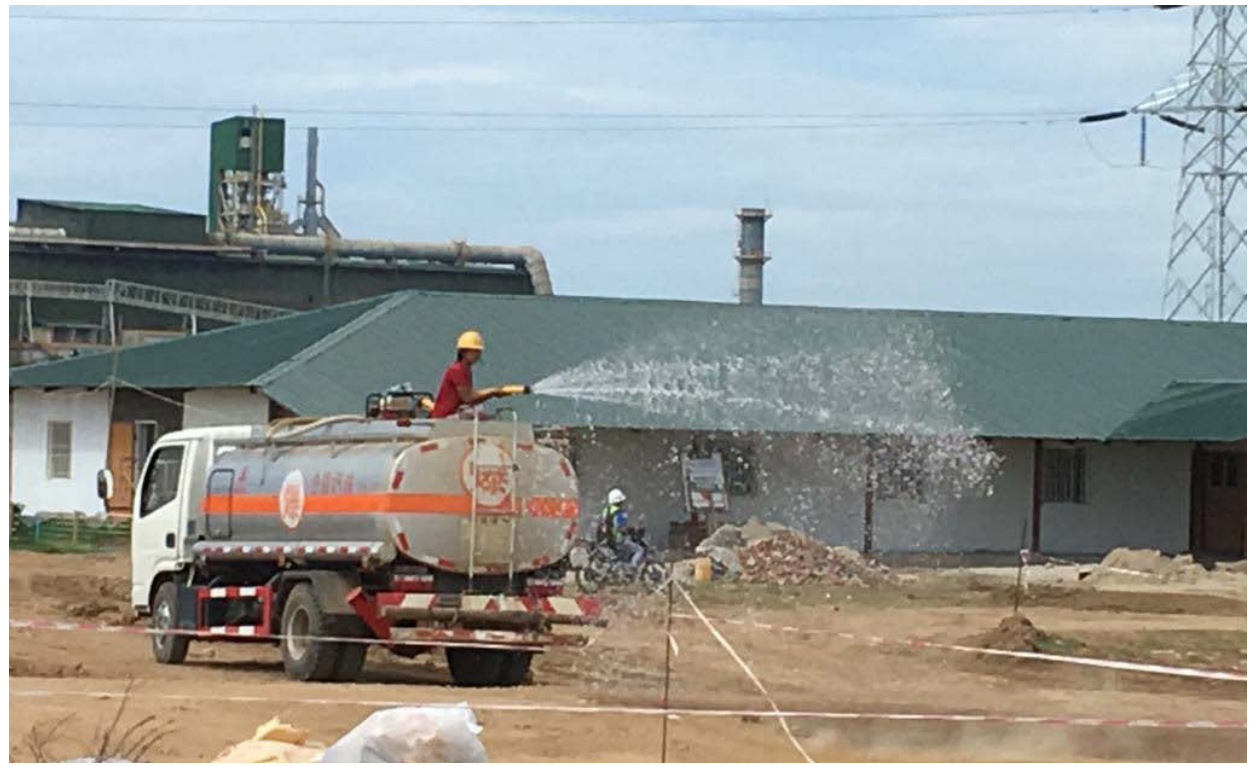
Photo 3: Dust suppression on site roads

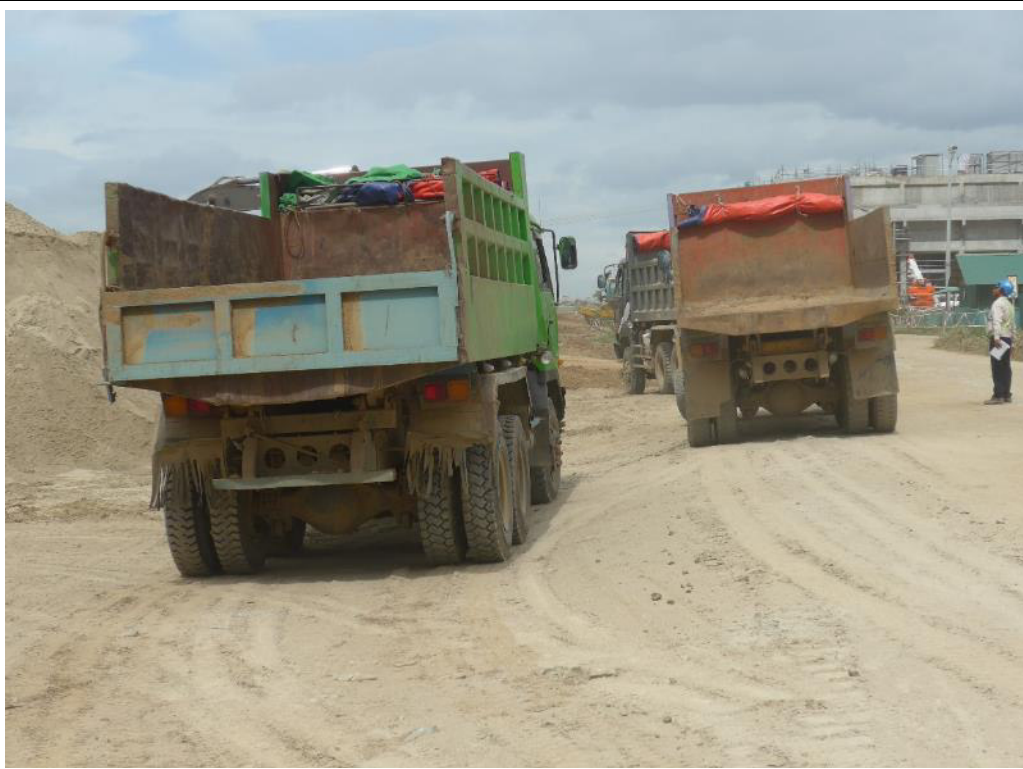
Photo 4: Trucks fitted with covers that are used when conveying soil and dusty materials

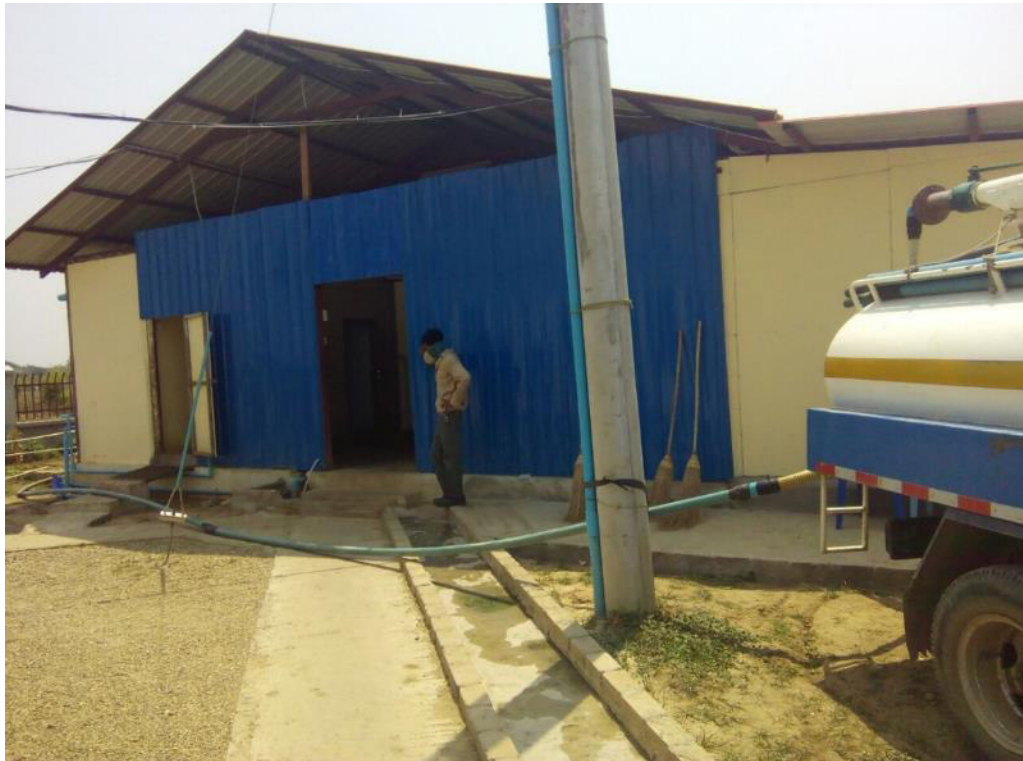
Photo 5: Vacuum tanker collecting sewage from septic tank at JEM camp

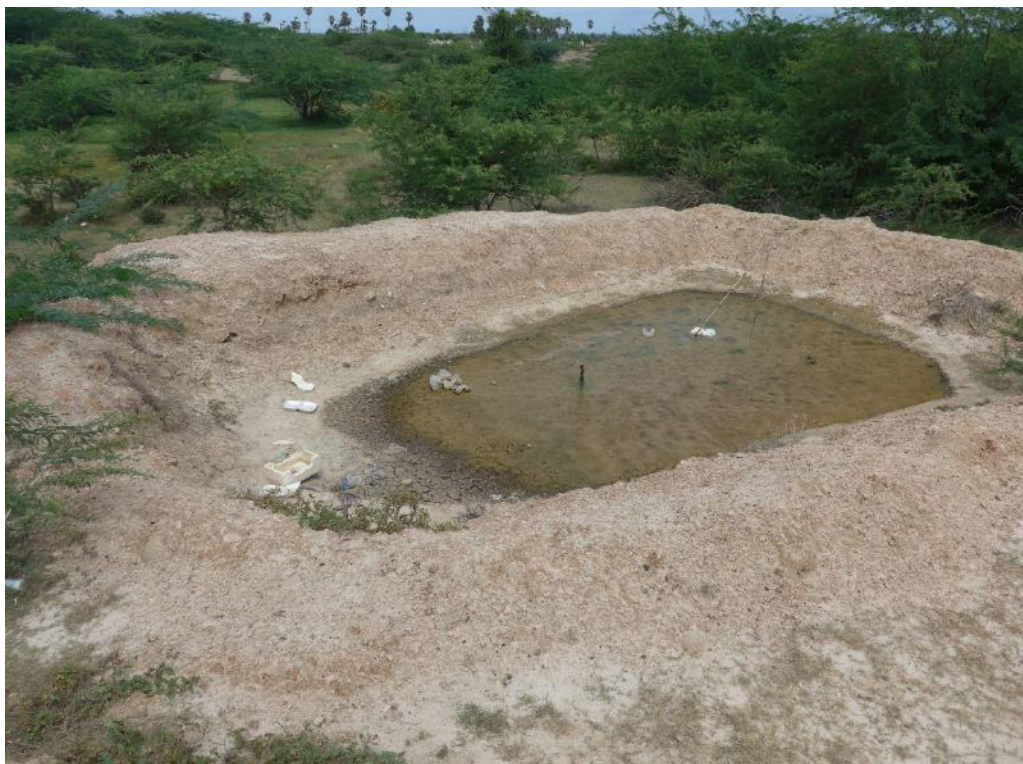
Photo 6: Wastewater disposal pit, reportedly used for disposal of sanitary wastewater

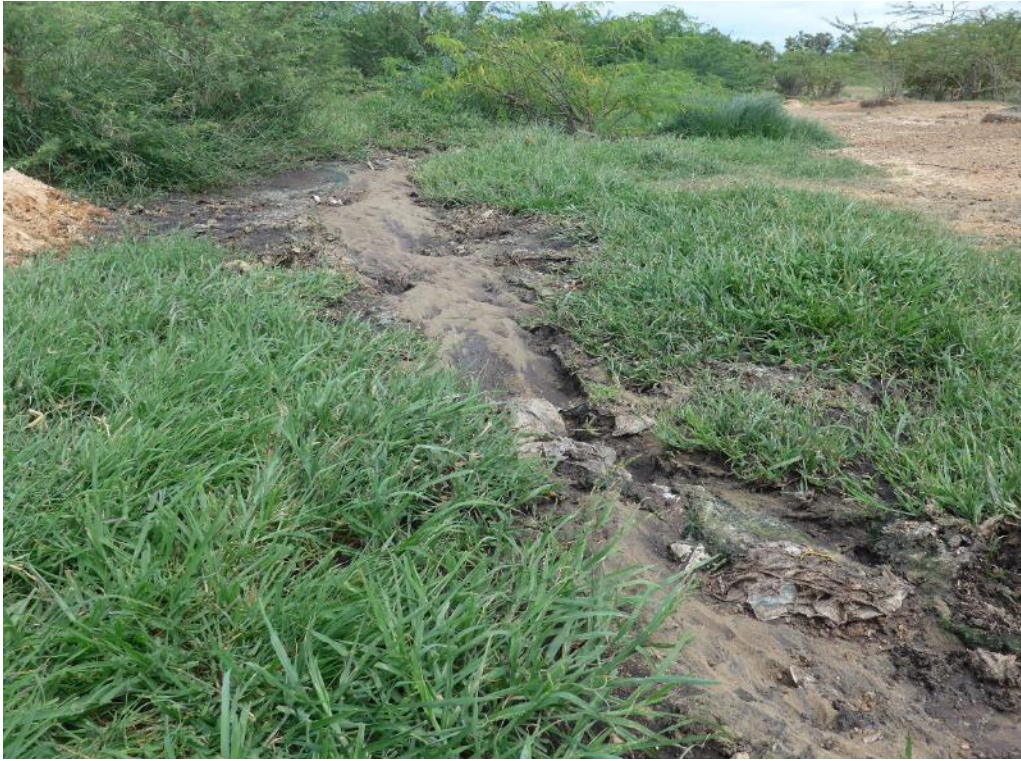
Photo 7: Evidence of wastewater disposal on soil adjacent to pit

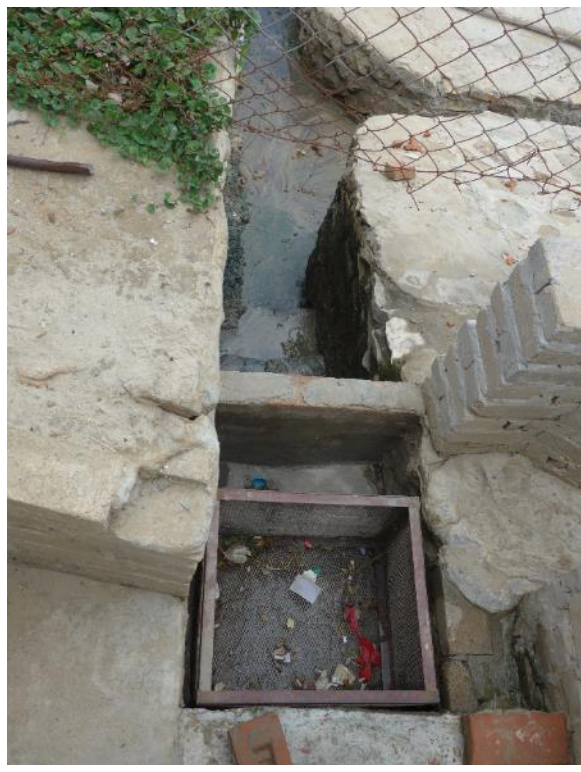
Photo 8: Screen on kitchen wastewater discharge at JEM camp

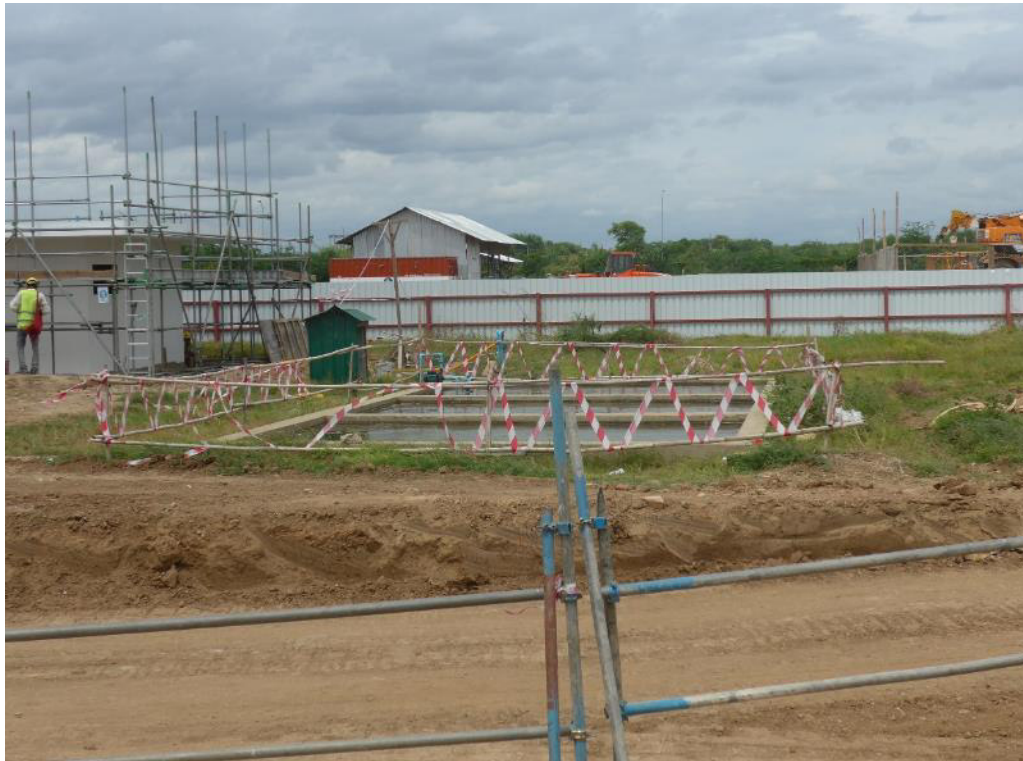
Photo 9: Surface water collection pit

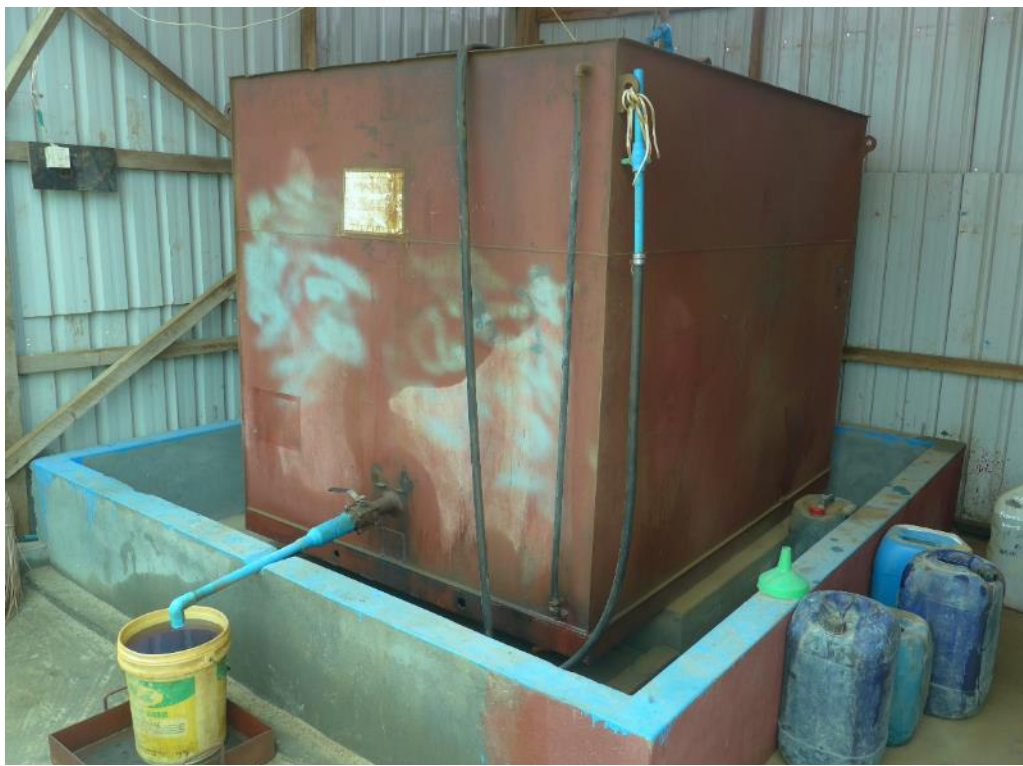
Photo 10: Bund appears to have less than 110% of the tank capacity

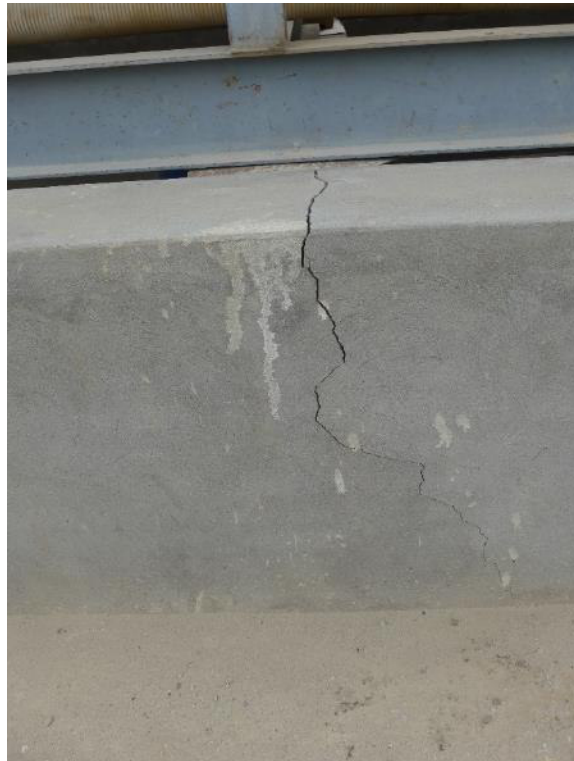
Photo 11: Cracks in bund wall around diesel tank at Concrete Batching Plant

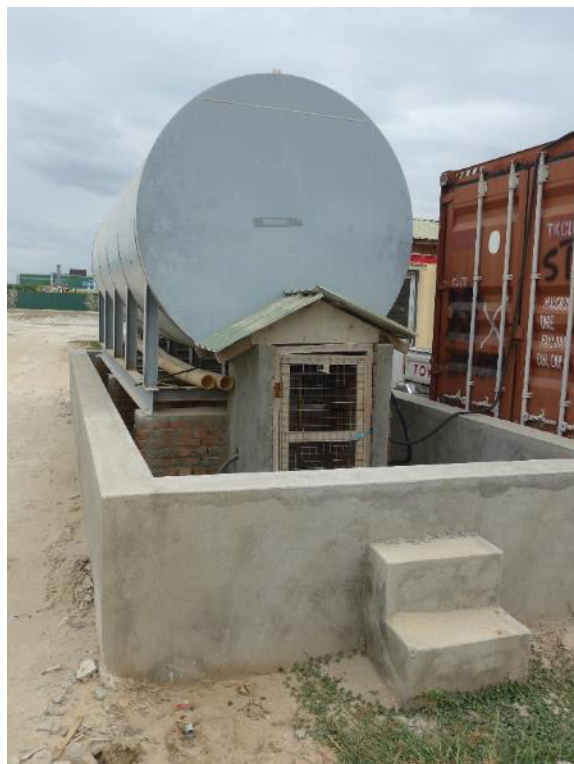
Photo 12: Drainage pipe from bunded area (bottom left of photo) had an open valve

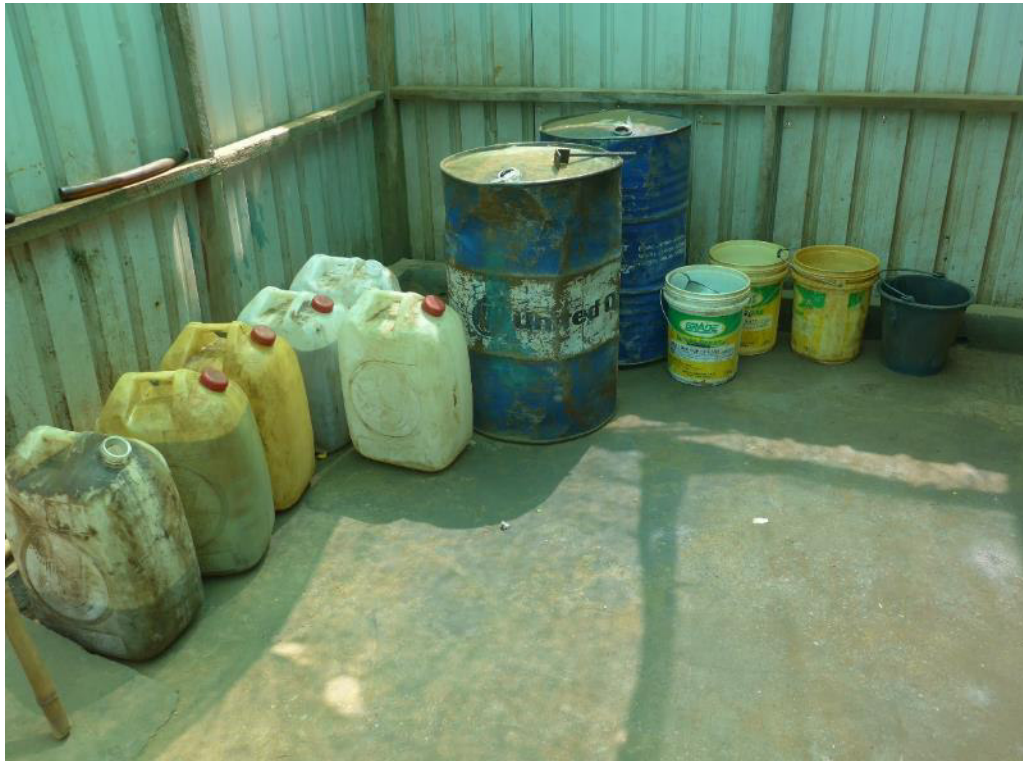
Photo 13: Several drainage holes in bund wall around diesel tank in SDCI area (most are obscured by the drums)

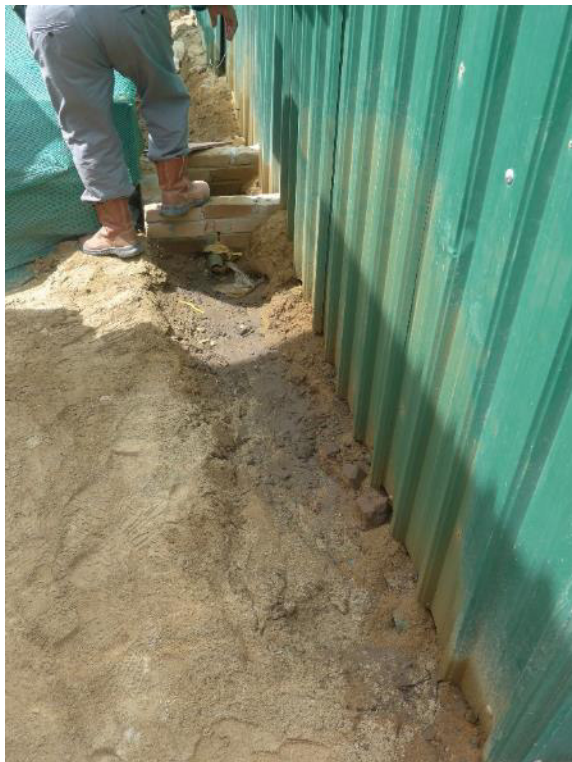
Photo 14: Soil contamination outside diesel tank in SDCI area

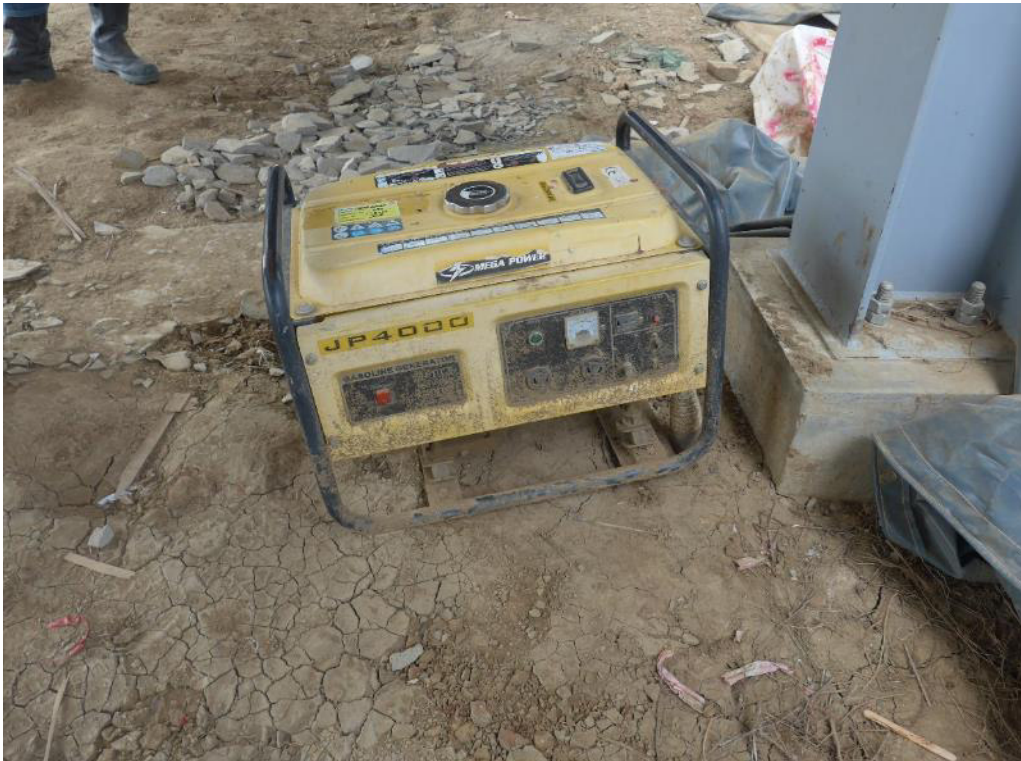
Photo 15: Portable generator without a drip tray

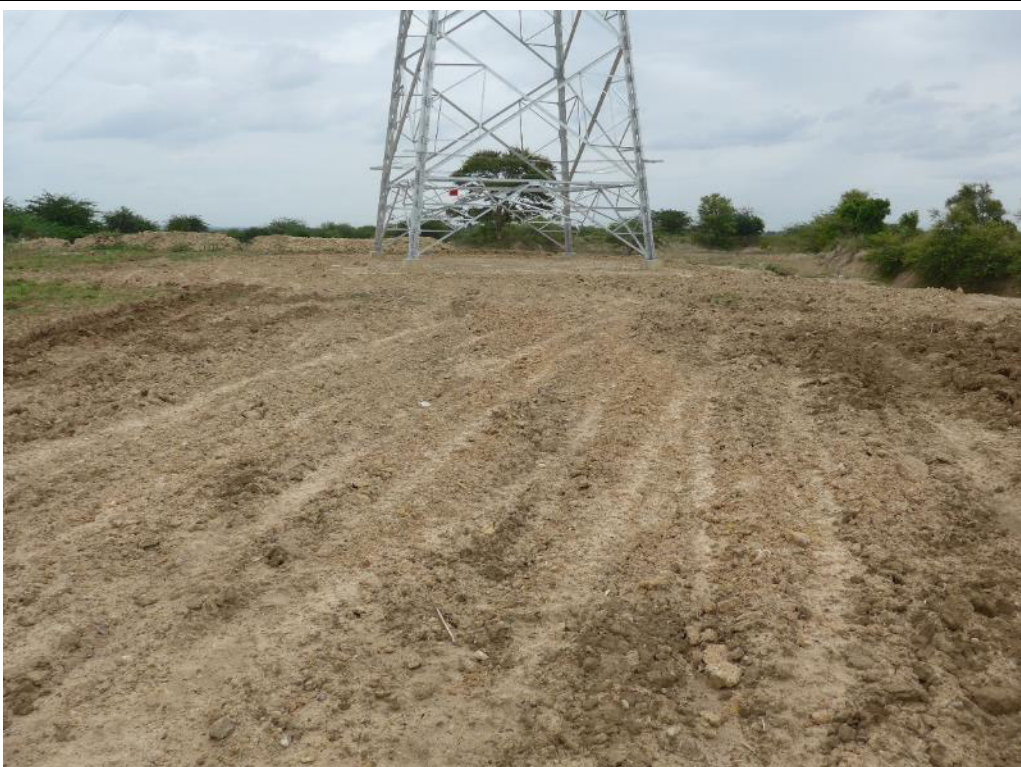
Photo 16: Physically restated land around transmission tower in a farmer's field

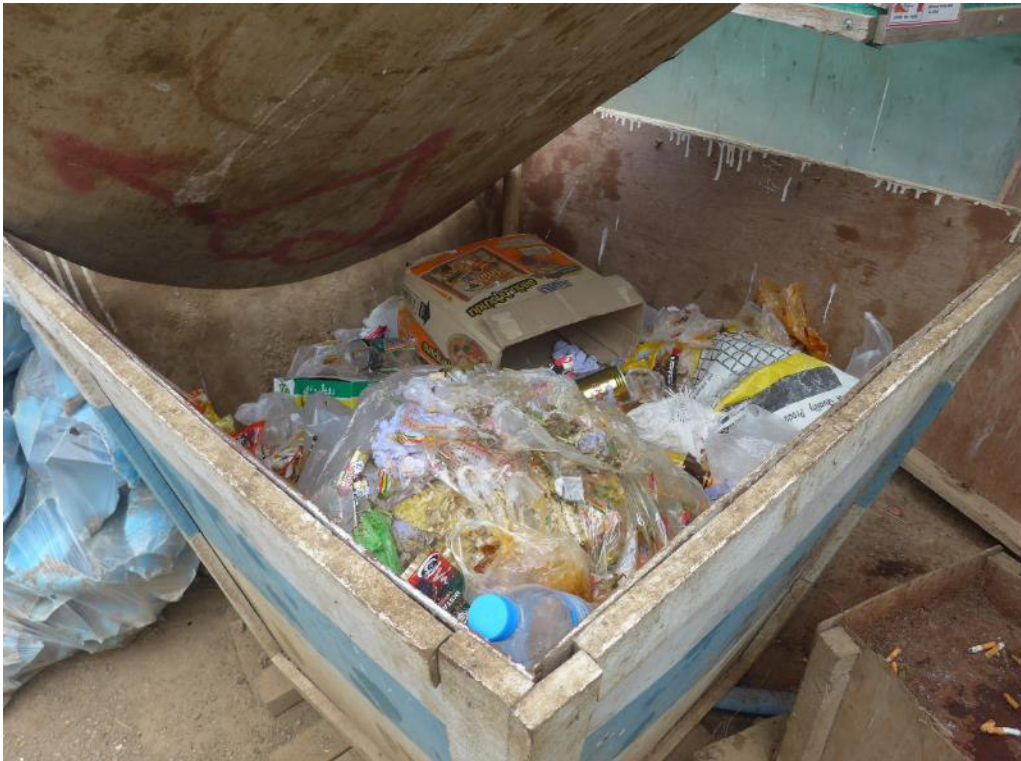
Photo 17: Poor containment of food waste

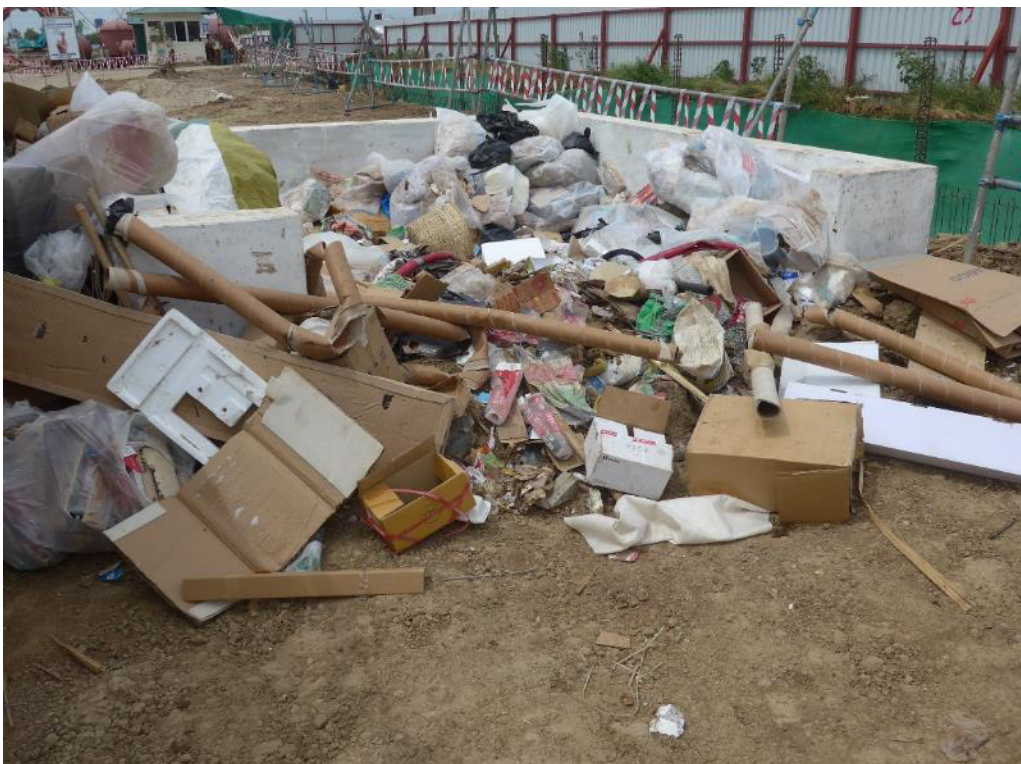
Photo 18: Inadequate containment of general waste

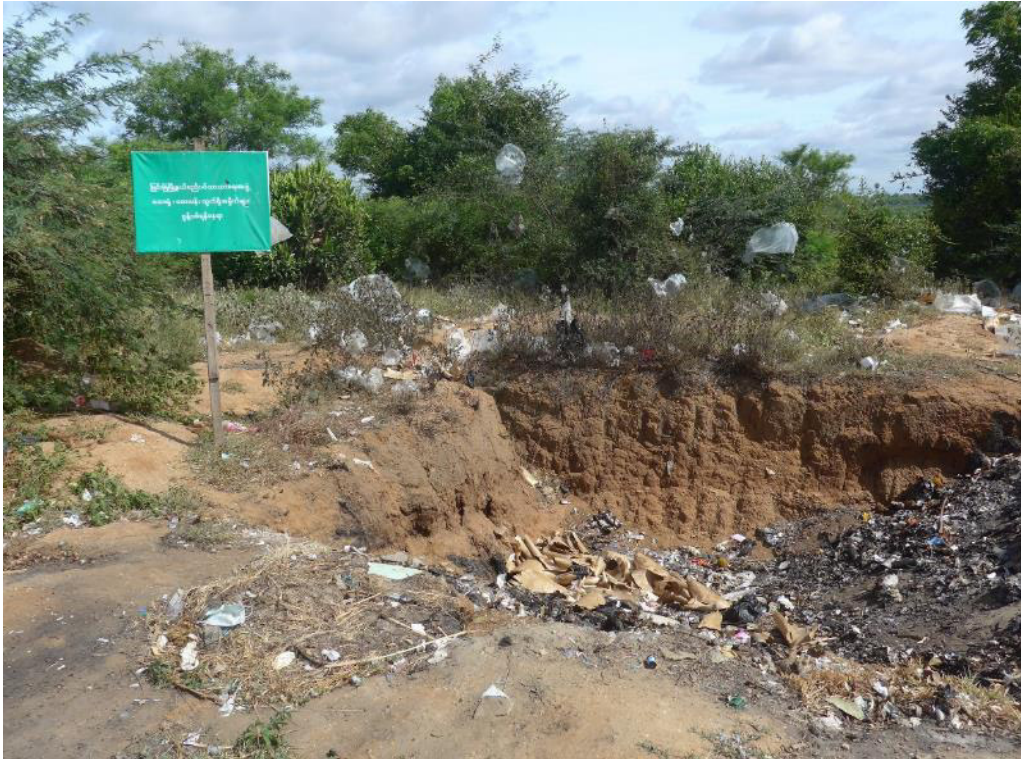
Photo 19: Medical waste disposal area in landfill site

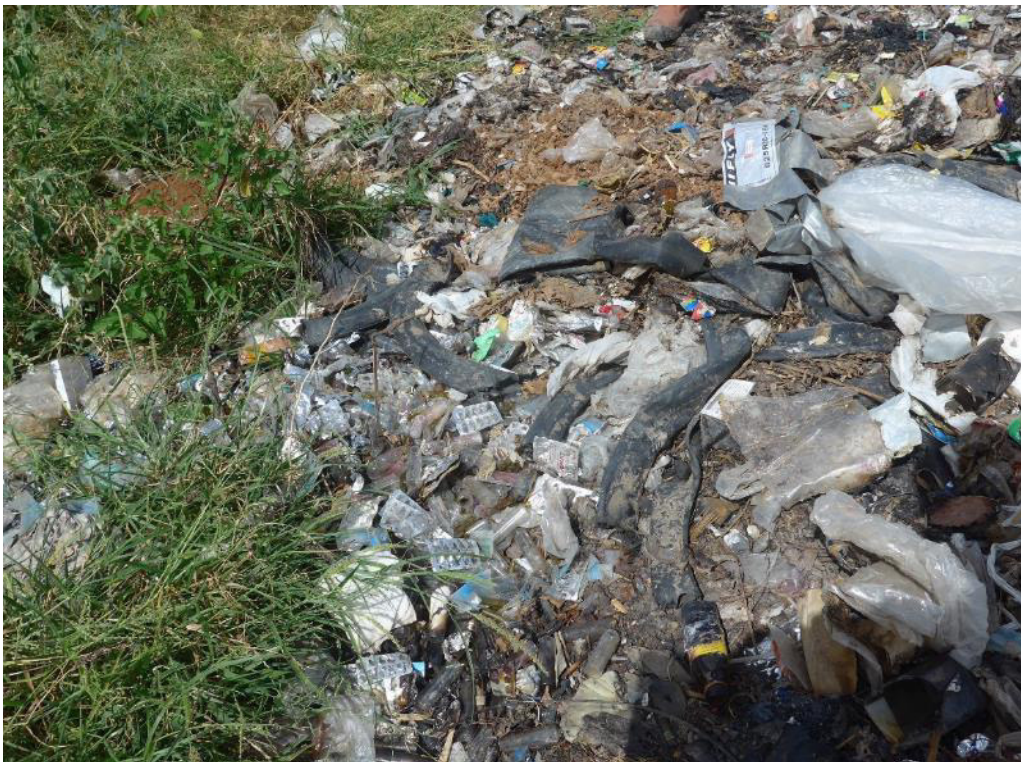
Photo 20: Medical waste mixed with general waste on surface of landfill

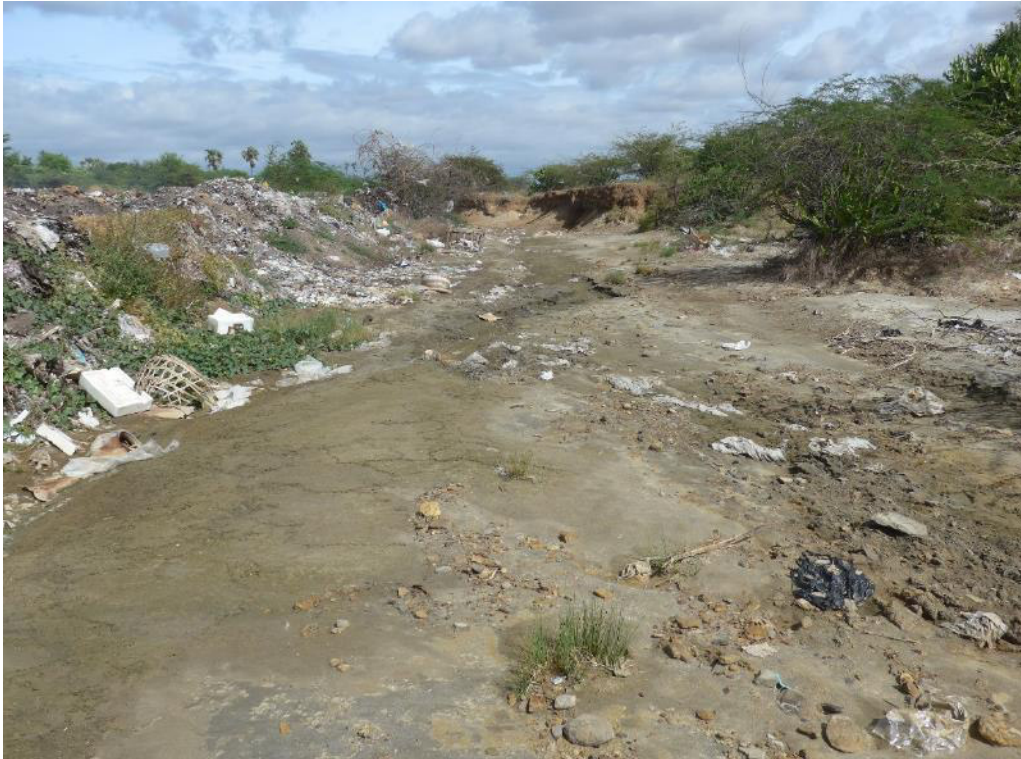
Photo 21: Waste falling from landfill into ephemeral stream bed adjacent to landfill site

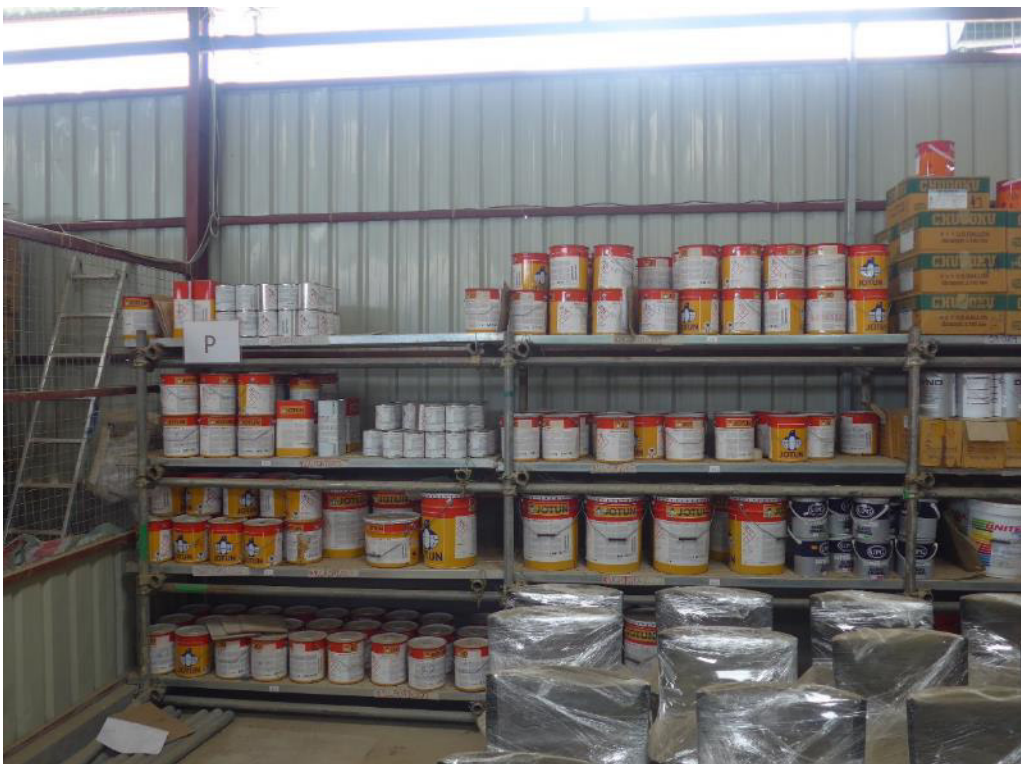
Photo 22: Excellent housekeeping in JEM maintenance warehouse

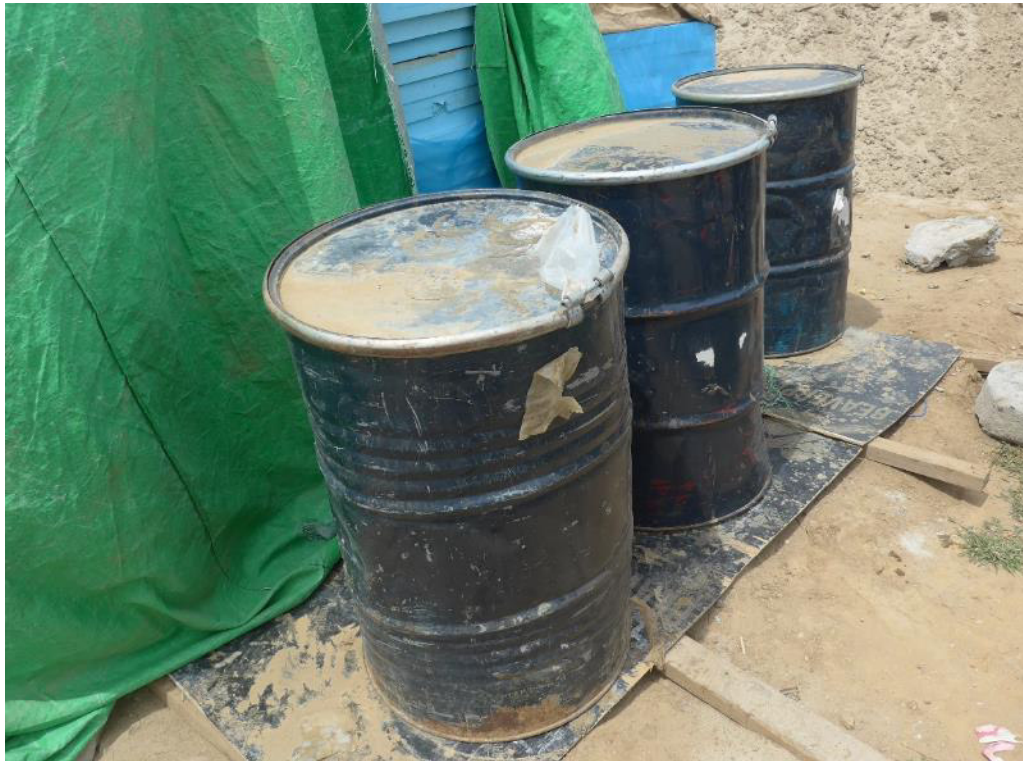
Photo 23: Unlabelled drums

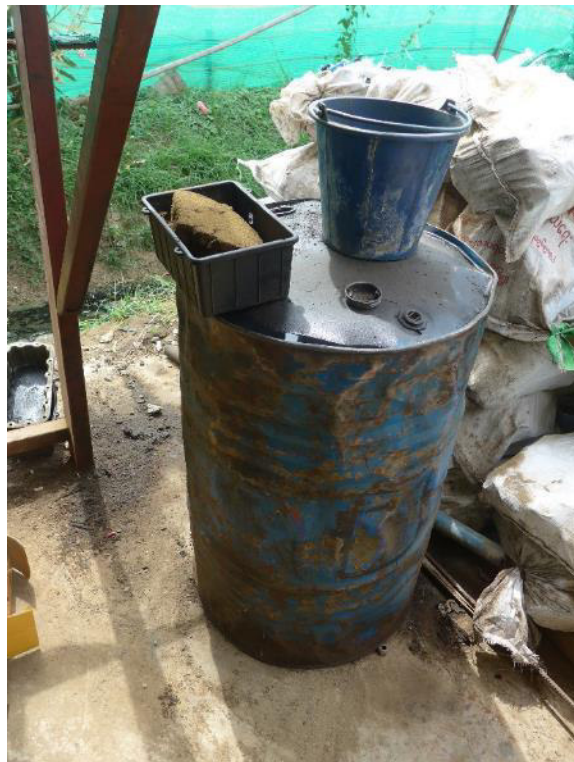
Photo 24: Oil drum in poor condition, with adjacent ground staining

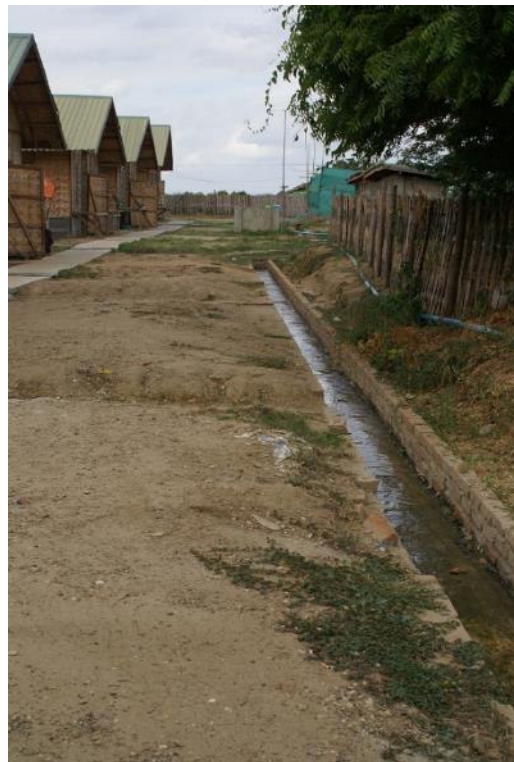
Photo 28: New drainage system at Min Dhama camp

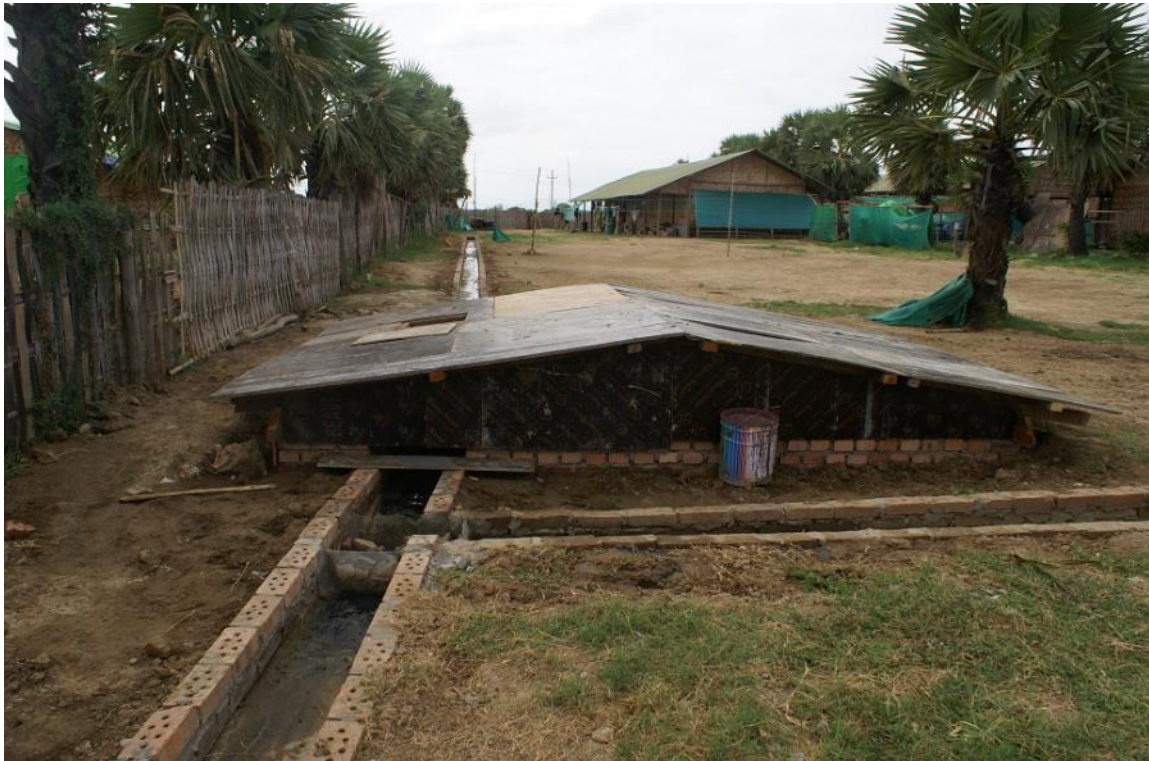
Photo 29: New drainage storage tank at Min Dhama camp

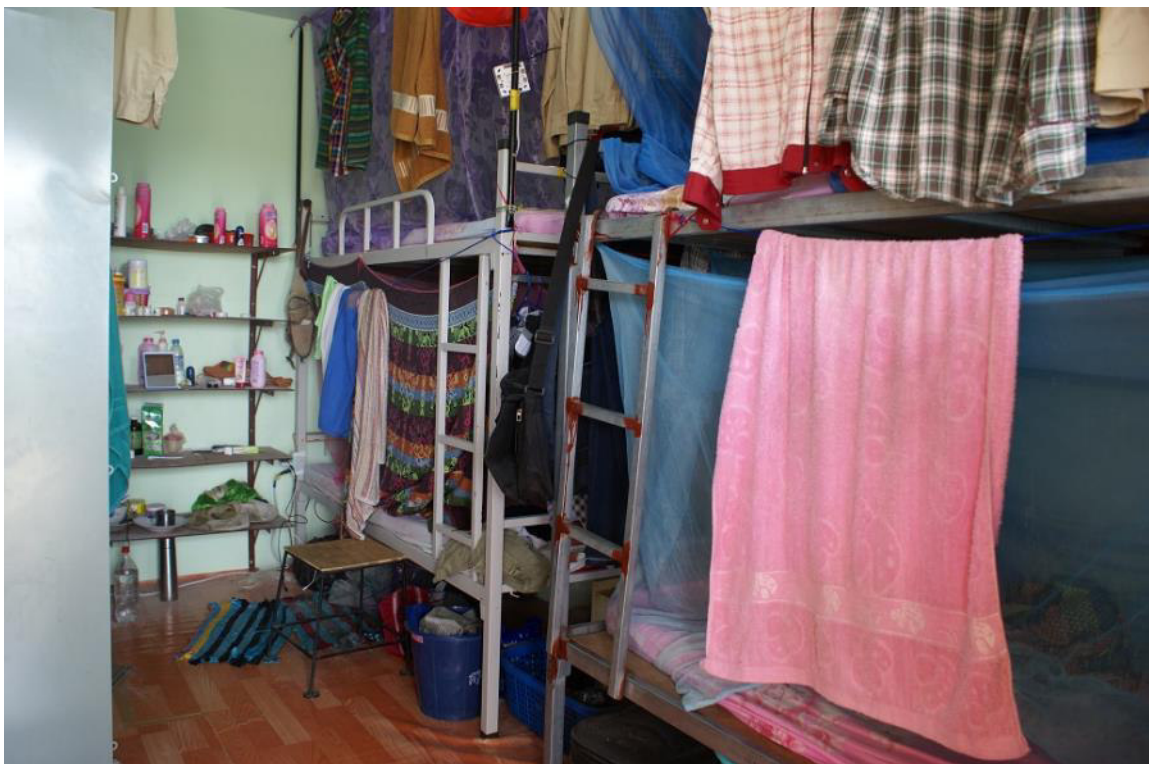
Photo 30: Room with six occupants at JEM workers camp

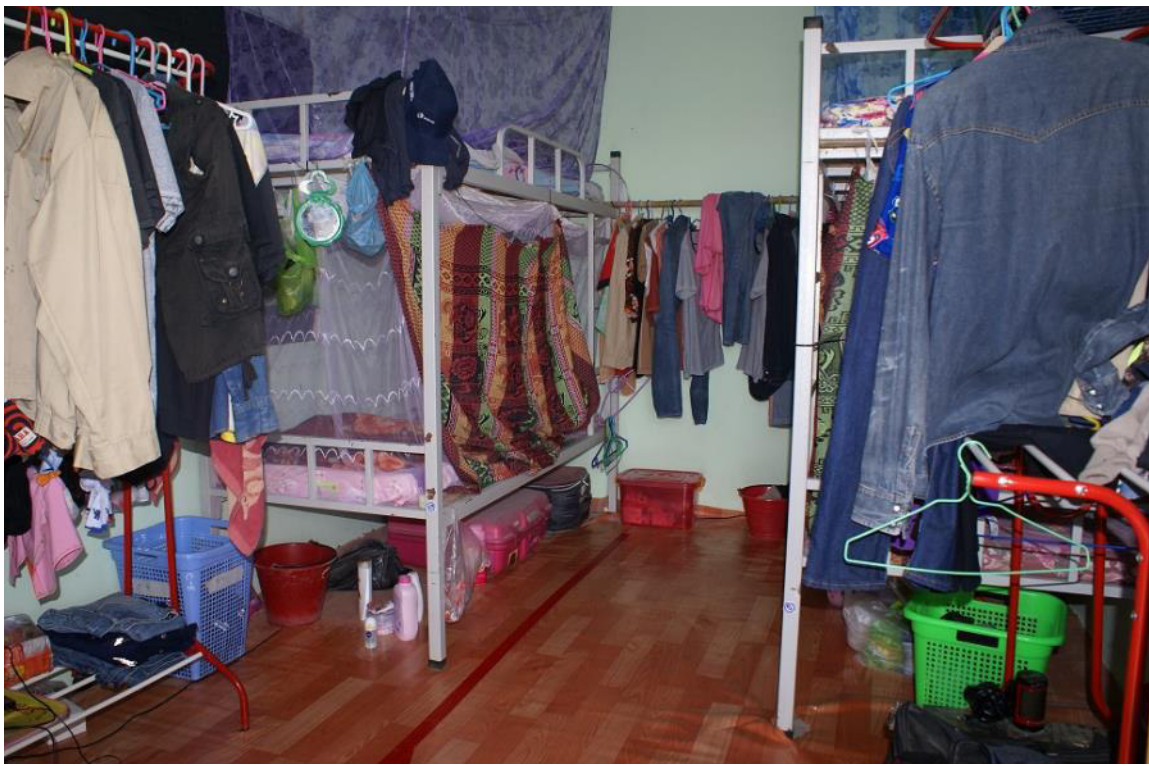
Photo 31: Room with four occupants at JEM workers camp

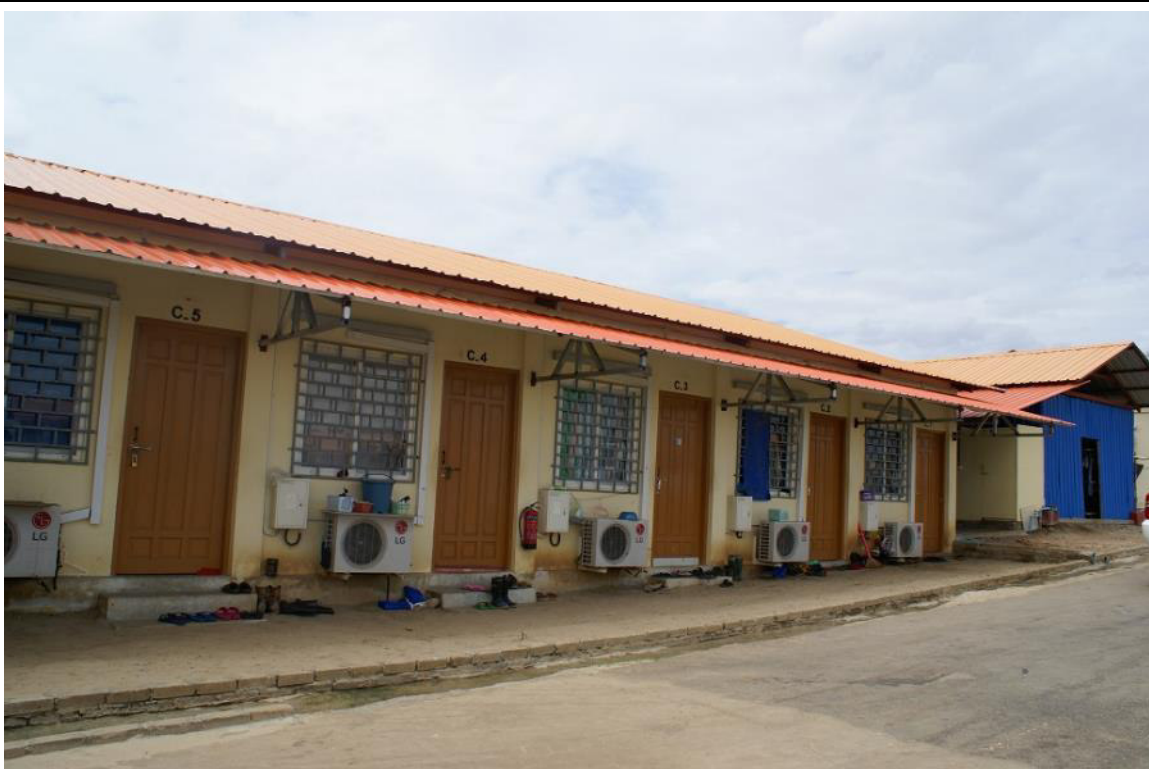
Photo 32: New zinc roof with drainage at JEM workers camp

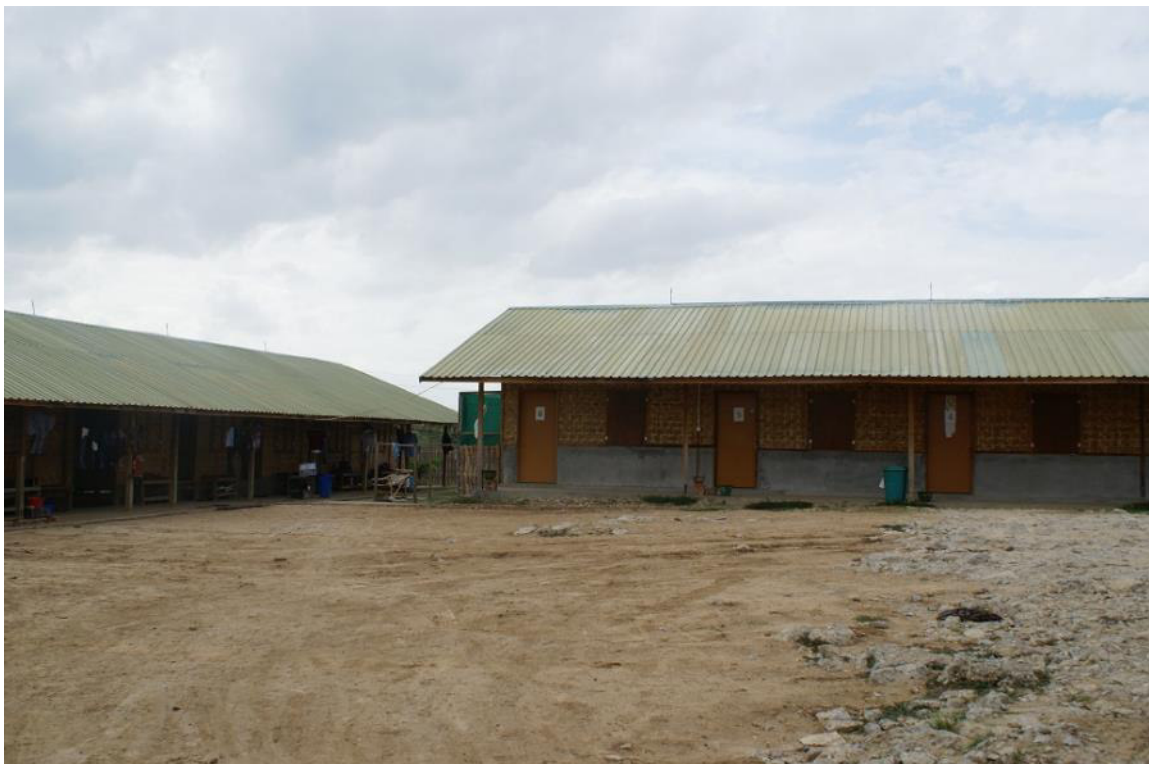
Photo 37: New zinc roof at the Min Dhama workers camp

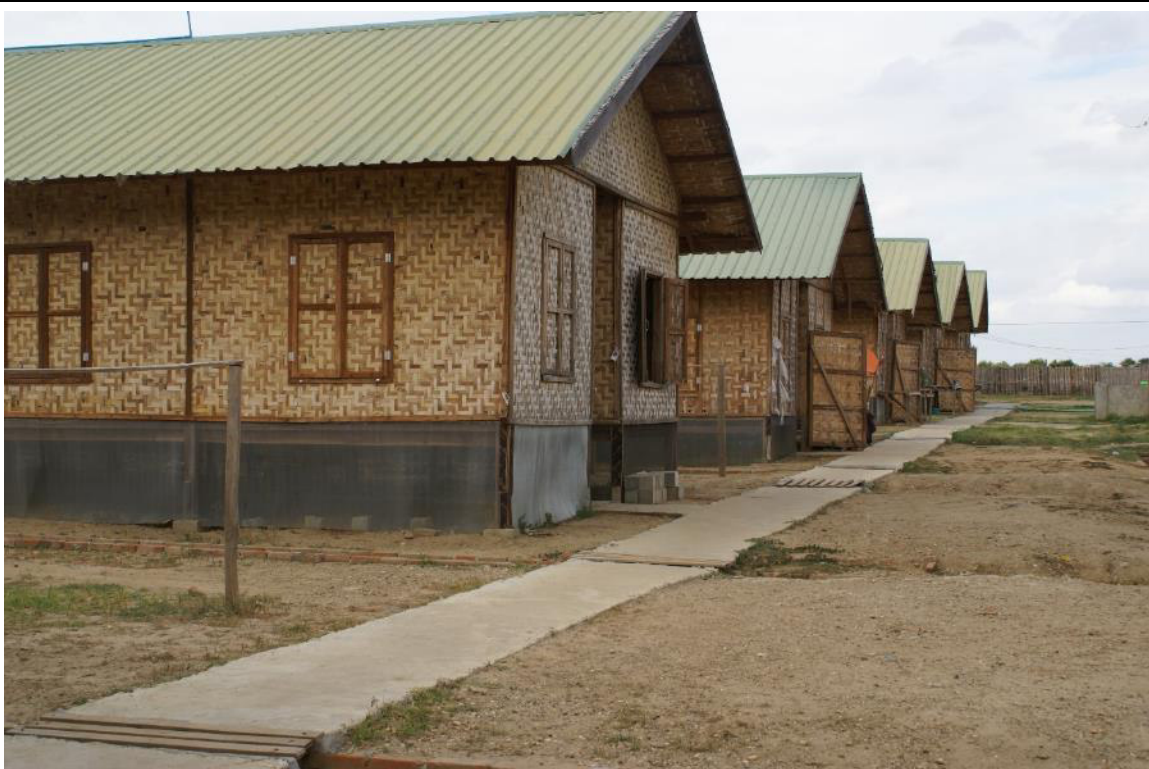
Photo 38: Unskilled workers housing at the Min Dhama workers camp
