Environmental and Social Monitoring Second Report

Project Number: 48368-001
August 2017

MYA: Myingyan Natural Gas Power Project Part 2

Title: Second Lenders' IESC Monitoring Report
Site: Myingyan CCPP, Myanmar

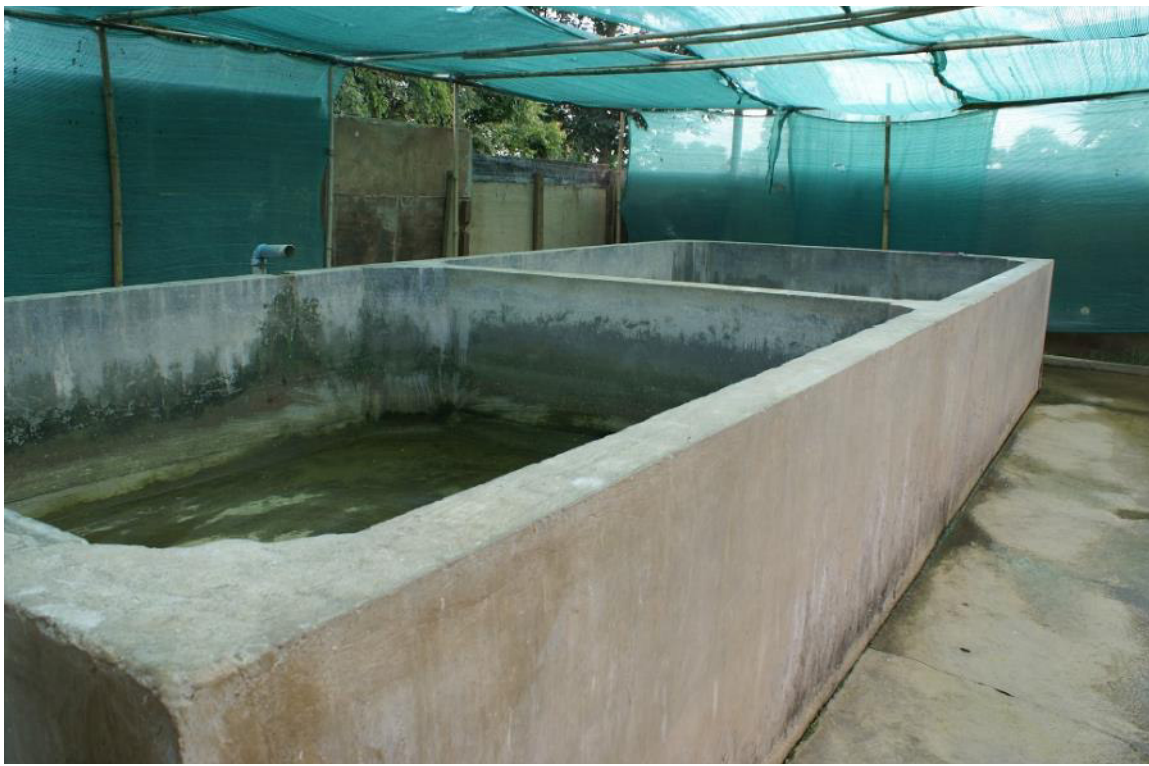
Photo 39: Women's rural bathing area at the Min Dhama workers camp

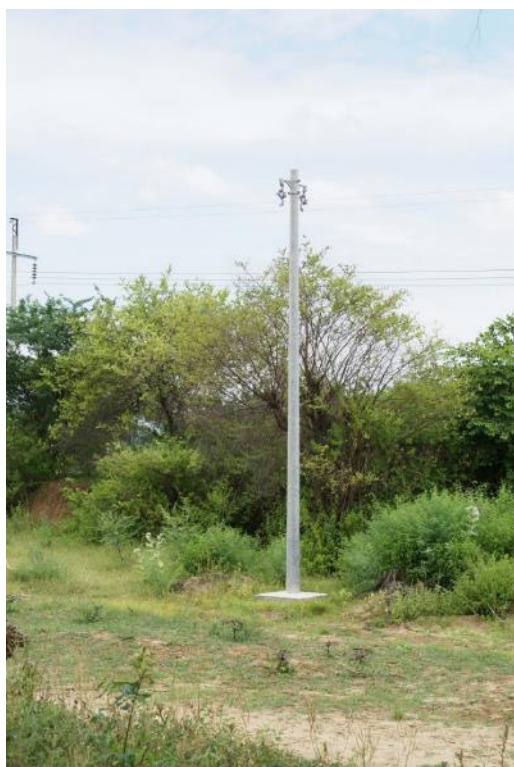
Photo 40: Power Pole along the river water supply pipeline
