Environmental and Social Monitoring Fourth Report

Project Number: 48368-001
January 2019

MYA: Myingyan Natural Gas Power Project Part 2

Title: Fourth Lenders' IESC Monitoring Report
Site: Myingyan CCPP, Myanmar

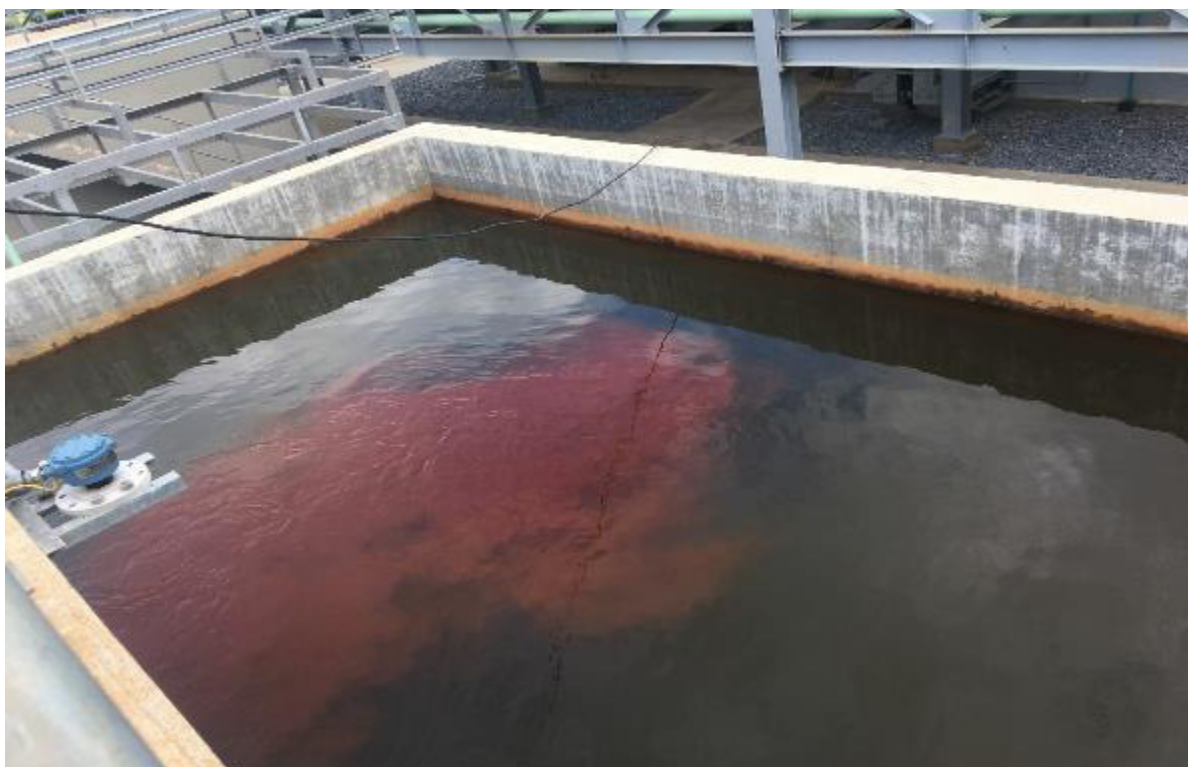
Photo 5: A faulty agitator in the sludge thickener tank resulted in an overflow of water sludge mixture into the recycle water tank.

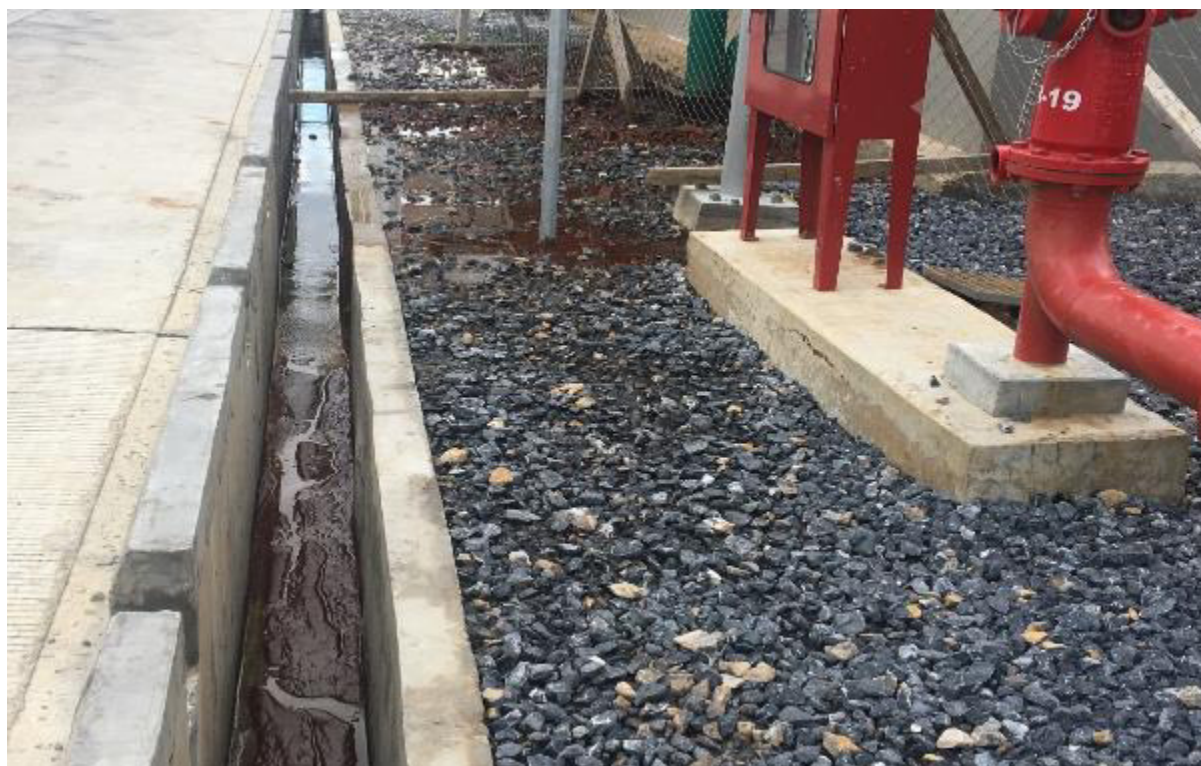
Photo 6: The water sludge mixture overflowed onto the gravel layer surrounding the recycle water tank and an adjacent internal drain

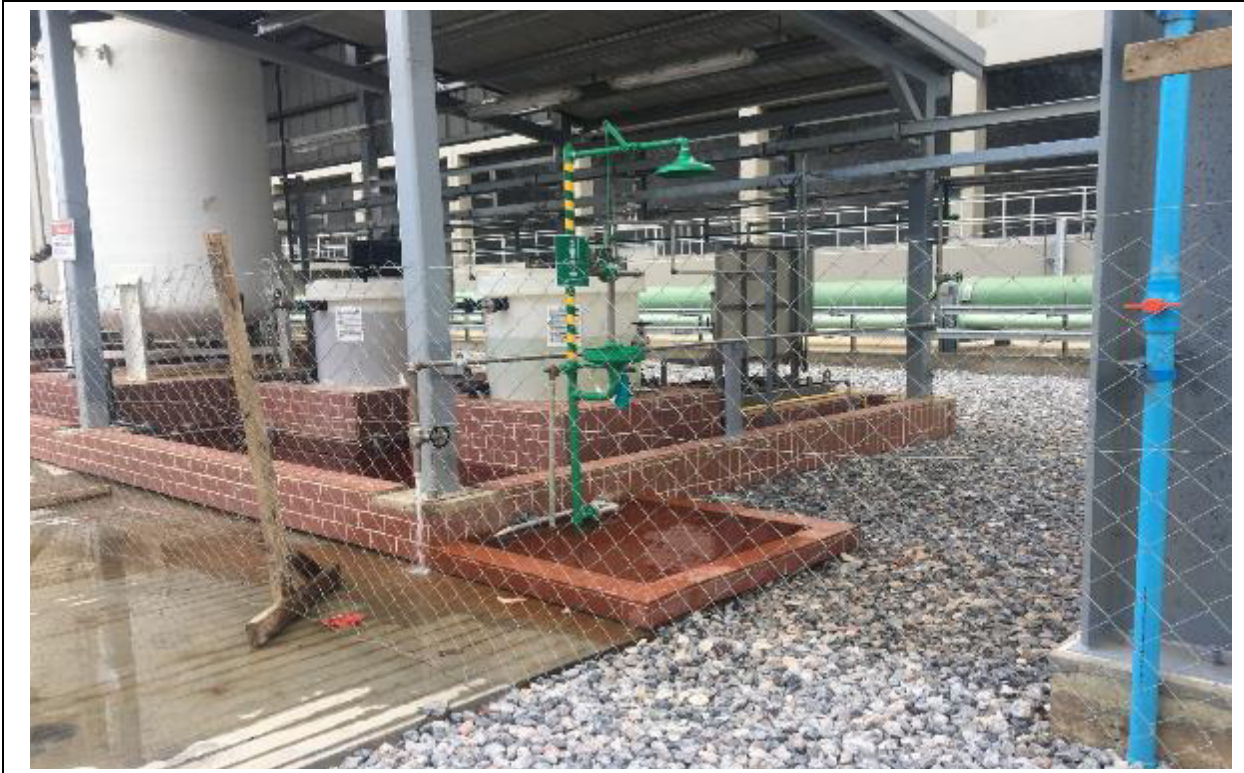
Photo 7: The excess sludge water mixture overflowed into adjacent chemical feed storage areas (up to one inch of water on the floor).

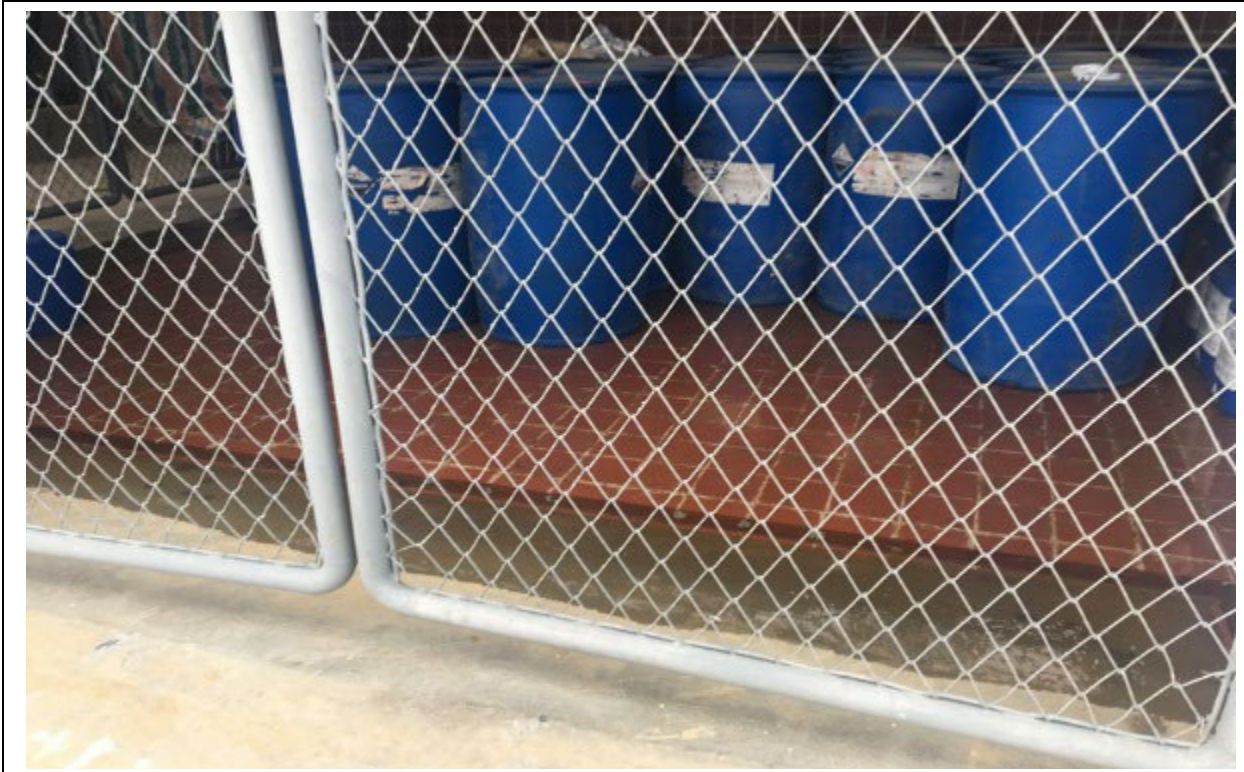
Photo 8: Insufficient containment at the chemical store (for water treatment chemicals) based on the volume of chemicals stored. Floor was inundated with approximately 1 inch of water.

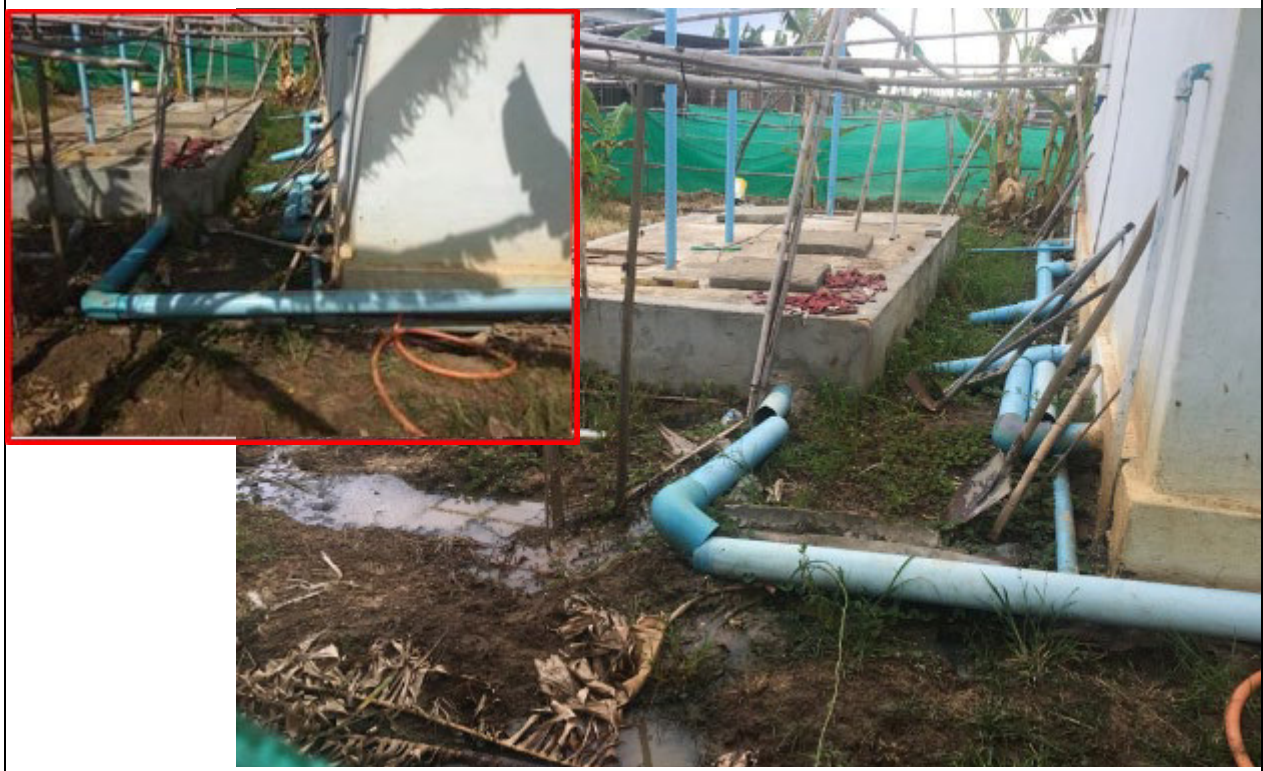
Photo 13: The toilet at the JEM Office had a broken pipe leading from the sink into the cess pit. Inset: The pipe was replaced a day later.

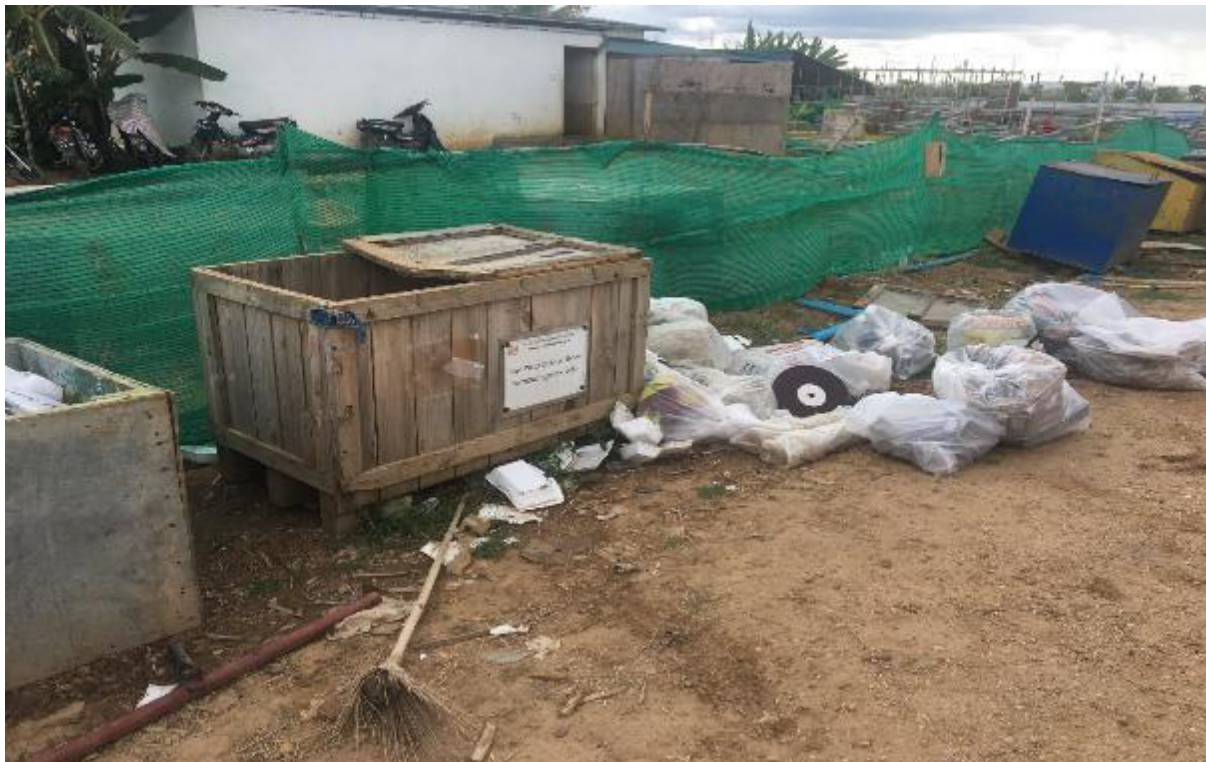
Photo 14: Food waste (in plastic bags) were left on the ground and in two uncovered skips at the JEM office and warehouse area. This issue was rectified a day later.

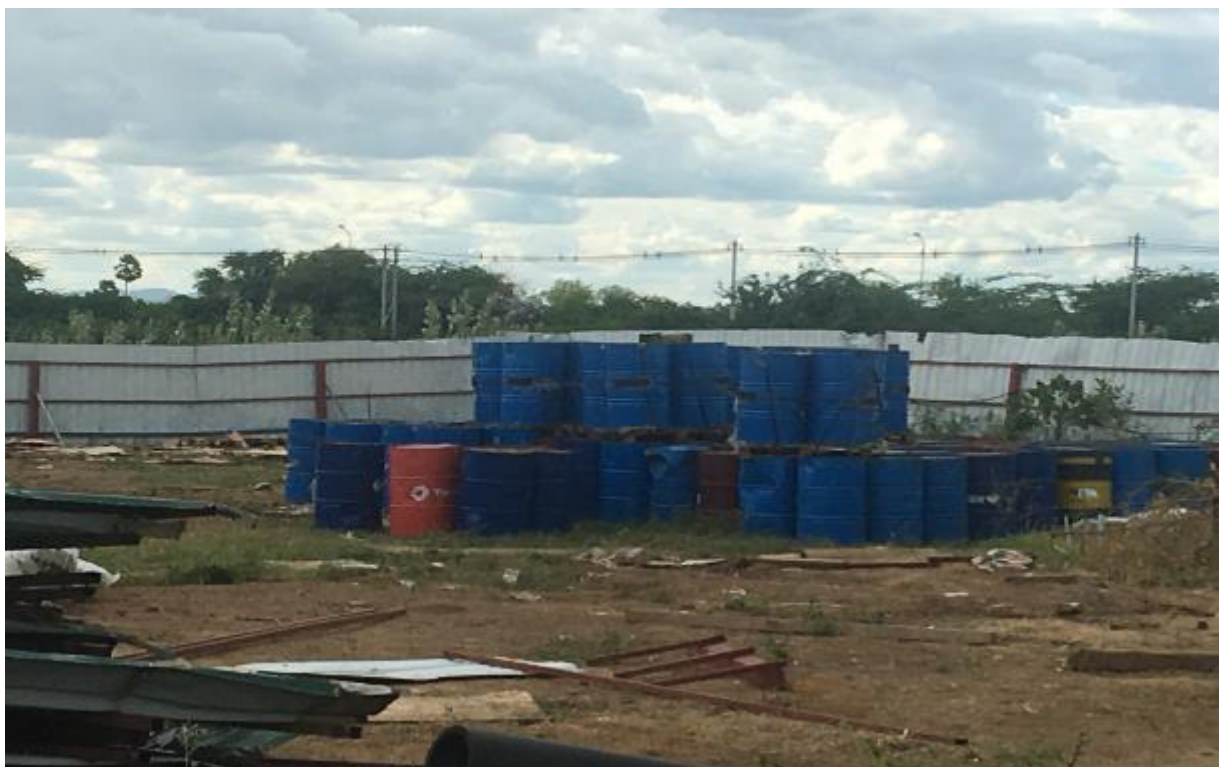
Photo 15: Empty chemical drums stored on bare ground at the JEM Office and warehouse area

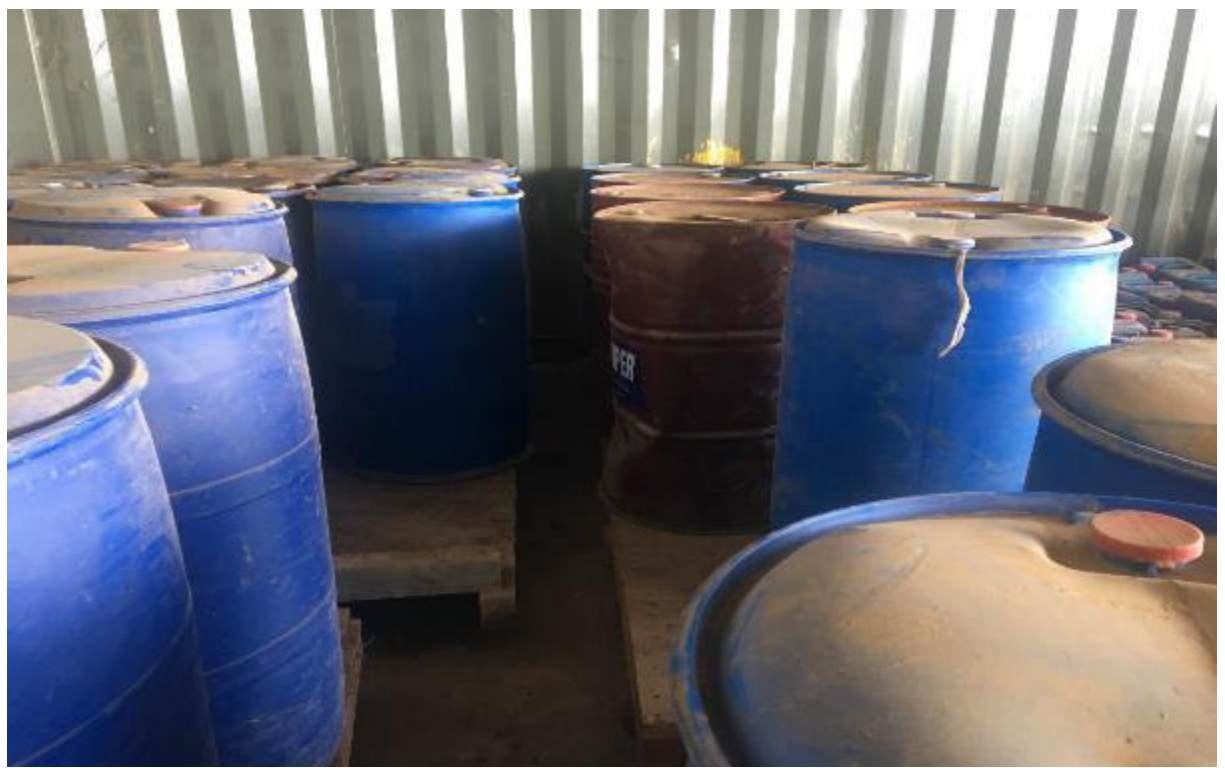
Photo 16: Dented drums with no labels at the JEM Office and Warehouse area

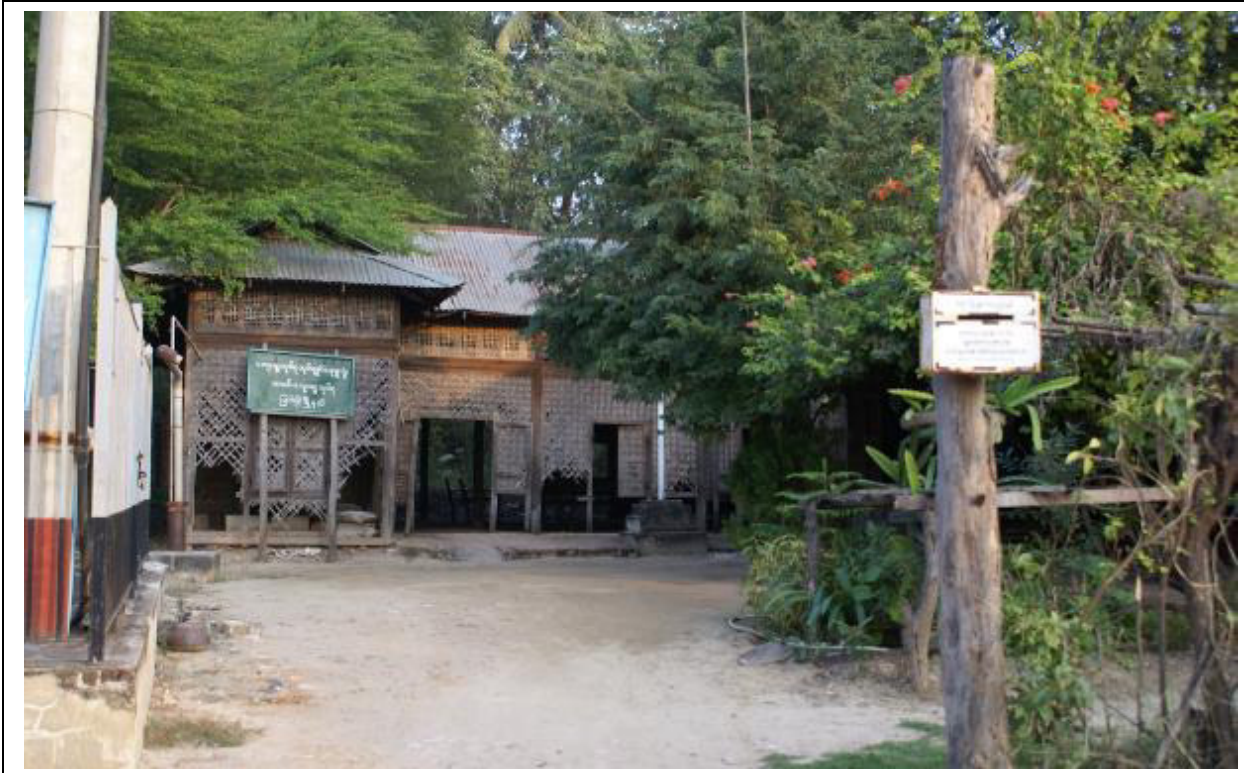
Photo 35: Sa Khar Village: Deteriorating conditions at the GAD Office (January 2018 site visit)
