APPENDIX 1
SITE VISIT PHOTO LOG

Title: Fifth Lenders' IESC Monitoring Report
Site: Myingyan CCPP, Myanmar

Date: December 2019
Project: 331000018

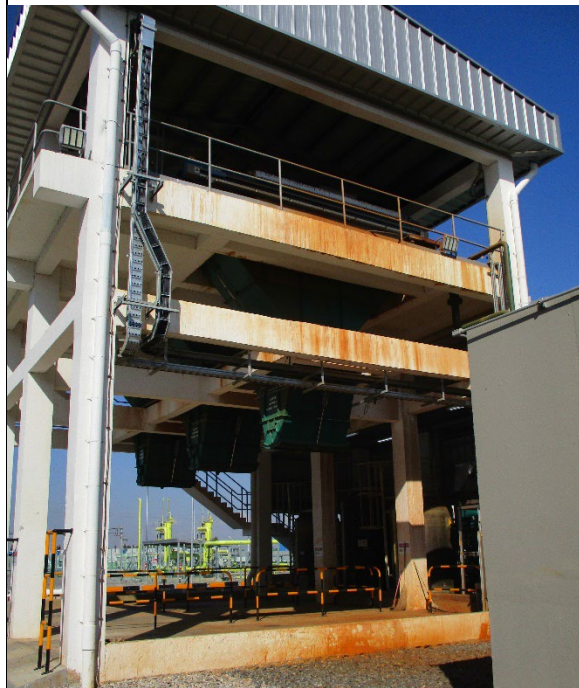
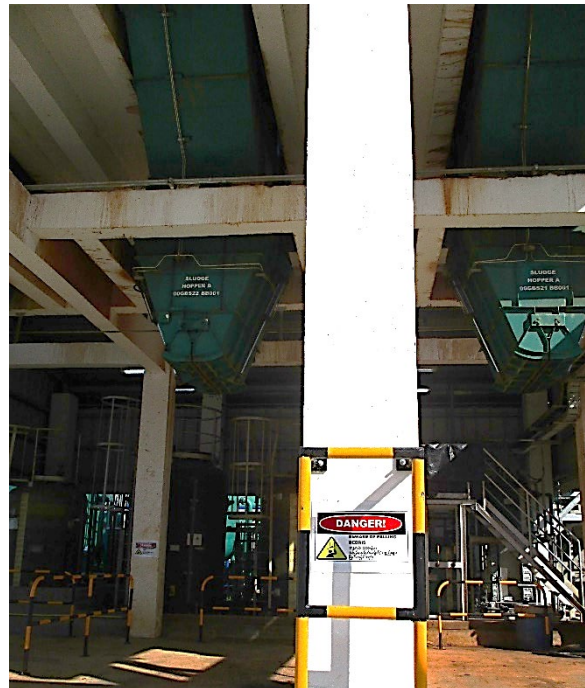
Photo 7: Sludge from the water treatment plant is collected at three (3) sludge hoppers and disposed by a licensed waste contractor.

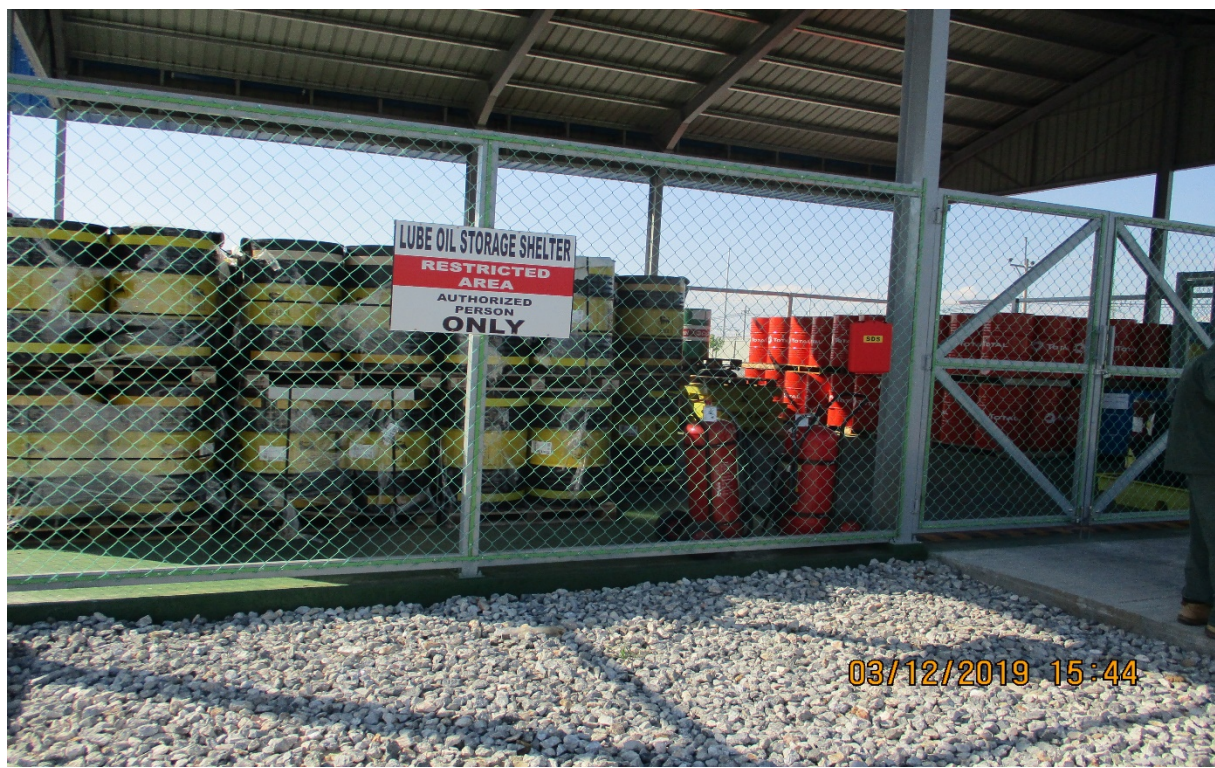
Photo 8: The lubricant oil storage area is paved, roofed and access controlled.

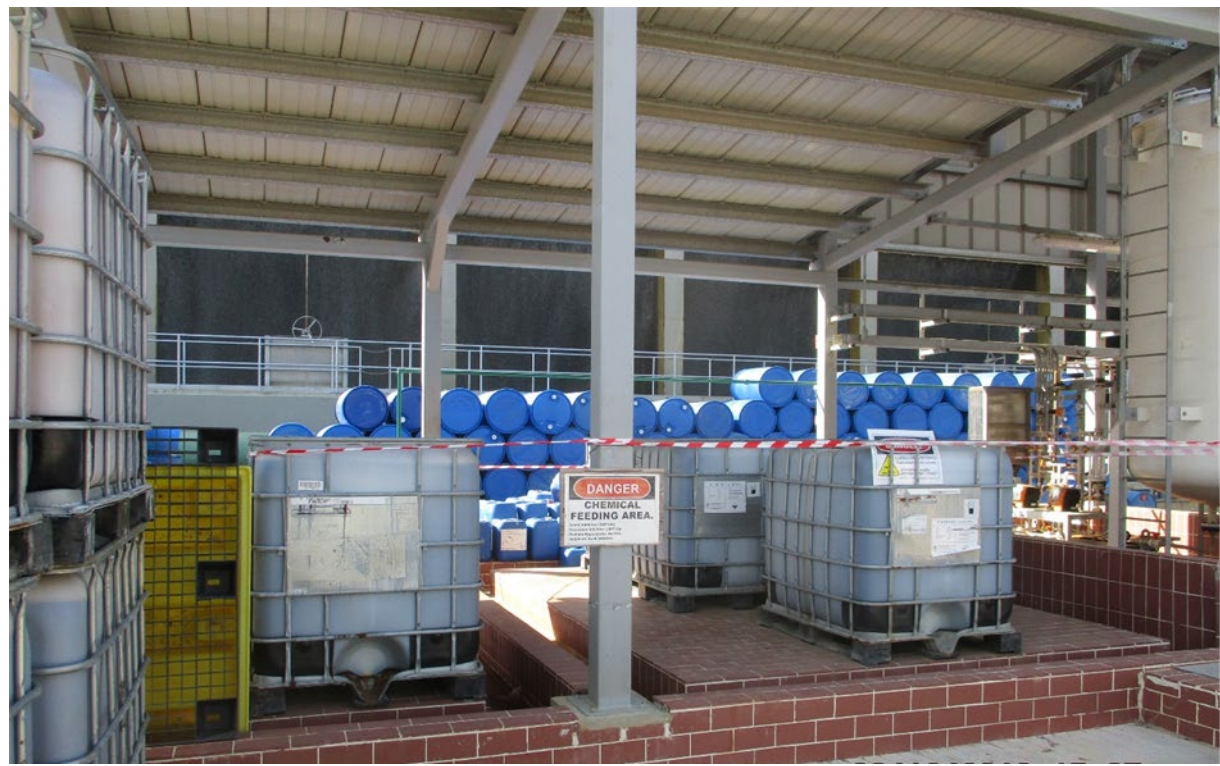
Photo 10: Chemical feeding area is roofed and contained within a bunded area.

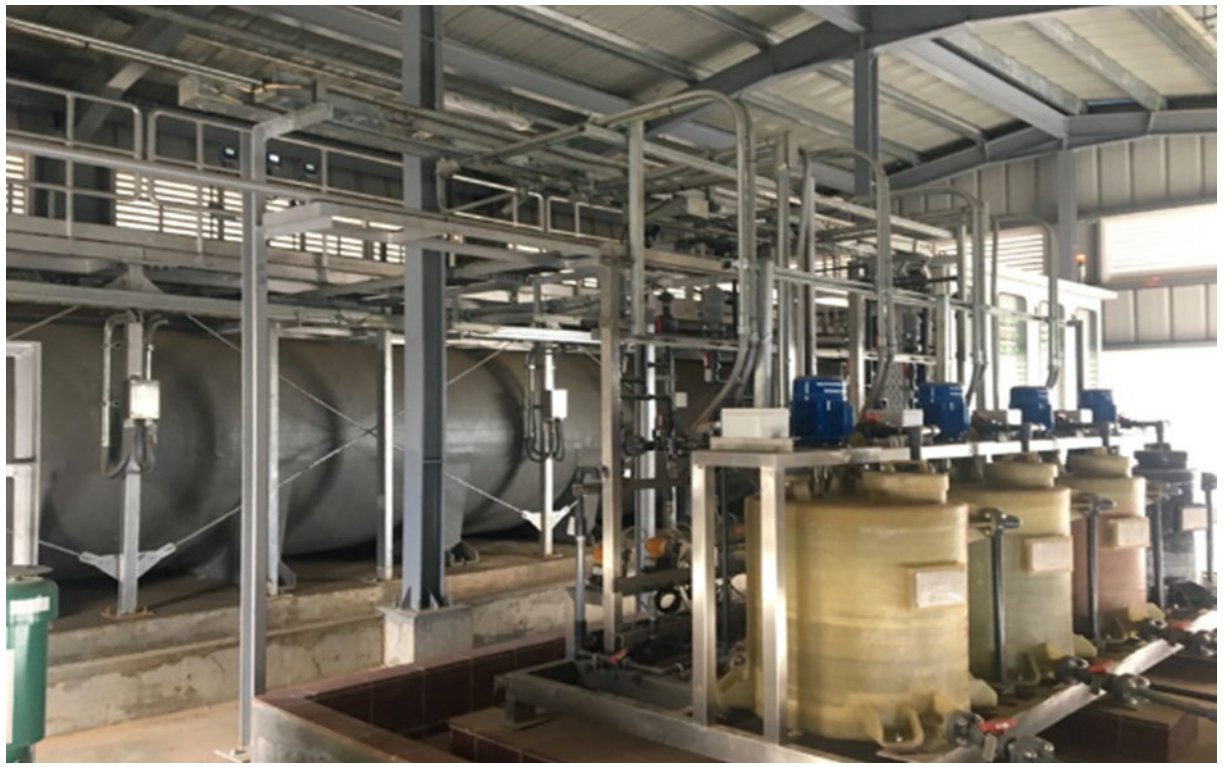
Photo 11: All sanitary wastewater from the Myingyan CCGT Plant is routed to the sanitary wastewater treatment plant

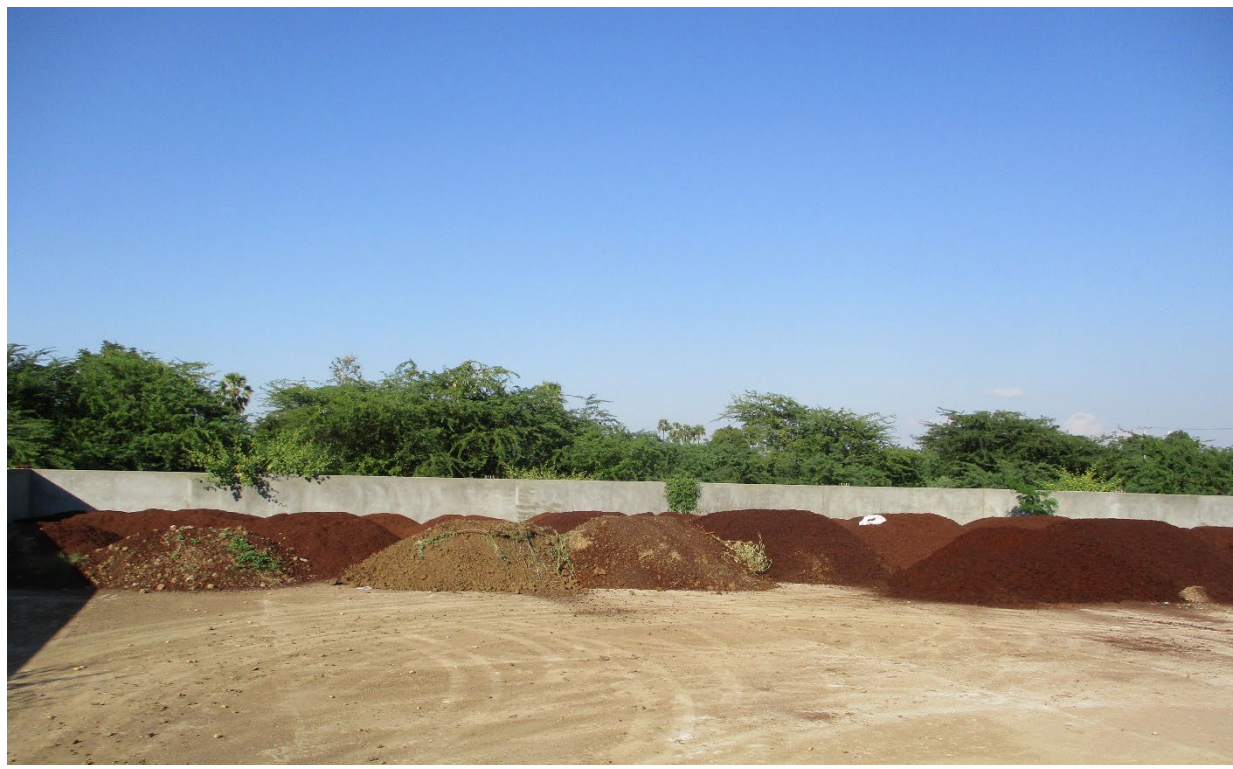
Photo 13: The sludge from the water treatment plant is transported to an offsite designated sludge storage area owned and operated by OK Service.

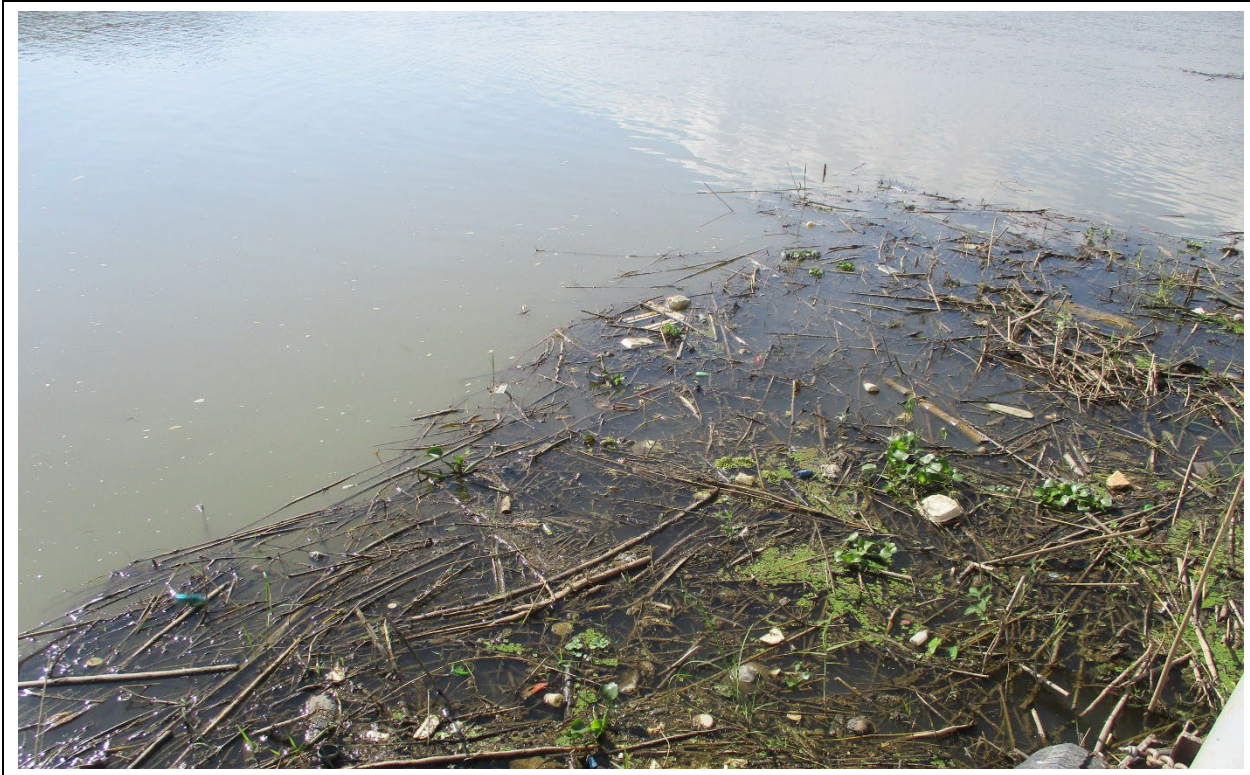
Photo 17: Debris collecting at the pumping station
