Environmental and Social Monitoring Fourth Report

MYA: Myingyan Natural Gas Power Project Part 7

MYINGYAN CCGT POWER PLANT

AUGUST 2018 ENVIRONMENTAL AND SOCIAL MONITORING VISIT

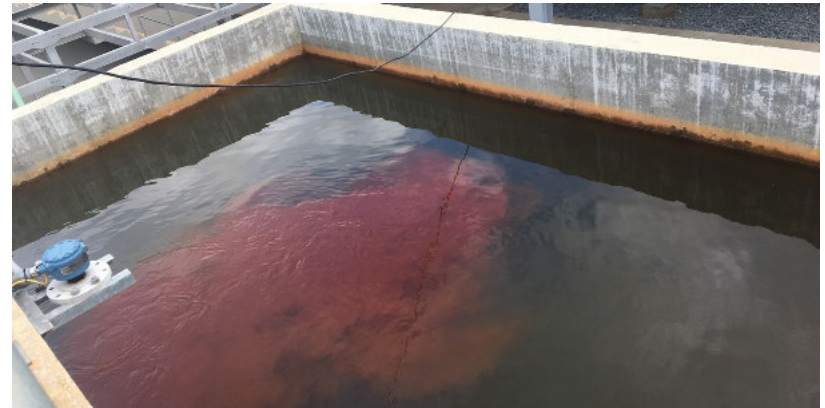
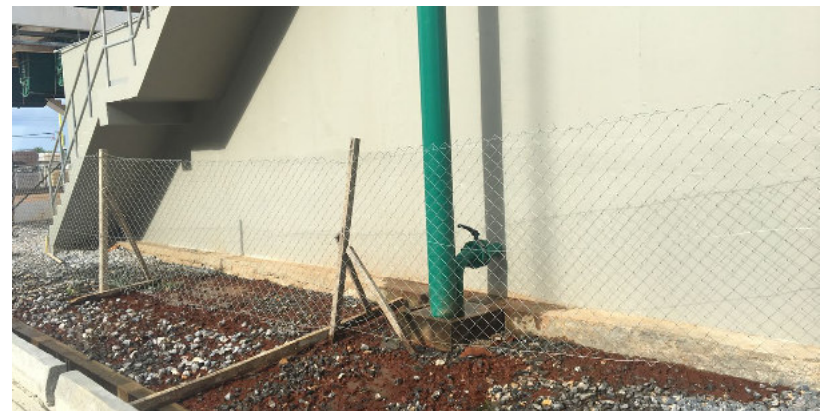
- Raw water treatment system: The agitator in the sludge thickener tank was faulty resulting in a overflow of water sludge mixture into the recycle water tank, the gravel layer surrounding the tank and an adjacent internal drain.
- The excess sludge water mixture overflowed into the neutralization pit and into one of the chemical stores (one inch of water on the floor).
- Rectification works is underway by the contactor with oversight from Sembcorp.

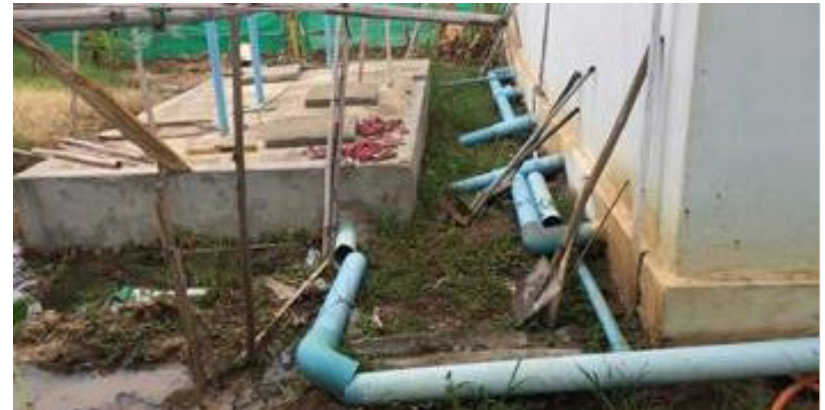
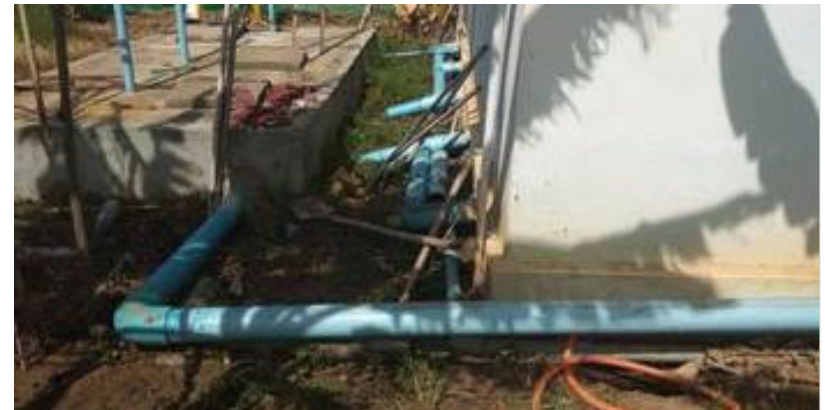
- JEM office/ warehouse has one cess pit and the pipe from the toilet sink leading to the cess pit was damaged at 2 locations (potential route for rainwater ingress into cess pit). The rectification of the broken pipe was completed today.

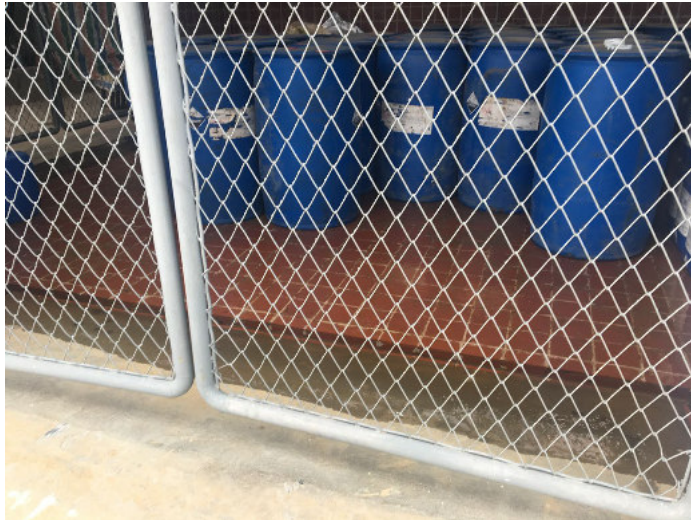
- Big improvements to secondary containment within the site but some issues remain:
 - Insufficient containment at the chemical store (for water treatment chemicals) based on the volume of chemicals stored.

Site is in discussions with a chemical supplier to have a chemical warehouse located in Myingyan for chemical storage to reduce the quantity of chemicals stored onsite and potentially, to accept used empty containers/drums for reuse.

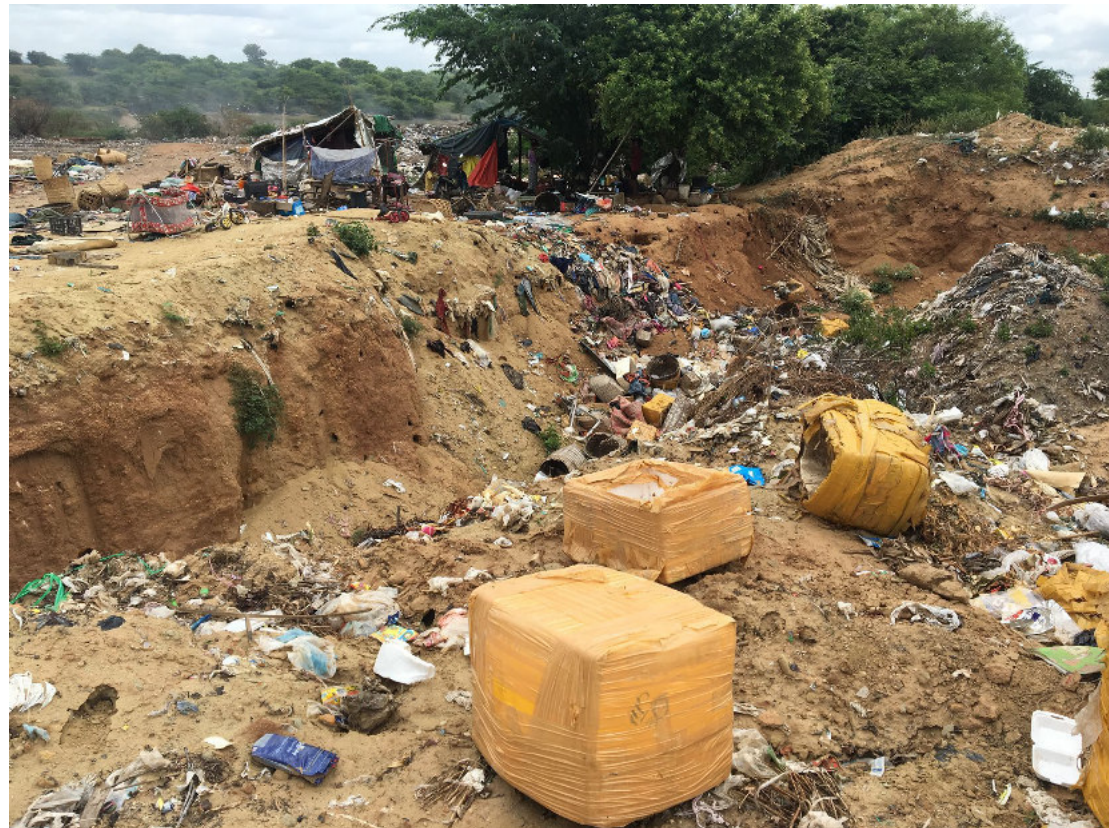
- Overall management of wastes at municipal landfill site: Solid waste now deposited in an excavated area approx. 100 feet by 100 feet. However, the area designated for Sembcorp was not clearly demarcated during this visit. The authorised collector has a dedicated person to conduct daily visits to disposal site to monitor project waste.

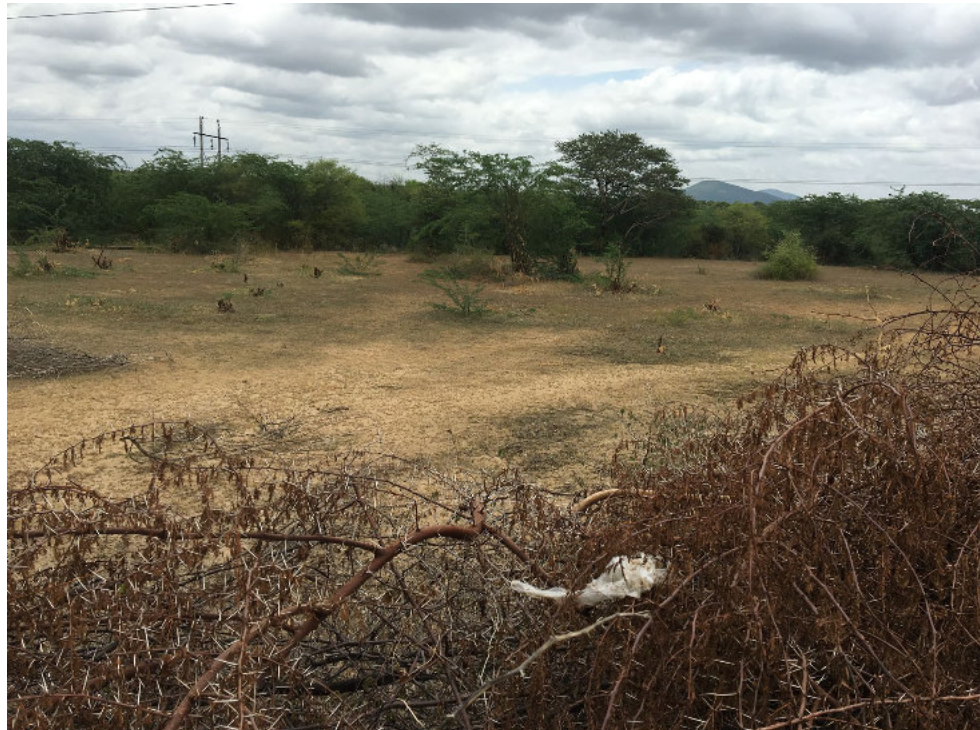
- The option for sludge treatment (sludge from raw water treatment and STP) is being discussed OK service.
- One location has been identified for the sludge to be dried and potentially used for land farming/ fertilizer (suitability to be confirmed upon testing of the sludge characteristics for ignitability, corrosivity, reactivity and toxicity).
- The plan and construction details for the sludge storage and drying area will be finalised by October 2018.

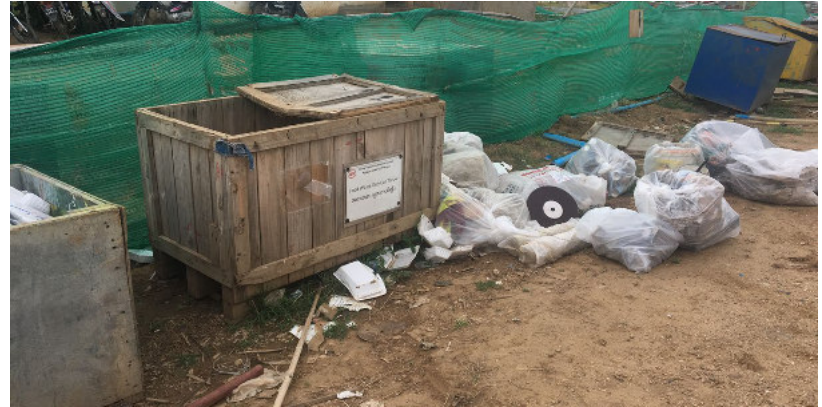
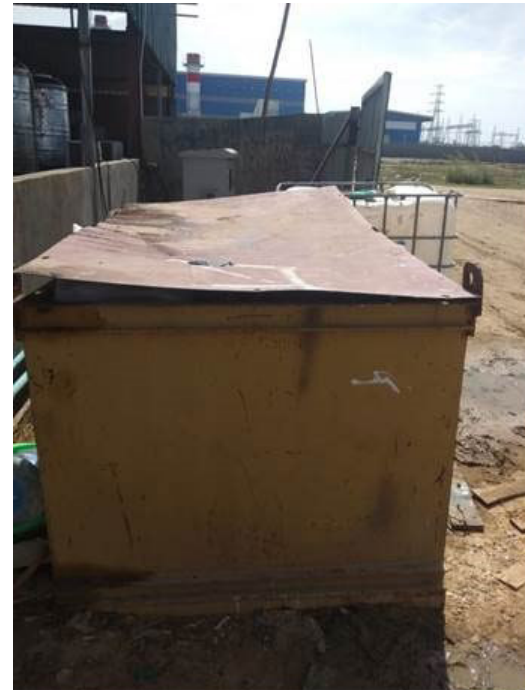
- At the JEM office and workshop area. Food waste (in plastic bags) were left on the ground and in two uncovered skips.
- This was corrected today by JEM

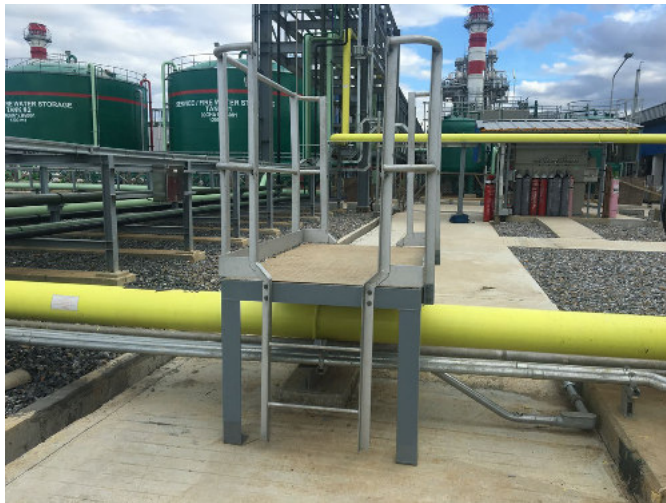
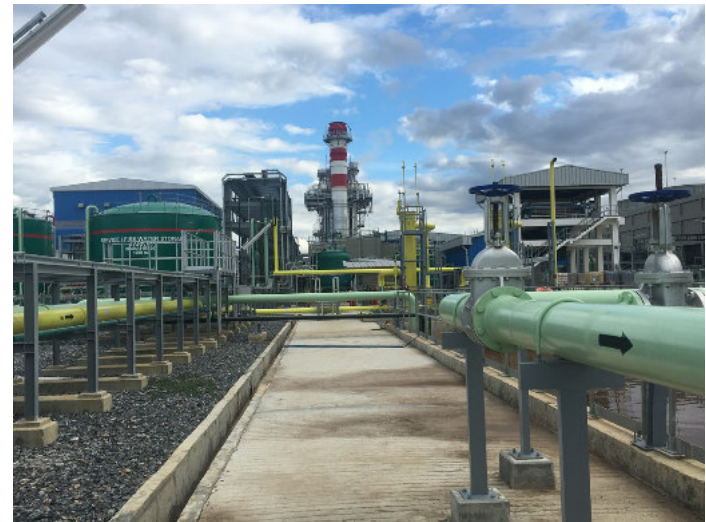
- Hazards appear to be well managed.
- Good safety culture
- 8,647,020 man-hours without LTI as of August 30, 2018
- Some areas for improvement e.g.
 - Visibility of PPE signs at some areas could be improved (i.e. ear protection at steam turbine area).
 - Opportunity to improve access/egress at the gas receiving station (in between the raw water pond and CMB).

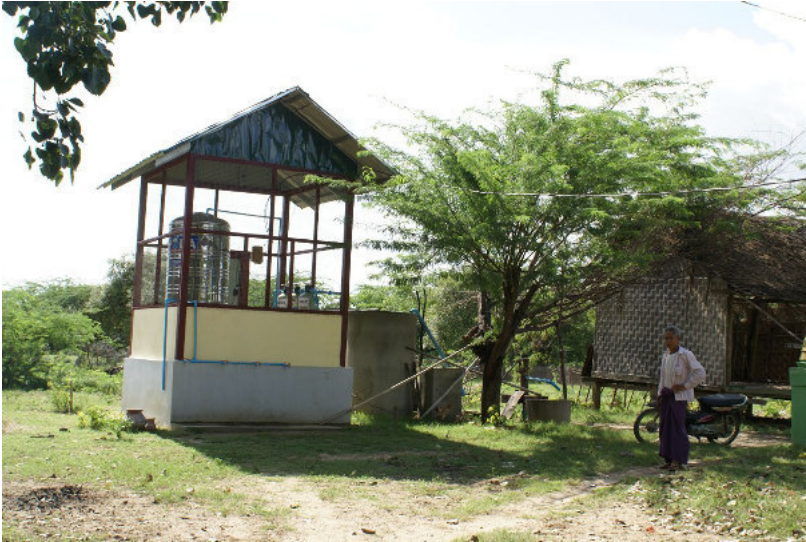
UV/UF water treatment system

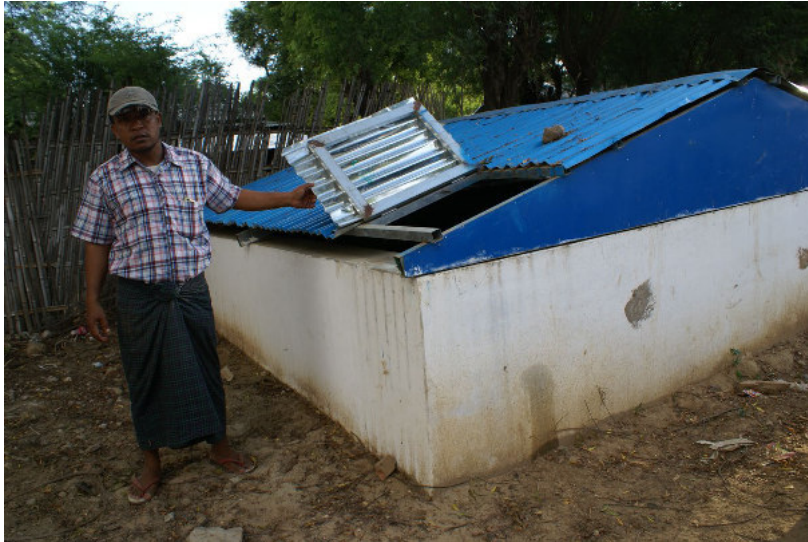
Underground firefighting water tank installed at each village
