# Environmental and Social Monitoring Second Report

Project Number: 48368-001  
August 2017

## MYA: Myingyan Natural Gas Power Project Part 1

# **MYINGYAN CCPP SECOND ENVIRONMENTAL AND SOCIAL MONITORING REPORT**

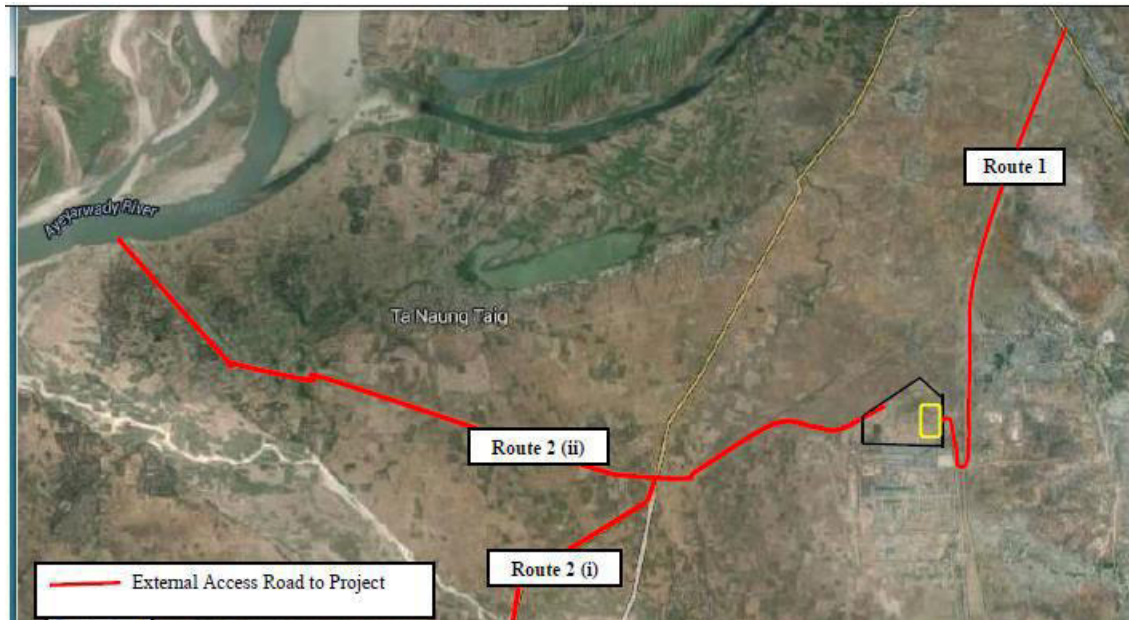
**Figure 4: Approved Site Access Routes**

Figure 4 shows the approved access routes to the Project site. Heavy loads are conveyed by barge to Nyaung Hla jetty, approximately 32 km South-West of the Project site, and then then by

road using a route which enters the construction site from the West, thereby avoiding impacts on nearby communities such as the small settlement near the main site entrance (Route 2 (ii)). Deliveries of heavy loads have now been completed.

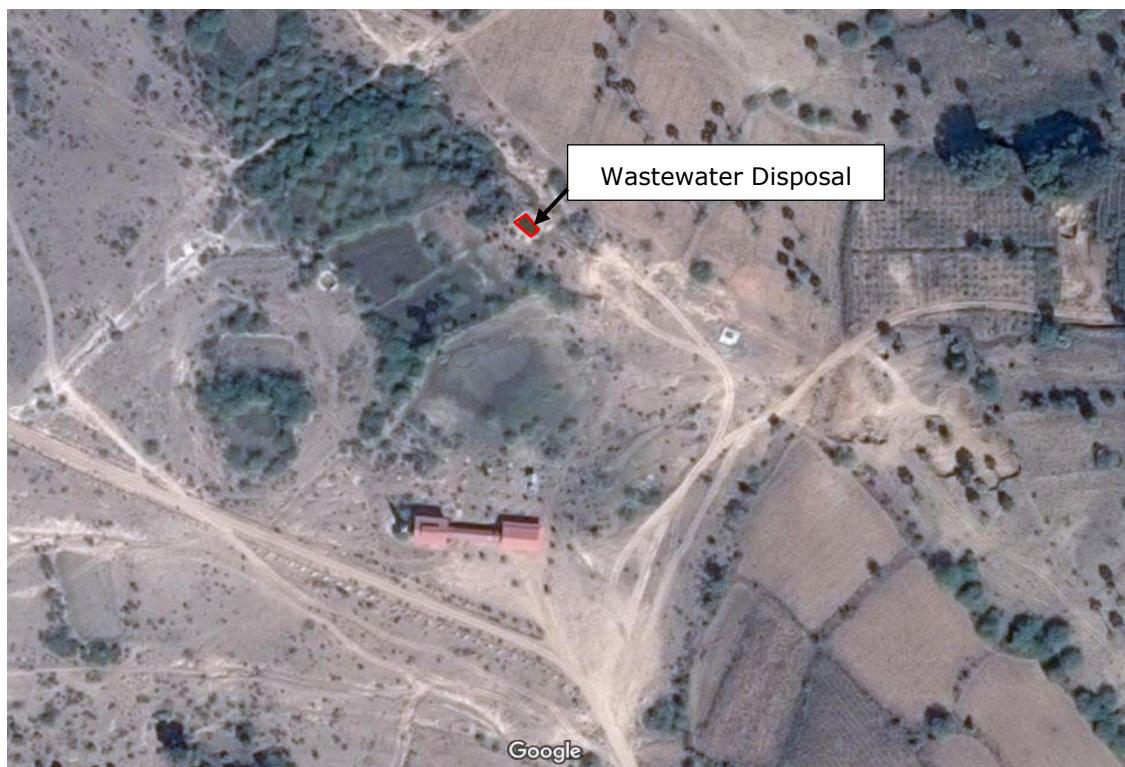
**Figure 6: Sanitary Wastewater Disposal Site**

the centre of Myingyan (Figure 5). It was reported that sanitary wastewater is pumped into an unlined soil pit, measuring around 5 m x 4 m (Photo 006 and Figure 6), which appeared to contain rainwater rather than sewage at the time of the IESC inspection. An area of stained ground was noted adjacent to the pit, where residues suggest that wastewater may be discharged onto the ground, where it flows downslope (Photo 007). The quality of wastewater disposed of at this location is not monitored, which is not consistent with the requirements of the Surface Water Management Plan.

No sensitive receptors were identified around the wastewater disposal site. The nearest building is the town's crematorium, 110 m to the South of the pit, and the nearest residential dwelling appears to be around 600 m to the North-East. The site is otherwise surrounded by agricultural land, and a wooded area immediately to the West, between the pit and the graveyard.

According to IFC PS3 and ADB's SPS SR1, the Project Company should avoid pollution through the application of GIIP. Neither the unlined pit nor the discharge onto soil are considered to represent GIIP for the disposal of untreated sanitary wastewater. The IESC recommends that Sembcorp evaluates alternative options for the disposal of sanitary wastewater for the remainder of the Project's construction phase. Discussions with Project representatives indicated that this is the only wastewater disposal site in the Myingyan region. Sembcorp should therefore consider options for a package sewage treatment plant that would be capable of treating the total volume of sanitary wastewater generated in the remainder of the Project's construction phase.

The IESC also recommends that the Project Company monitors the quality of wastewater disposed of at the municipal site to determine whether it meets the guidelines stated in the WBG General EHS Guidelines.
