# Environmental and Social Monitoring Third Report

Project Number: 48368-001  
July 2018

## MYA: Myingyan Natural Gas Power Project Part 1

# **MYINGYAN CCPP THIRD ENVIRONMENTAL AND SOCIAL MONITORING REPORT**

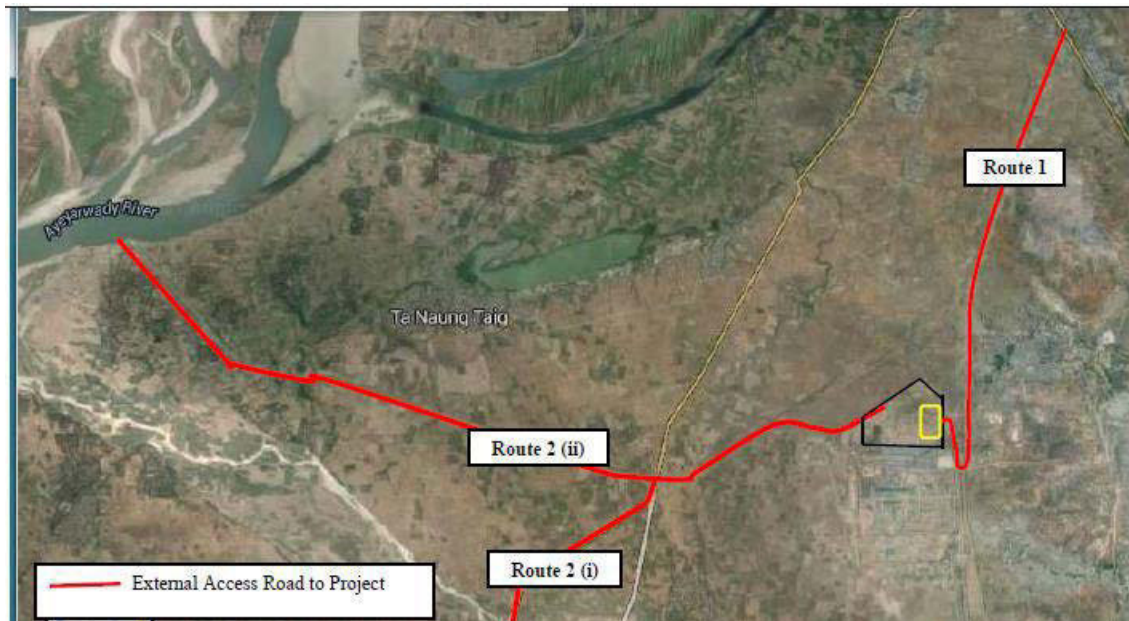
**Figure 4: Approved Site Access Routes**

Figure 4 shows the approved access routes to the Project site. Heavy loads were conveyed by barge to Nyaung Hla jetty, approximately 32 km South-West of the Project site, and then by road using a route which enters the construction site from the West, thereby avoiding impacts on nearby communities such as the small informal settlement near the main site entrance (Route 2 (ii)). Deliveries of heavy loads have now been completed.

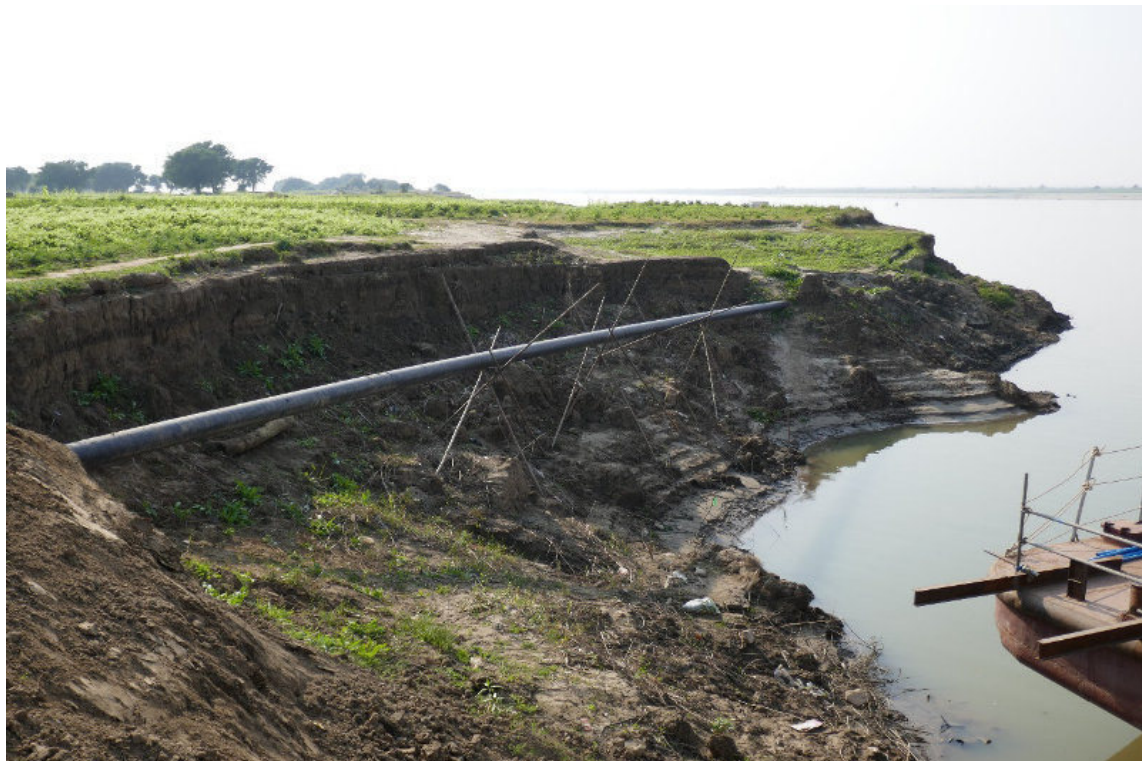
**Photo 3:** Wastewater pipeline exposed by river bank erosion

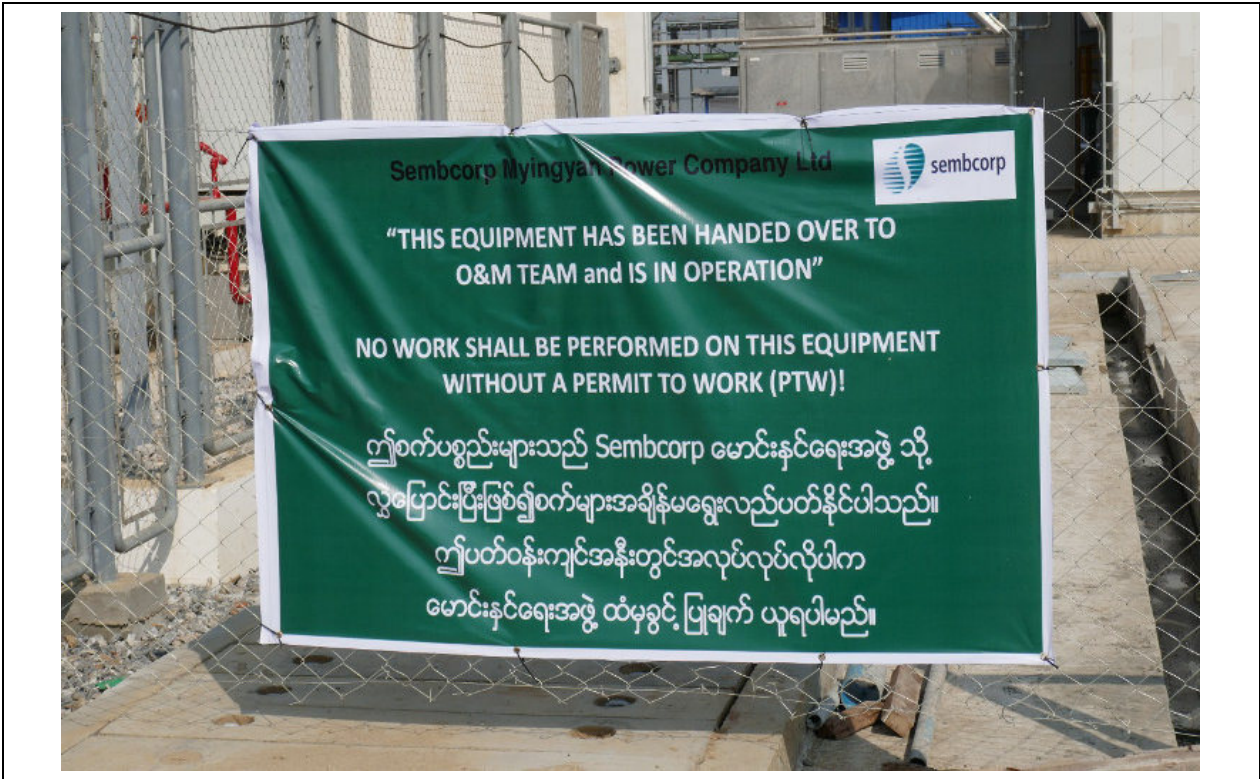
The Project has developed simultaneous operations (SIMOPS) protocols to manage HSE risks during the transition period from construction to operations, as documented in the Managing Simultaneous Works SOP (SOP-MYN-016, dated 3<sup>rd</sup> November 2017). The construction team will retain overall control of the Project site until COD2 in May 2018. However, construction personnel require a Permit to Work (PTW) to enter operational areas after COD1, and a Lock Out Tag Out (LOTO) system provides an additional level of control during the SIMOPS phase. During the site inspection, fences were noted around operations areas to restrict access (Photo 005).

**Photo 5:** Restricted access to areas handed over to the operations team

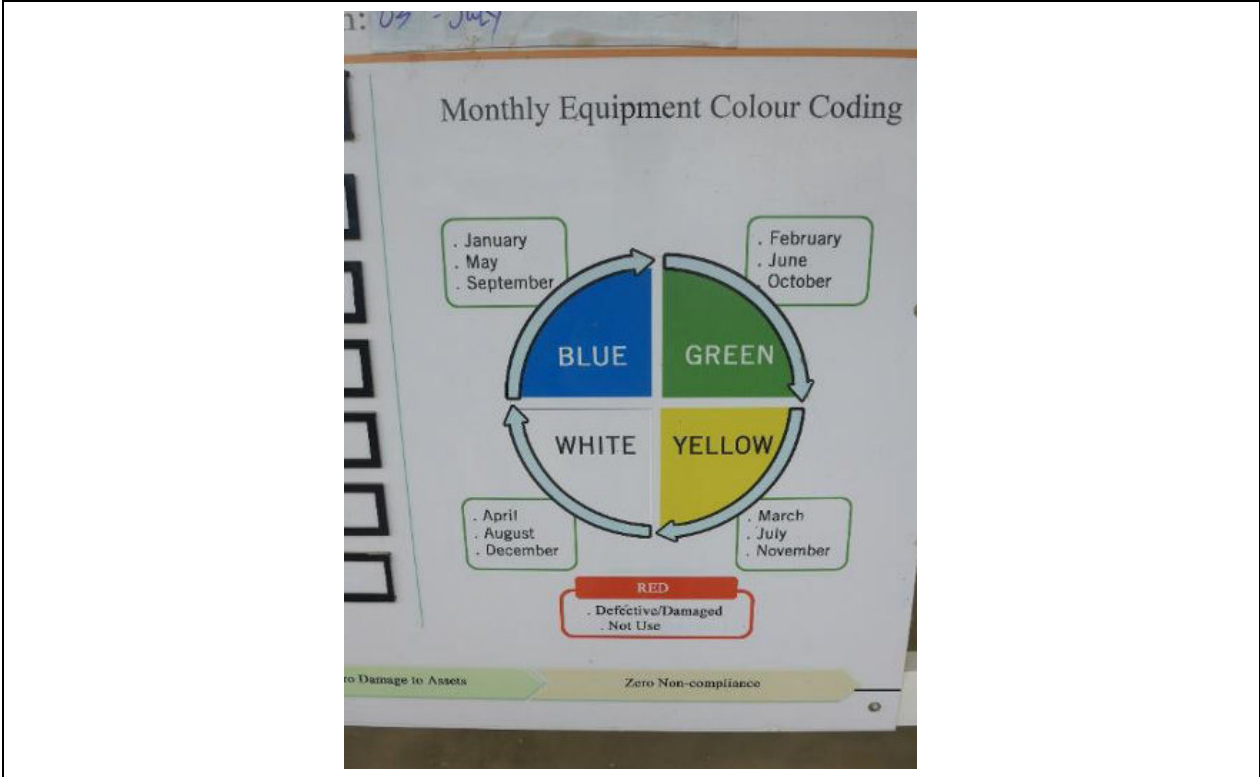
As noted in section 5.3.1, compliance with the machinery and equipment inspection and maintenance system, using colour coded labels, is good. During the site inspections no major issues were noted with the condition of plant and equipment.

**Photo 6:** Equipment colour-coding to demonstrate maintenance and fitness-for-use

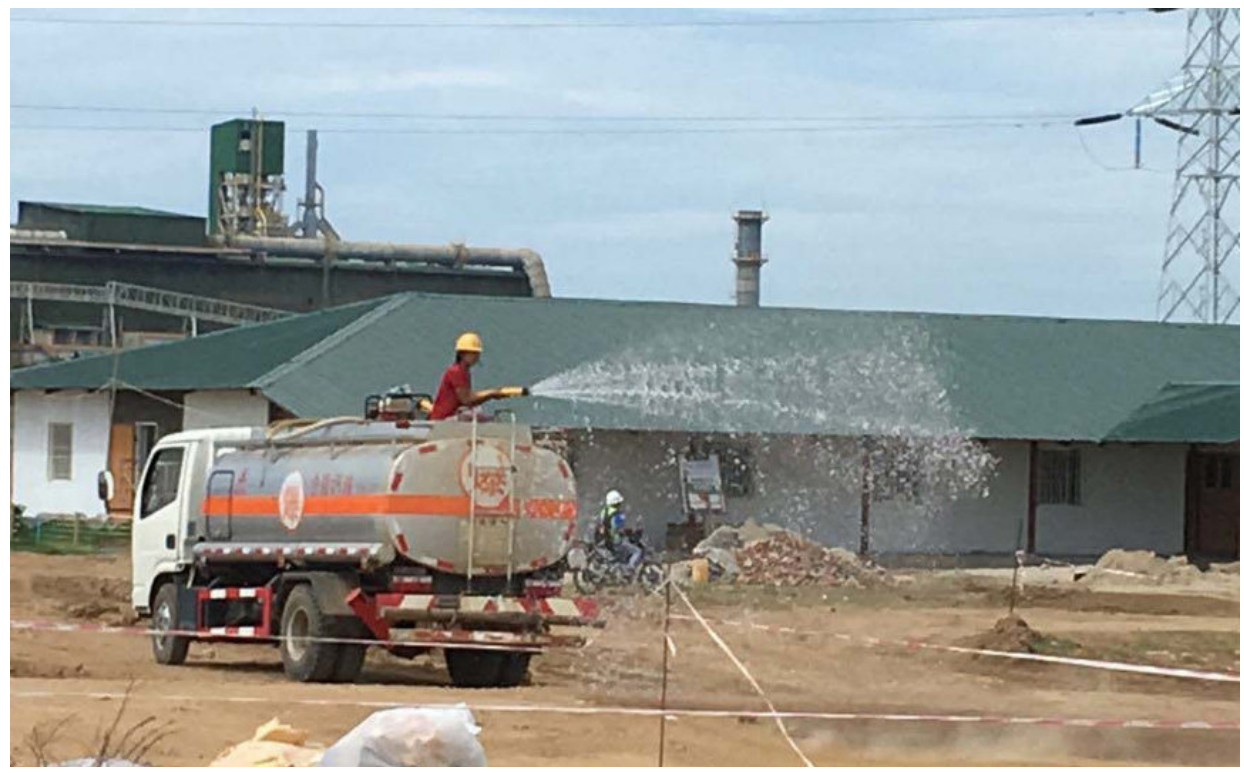
- Onsite roads and some off-site roads are sprayed daily with water abstracted from onsite groundwater boreholes to suppress dust (Photo 007). This activity was witnessed by the IESC during the monitoring visit and appears to be effective. One water spraying truck is used every day, but two or three vehicles are used in very dry periods.
- Trucks used to carry construction materials are covered (Photo 008). No breaches of this Project commitment were observed during the site inspections.
- Hoppers and conveyor belts at the CBP are enclosed (Photo 009), and dust was not an issue when the CBP was inspected.
- The site is surrounded by 2 m high hoardings, which reduce the potential for dust to be blown to surrounding areas.
- A 15 km/hour speed limit is strictly enforced at the construction site, which reduces dust generation by vehicles.

**Photo 7:** Dust suppression on site roads

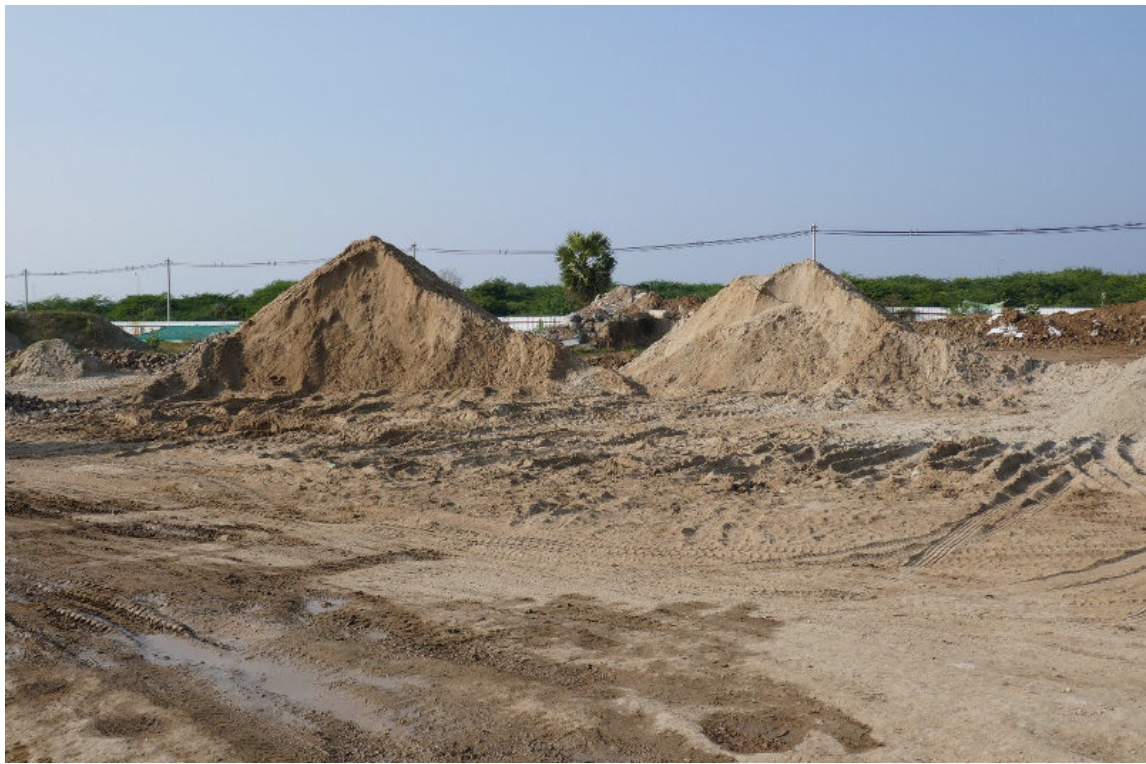
Site management reported that soil stockpiles have been reduced in height to below 2 m, and compacted to reduce dust generation. However, during the site inspection, stockpiles of soil and sand up to 4 m high were noted (Photo 010).

**Photo 10:** Soil stockpiles exceeding 2 m high

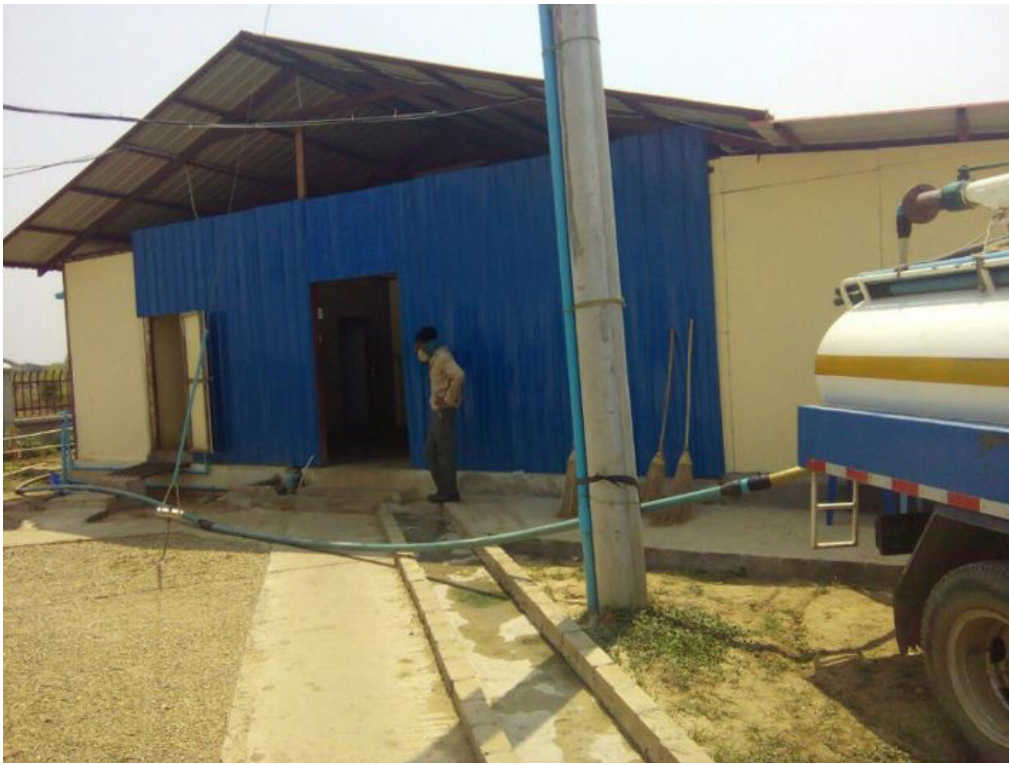
Sanitary wastewater from cess pits at the construction site and worker accommodation camps is periodically removed by the Myingyan Municipality, using vacuum tankers (Photo 015). The contents of cess pits are taken to a municipal wastewater disposal site adjacent to the Myingyan cemetery and graveyard, approximately 7 km South of the centre of Myingyan (Figure 5). It was reported that sanitary wastewater is pumped into an unlined soil pit, measuring around 5 m x 4 m (Photo 016 and Figure 6), which appeared in the July 2017 IESC visit to contain rainwater rather than sewage. An area of stained ground was noted adjacent to the pit, where residues suggest that wastewater may be discharged onto the ground, where it flows downslope (Photo 017). The quality of wastewater disposed of at this location is not monitored, which breaches the requirements of the Surface Water Management Plan.

**Photo 15:** Vacuum tanker collecting sewage from septic tank at JEM camp

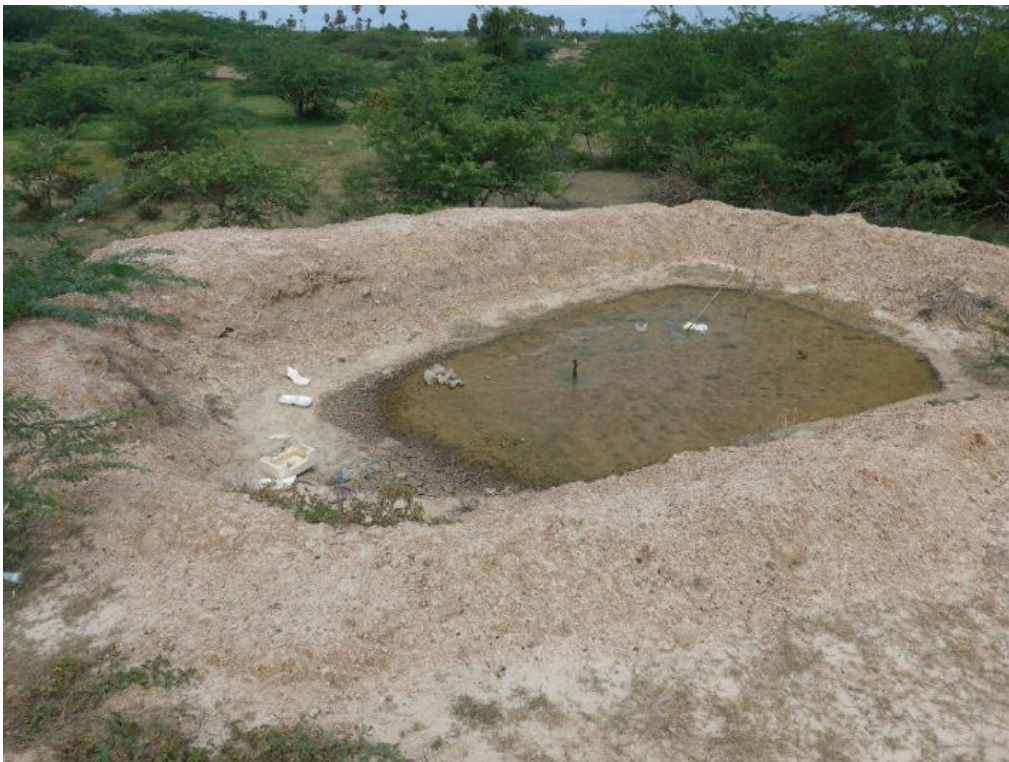
**Photo 16:** Wastewater disposal pit, reportedly used for disposal of sanitary wastewater

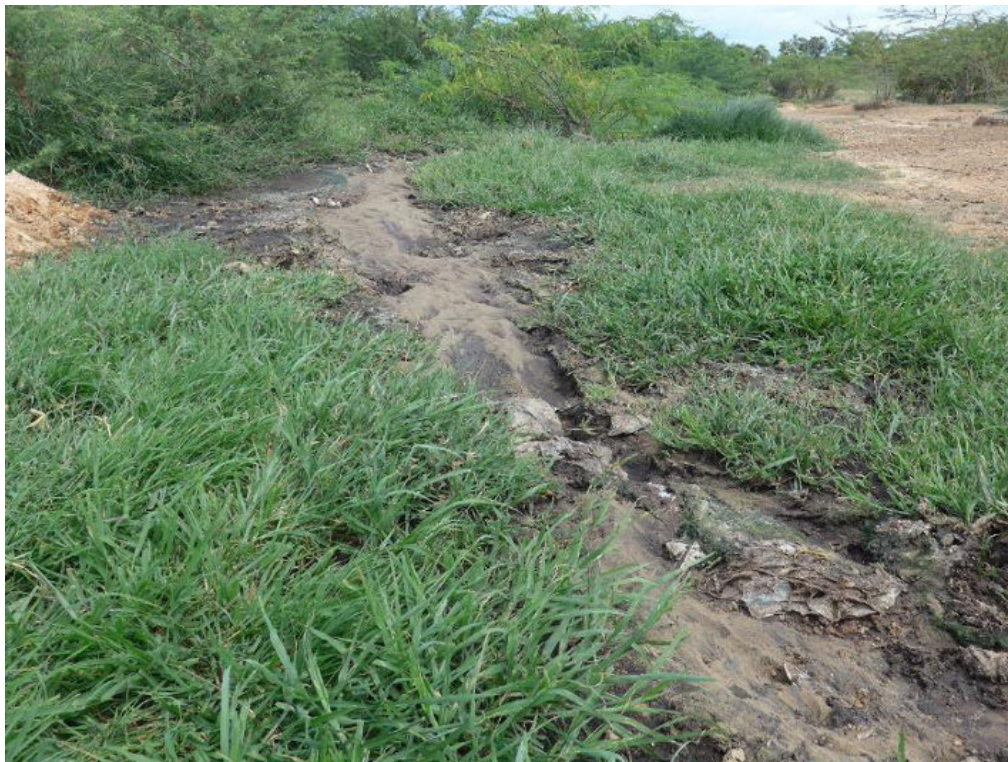
**Photo 17:** Evidence of wastewater disposal on soil adjacent to pit

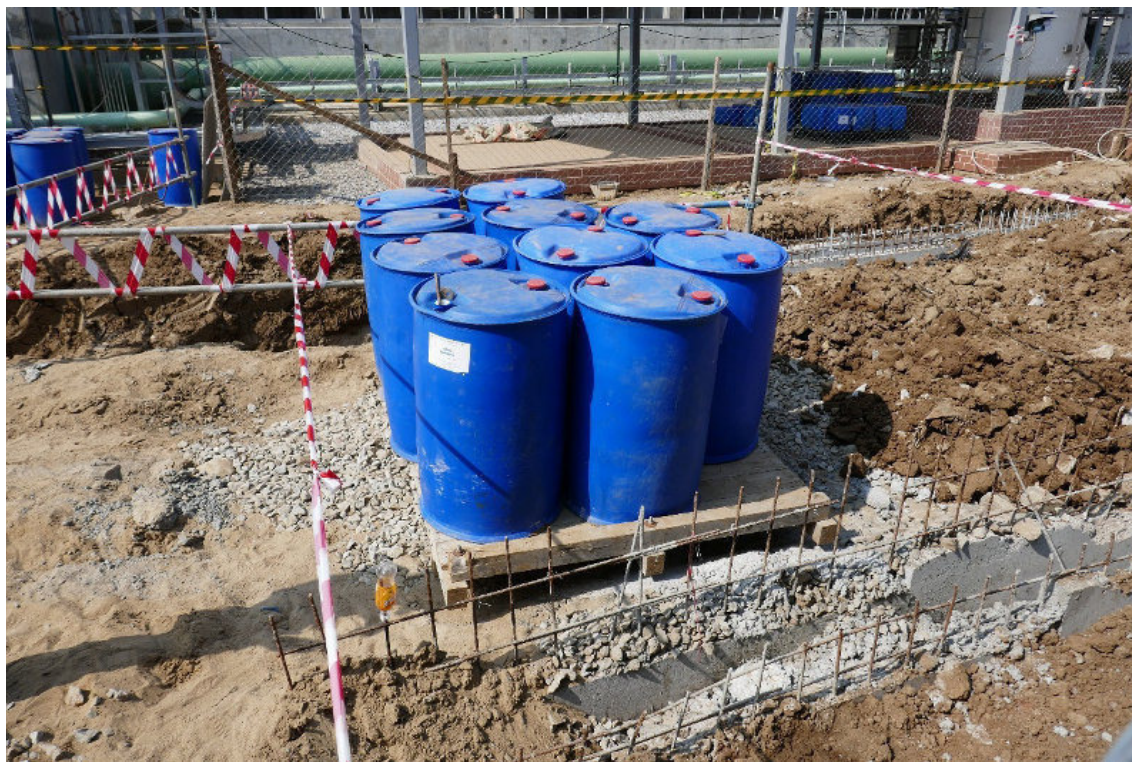
**Photo 22:** Sodium hypochlorite tanks with no secondary containment

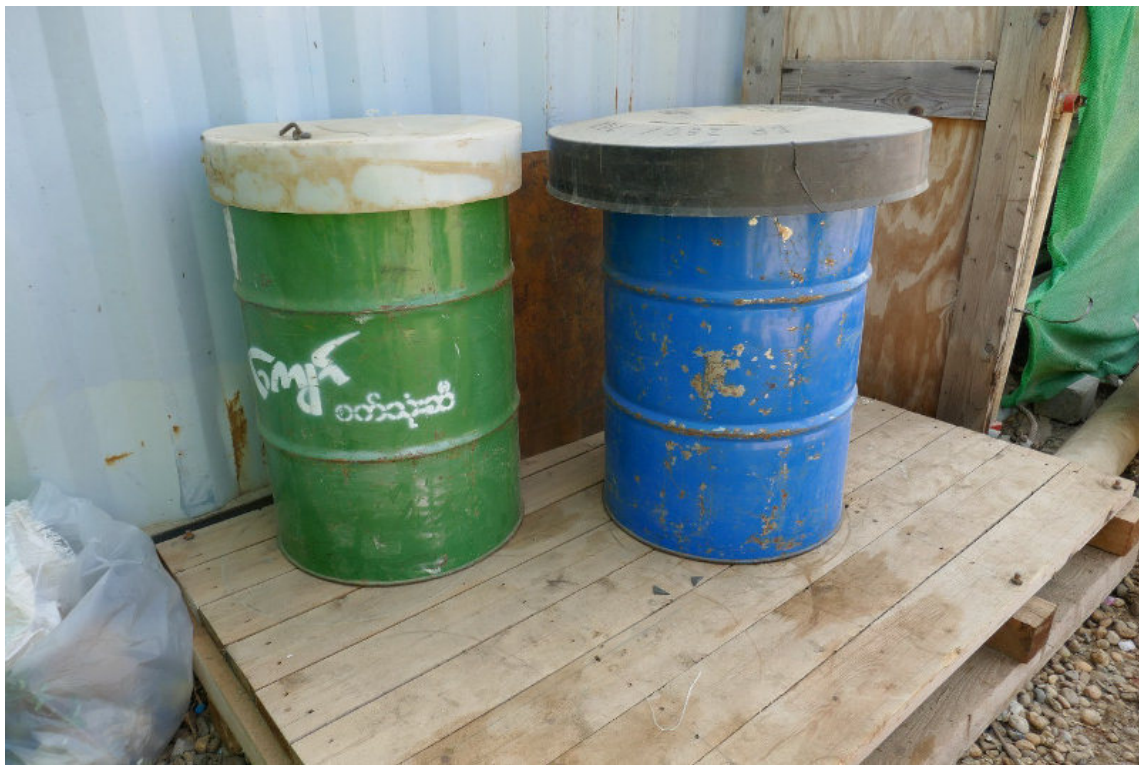
**Photo 23:** Oil drums with no drip trays

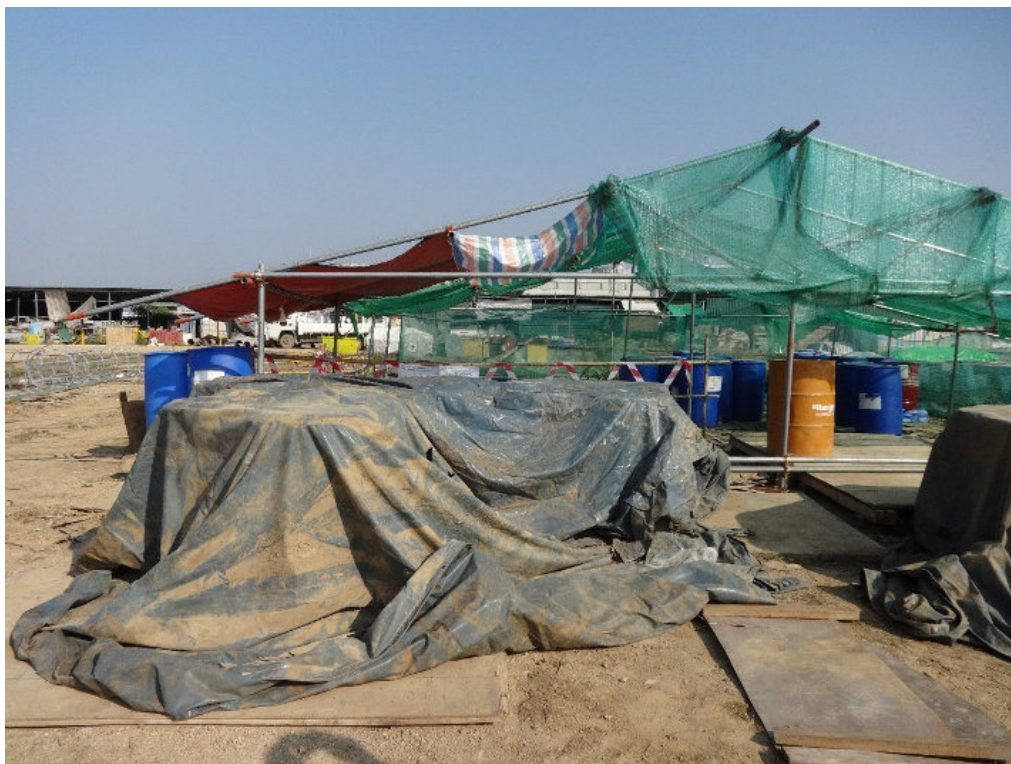
**Photo 24:** Storage of chemicals and oil without secondary containment

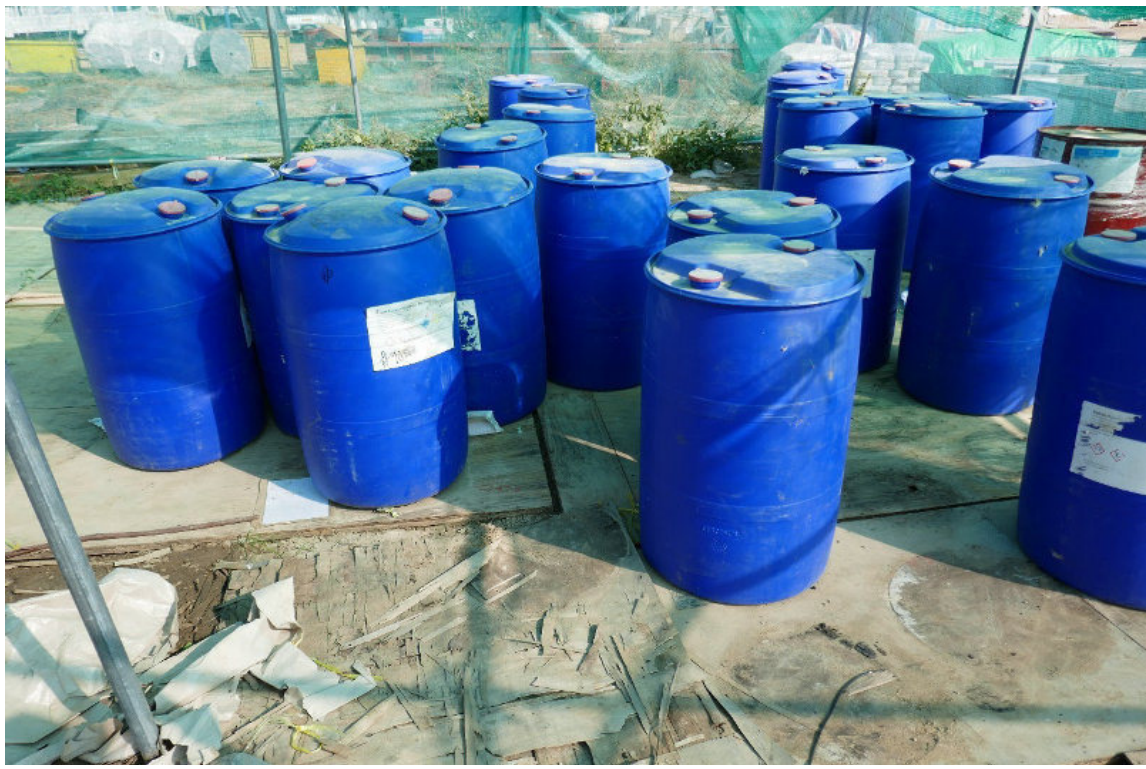
**Photo 25:** Some chemical storage drums are deformed from exposure to sunlight

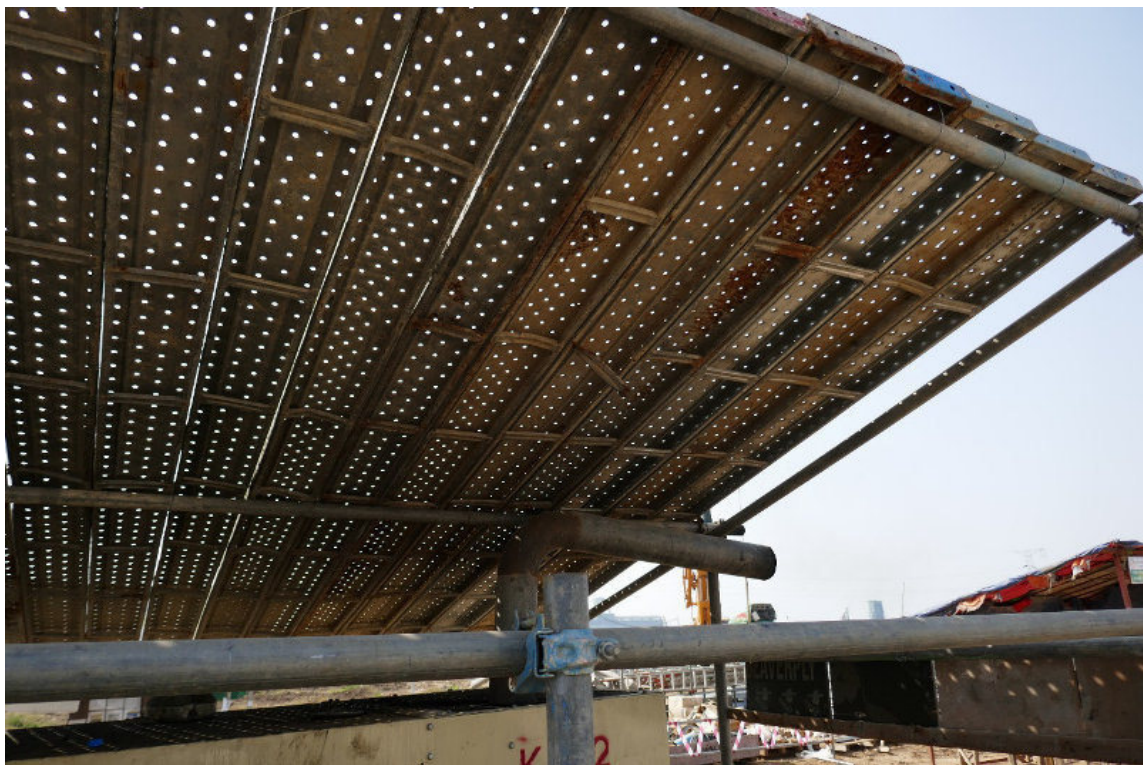
**Photo 26:** Non-watertight roof over a diesel generator

**Photo 27:** Roof over generator replaced immediately after site visit

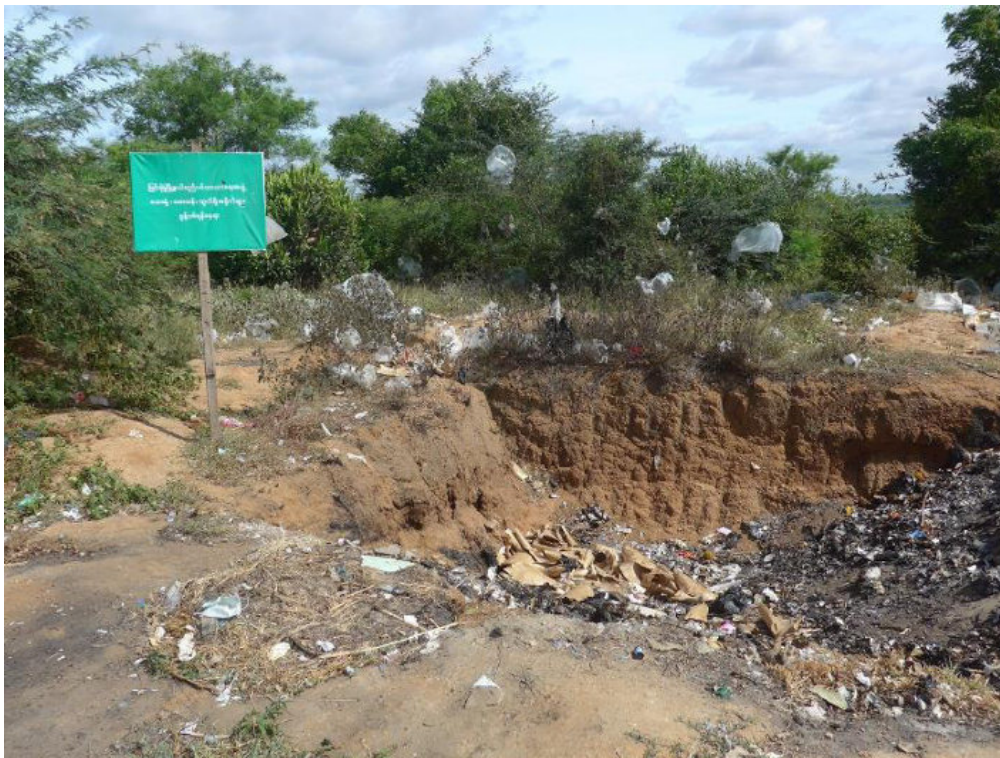
Site representatives reported that medical waste from the Project is comingled with waste from the local hospital before being deposited in an unlined soil pit (approximately 5 m by 5 m in area and 2 m deep) around 100 metres North of the site entrance (Photo 028). It is doused with petrol then burned. Sembcorp recently constructed a medical waste incinerator at the Myingyan Hospital, which has been used to dispose of medical waste produced at the hospital and from the Project site since September 2017 (Photo 029).

**Photo 28:** Landfill of medical waste in July 2017

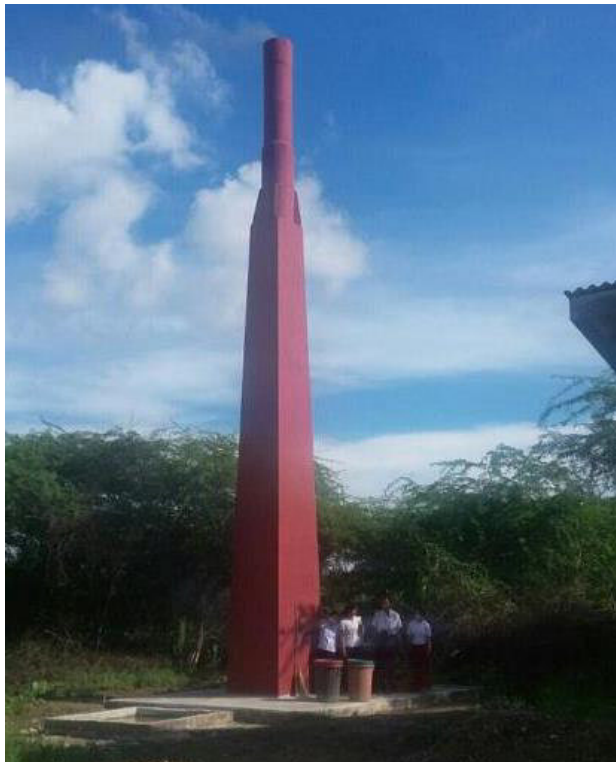
A positive community service initiative undertaken by Sembcorp includes the recently constructed medical waste incinerator at the Myingyan Hospital. This will provide a safe means for the disposal of clinical and medical wastes which previously were burnt at the unlined municipal landfill.

**Photo 29:** Medical waste incinerator at Myingyan Hospital

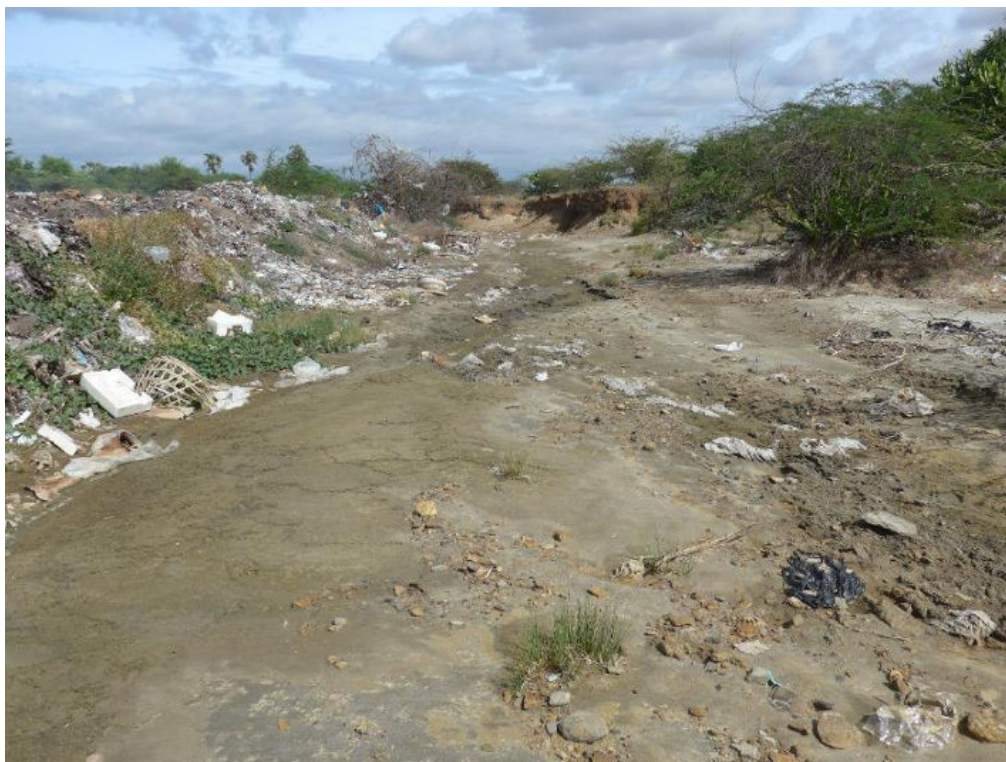
**Photo 30:** Waste falling from landfill into ephemeral stream bed adjacent to landfill site
