Environmental and Social Monitoring Fourth Report

Project Number: 48368-001
January 2019

MYA: Myingyan Natural Gas Power Project Part 1

MYINGYAN CCPP FOURTH ENVIRONMENTAL AND SOCIAL MONITORING REPORT

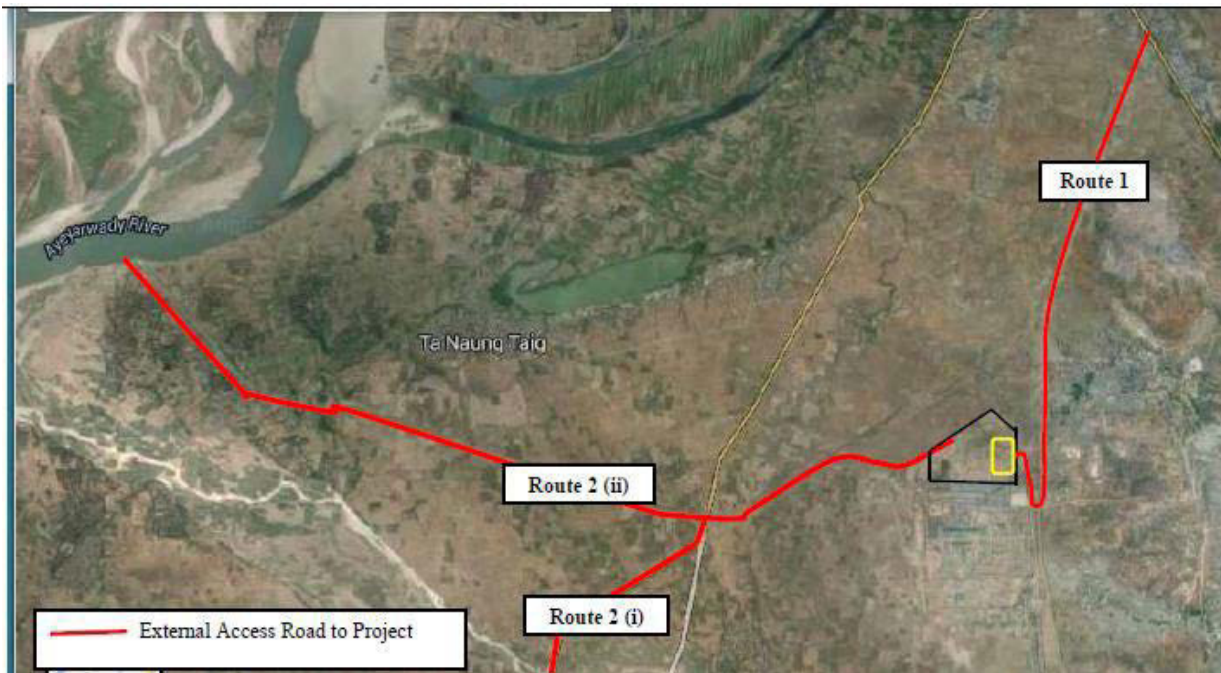
Figure 4: Approved Site Access Routes

Figure 4 shows the approved access routes to the Project site. Heavy loads were conveyed by barge to Nyaung Hla jetty, approximately 32 km South-West of the Project site, and then by road using a route which enters the construction site from the West, thereby avoiding impacts on nearby communities such as the small informal settlement near the main site entrance (Route 2 (ii)). Deliveries of heavy loads have now been completed.

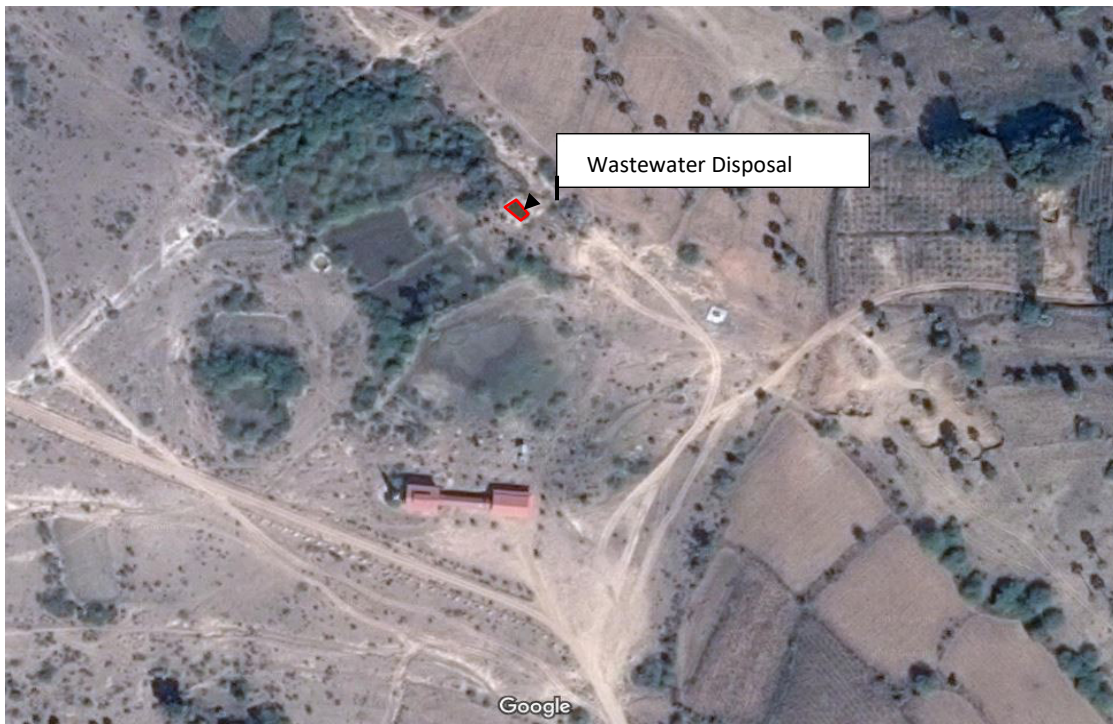
Figure 6: Sanitary Wastewater Disposal Site

No sensitive receptors were identified around the wastewater disposal site. The nearest building is the town's crematorium, 110 m to the South of the pit, and the nearest residential dwelling appears to be around 600 m to the North-East. The site is otherwise surrounded by agricultural land, and a wooded area immediately to the West, between the pit and the graveyard.

ID	Aspect	Issue Description	Phase	Standard	IESC Recommendations	August 2018 Update	Significance
004	Sanitary wastewater disposal	The off-site wastewater disposal site does not meet lender standards and represents an environmental risk.	Construction	<ul style="list-style-type: none"> IFC PS3 WBG EHS Guidelines ADB-ES Principle 9 	Evaluate options for on-site or off-site treatment of sanitary wastewater before it is disposed of.	<p>All sanitary wastewater from the site is routed to the onsite sanitary wastewater treatment plant from April 2018 onwards.</p> <p>However, sanitary wastewater from JEM's office and warehouse area was still being collected and disposed by the municipal council during the August 2018 monitoring visit. Moving forward, the IESC was informed that it will be pumped to the site's injector pit and treated at the sanitary wastewater treatment plant.</p>	Minor
005	Hydrotest wastewater	Wastewater will be generated by hydrotesting of pipelines during pre-commissioning, but plans have not yet been developed for its disposal.	Construction	<ul style="list-style-type: none"> IFC PS3 WBG EHS Guidelines ADB-ES Principle 9 	<p>Develop plans for sourcing water for hydrotesting and disposal of the water after the hydrotesting.</p> <p>Consideration may need to be given to treatment if chemical additives (e.g. corrosion inhibitor or biocide) are used in the process.</p>	Hydrotesting was completed in the second half of 2017 using river water. No chemicals were added, and analysis of water before discharge to the Ayeyarwady River demonstrated that it was chemically potable.	Issue Closed

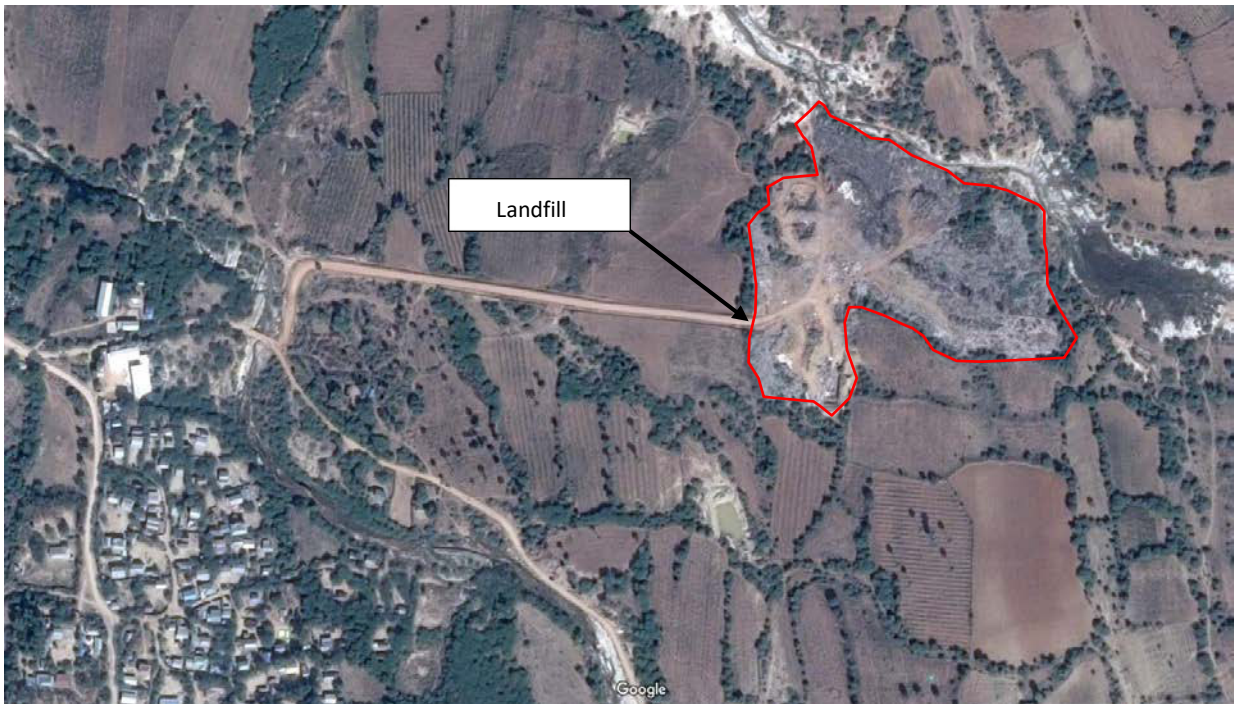
Figure 7: Municipal Waste Disposal Site

During the July 2017 monitoring visit, at least ten scavengers were seen collecting waste materials for recycling. They appeared to live in simple shacks made of waste materials, within the site, close to the entrance (Photo 021). The disposal site was visited during the August 2018 monitoring visit and the scavengers remain and live in simple shacks, within the site as noted in the July 2017 monitoring visit.

Waste is not properly contained in the disposal site as much of it is left on the surface and not covered with soil. Reportedly only hazardous waste is buried in unlined pits within the site. In addition, a considerable amount of wind-blown litter was observed in trees and on the ground surrounding the site.

The key moderate significance environmental finding is related to the off-site waste disposal site that does not meet lender standards. Sembcorp reviewed disposal options and the disposal site (landfill) operated by the Myingyan Municipality was the only available facility in the area. While not an ideal option, an assessment of potential impacts revealed that there are no sensitive receptors in close proximity and the disposal site is a municipal landfill where all types of wastes are disposed. Sembcorp should work with OK Service and the municipality to improve conditions at the waste disposal site. In particular, effort should focus on improving containment of waste.
