**Table 3: Summary of Findings - Environmental and Social Management System**

### 5.3 Air Quality and Dust

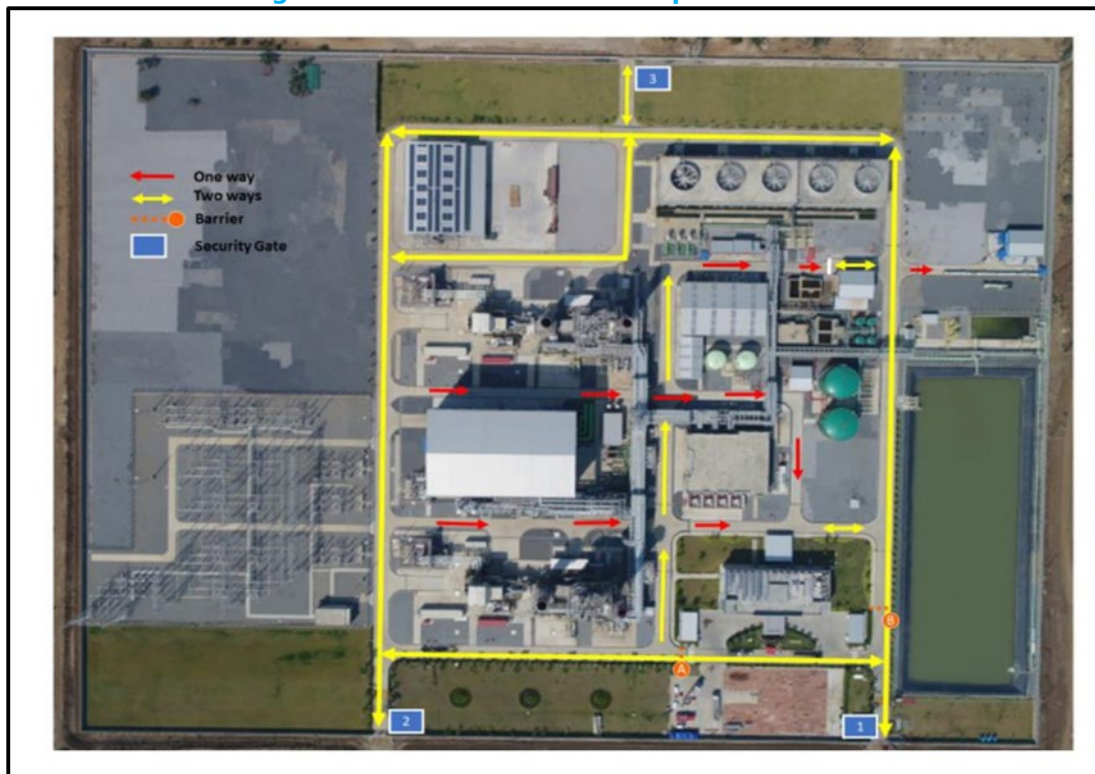
**Figure 3: Site Traffic Flow for Operations Phase**

**Figure 3** shows the internal traffic layout within the site. There are several signs clearly displaying the speed limit of 15 km/hour at various locations within the site. There are three (3) security gates and security personnel at the entrance check that all vehicle occupants are wearing a seat belt before vehicles are allowed to enter.

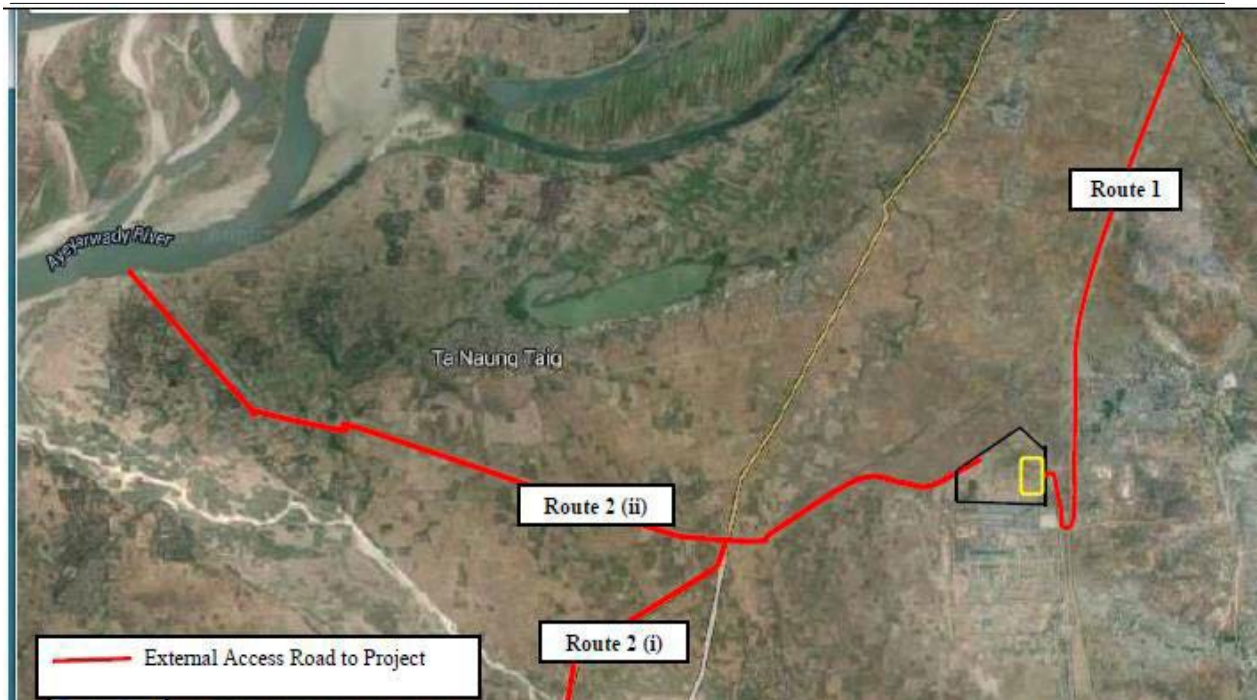
**Figure 4: Approved Site Access Routes**

**Figure 4** shows the approved access routes to the Project site during the construction phase. Heavy loads were conveyed by barge to Nyaung Hla jetty, approximately 32 km South-West of the Project site, and then by road using a route which enters the site from the West, thereby avoiding impacts on nearby communities such as the small informal settlement near the main site entrance (Route 2 (ii)).

Deliveries of heavy loads have now been completed and is no longer considered an issue for the operational phase of the project.

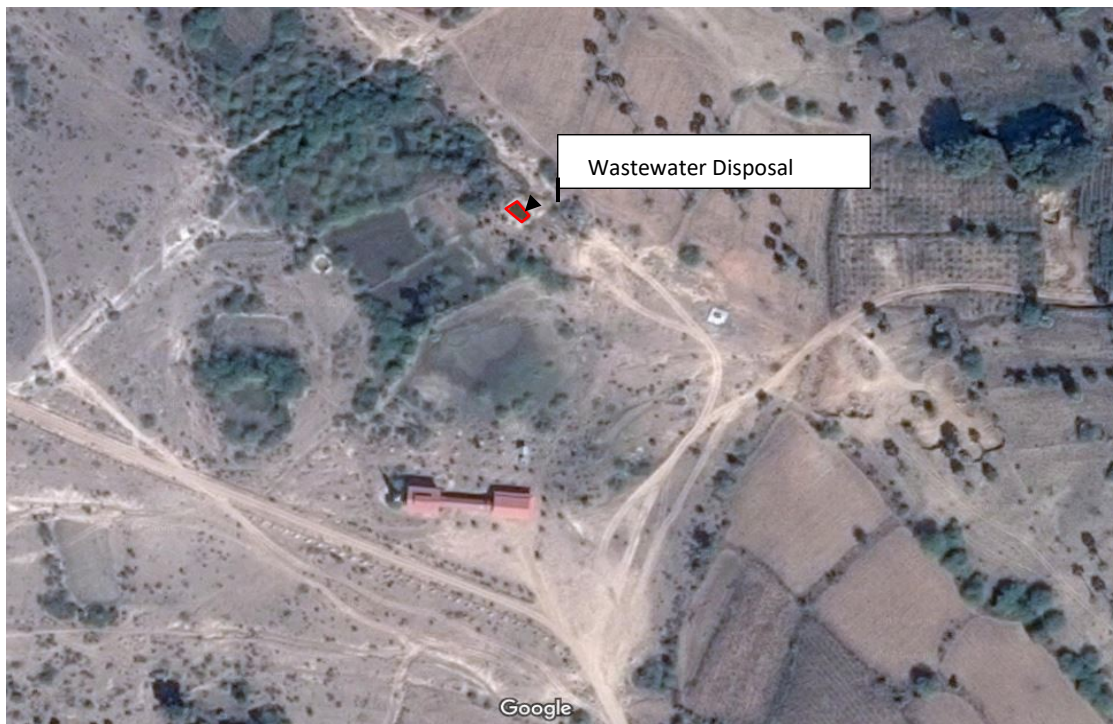
**Figure 6: Sanitary Wastewater Disposal Site**

The contents of the cess pit will be taken to a municipal wastewater disposal site adjacent to the Myingyan cemetery and graveyard, approximately 7 km South of the centre of Myingyan (**Figure 5**). Once collected by the Municipal council, it will be pumped into an unlined soil pit, measuring around 5 m x 4 m (**Figure 6**).

No sensitive receptors were identified around the wastewater disposal site. The nearest building is the town's crematorium, 110 m to the South of the pit, and the nearest residential dwelling appears to be around 600 m to the North-East. The site is otherwise surrounded by agricultural land, and a wooded area immediately to the West, between the pit and the graveyard.

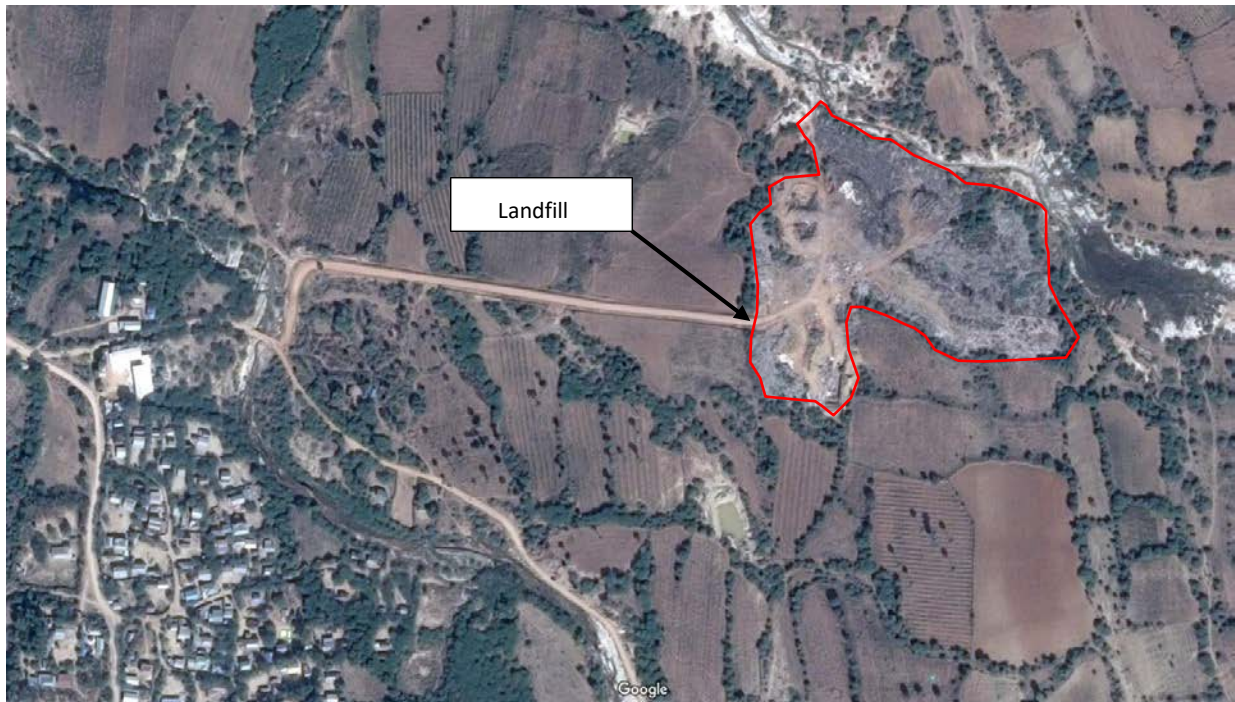
**Figure 7: Municipal Waste Disposal Site**

Solid general waste is collected from the site twice per month by OK Service, then transported to a landfill site operated by the Myingyan Municipality, around 4 km East of the centre of Myingyan (**Figure 7**). This facility, which was opened around three years ago, is not an engineered landfill but a poorly controlled and unlined waste dump. Most waste appears to be deposited on the surface, where it is neither compacted nor buried. During the August 2018 visit, it was noted that the waste across much of the site is smoldering and that the waste is routinely burned. It is understood that smoke sometimes blows towards Myingyan, where it causes a nuisance. The Project keeps records of the type and volume of waste deposited at the municipal landfill site.

In previous monitoring visits, approximately ten scavengers were seen collecting waste materials for recycling. They appeared to live in simple shacks made of waste materials, within the site, close to the entrance. The disposal site was visited again during the August 2018 monitoring visit and the scavengers remain and live in simple shacks, within the site as noted previously. Waste is not properly contained in the disposal site as much of it is left on the surface and not covered with soil. Reportedly only hazardous waste is buried in unlined pits within the site. In addition, a considerable amount of wind-blown litter was observed in trees and on the ground surrounding the site. During fourth monitoring visit, there was no fence and demarcation of SMPC's disposal area was not very clear.

The IESC did not visit the waste disposal site in December 2019. However, as noted in Section 5.10.1 of the report, waste quantities for the operations phase has been drastically reduced. Therefore, SMPC no longer maintains a specially demarcated area at this disposal site specifically for its waste.
