June 14, 2021

335000259

MYINGYAN CCPP SIXTH ENVIRONMENTAL AND SOCIAL MONITORING REPORT

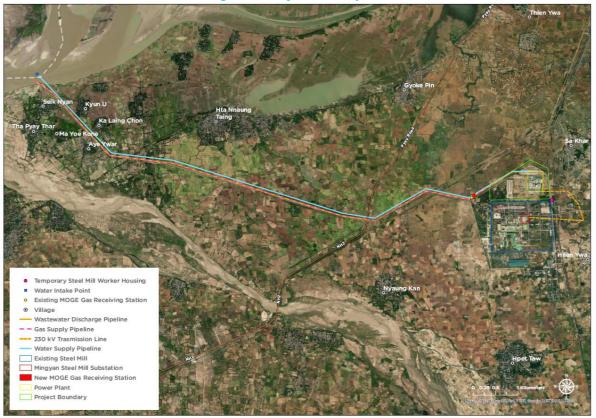
Figure 2: Project Site Layout

The Project, Sembcorp Myingyan Independent Power Plant (IPP), is a 225-megawatt combined-cycle, gas-fired power plant project This project was developed under a build-operate-transfer agreement between Sembcorp Myingyan Power Company Limited and the Ministry of Electricity and Energy (MOEE) of Myanmar signed in January 2017. Under the agreement, SMPC will build and operate the power plant for 22 years, after which the facility will be transferred to the government⁴.

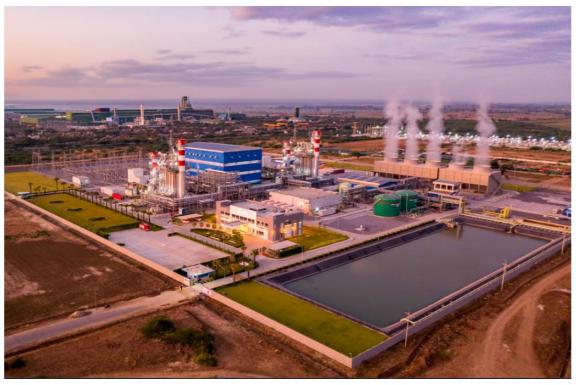
Figure 3: Project Aerial (Photo from Sembcorp)

The river water supply and wastewater pipelines are both buried 2 m below the ground surface in a right of way (RoW) 2 m wide, and mostly aligned next to an existing irrigation canal. The RoW was physically reinstated. Land users (farmers) were allowed to reinstate crops beginning in July 2017, but large trees were not permitted in order to avoid damage to the pipelines.

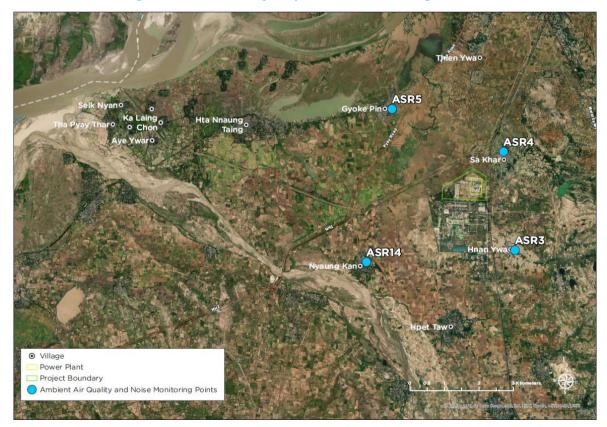
Figure 6: Ambient Air Quality and Noise Monitoring Locations

The ambient air quality monitoring points are located at village houses in the vicinity of the Project, as follows (refer to **Figure 6**):

- Hnan Ywa village (ASR3);
- Sa Khar village (ASR4);
- Gyoke Pin village (ASR5); and
- Nyaung Kan village (ASR14).

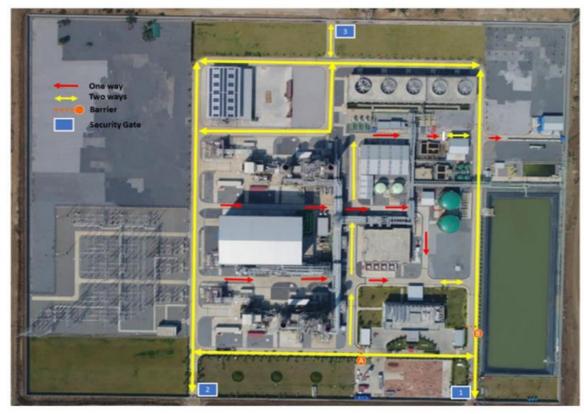
Figure 7: Site Traffic Flow for Operations Phase

Figure 7 shows the internal traffic layout within the site. The Fifth Monitoring Round noted that there were several signs clearly displaying the speed limit of 15 km/hour at various locations within the site, and that there were three (3) security gates and security personnel at the entrance check that all vehicle occupants are wearing a seat belt before vehicles are allowed to enter.

It is recommended that on-site traffic management be reviewed again during the next IESC site visit.

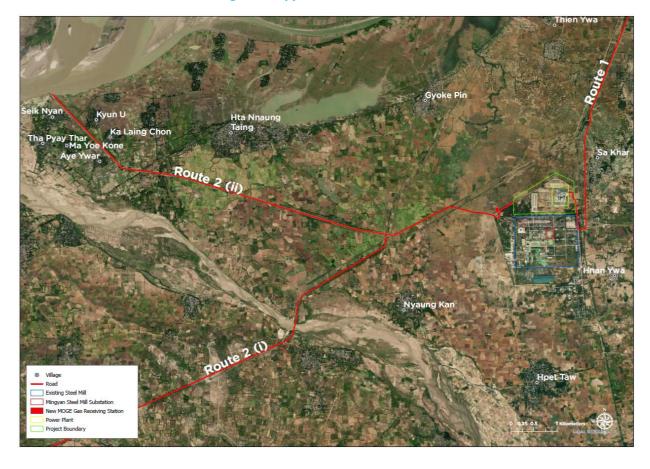
Figure 8: Approved Site Access Routes

The approved access routes to the Project site during the construction phase (refer to **Figure 8**) remain the main access routes to the facility during the operations phase.

Construction phase heavy vehicle movements have now ceased and traffic movements to the Project now, during the operations phase, is no longer considered a significant issue. However, it is recommended that off-site traffic management be reviewed again during the next IESC site visit to assess operations phase impact, if any, on nearby communities such as the small informal settlement near the main site entrance (Route 2 (ii)).

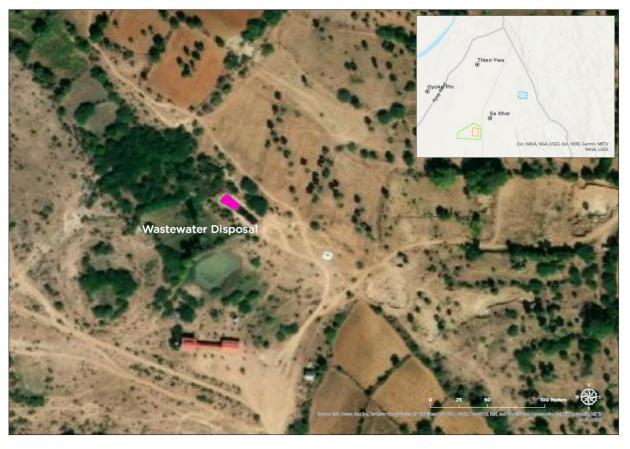
Figure 10: Sanitary Wastewater Disposal Site

The contents of the cess pit are taken to a municipal wastewater disposal site adjacent to the Myingyan cemetery and graveyard, approximately 7 km south of the centre of Myingyan (**Figure 9**). Once collected by the Municipal Council, it will be pumped into an unlined soil pit, measuring around 5 m \times 4 m (**Figure 10**).

The Fifth Monitoring Round noted that no sensitive receptors were identified around the wastewater disposal site; the nearest building is the town's crematorium, 110 m to the south while the nearest residential dwelling appeared to be around 600 m to the north-east. The site was otherwise surrounded by agricultural land, and a wooded area immediately to the west, between the pit and the graveyard. This information will be reconfirmed during the IESC's next physical site visit to Myingyan.

It is recommended that the wastewater disposal site is revisited during the next monitoring round to determine whether the Project's waste is disposed of appropriately.

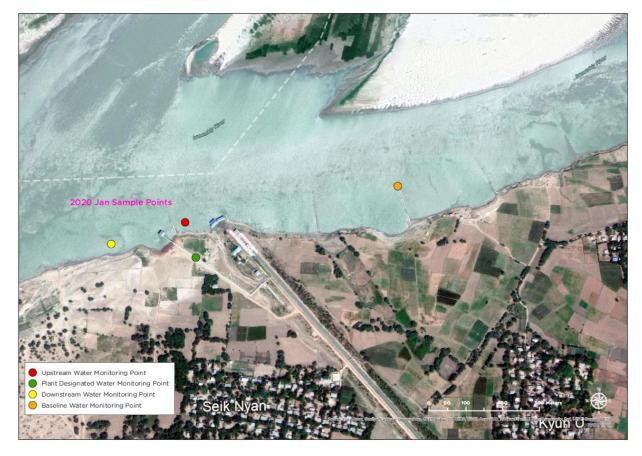
Figure 11: Water Monitoring Locations

Monitoring is carried out at the following locations (refer to Figure 11):

- Upstream (100 m from the discharge point at Sa Khar Village);
- Upstream mid-river; and
- Downstream (100 m from the discharge point at Sa Khar Village).

The results were in compliance to the stipulated limits with the exception of exceedances of Iron monitored at the discharge pipeline sampling point; exceedances of Iron were also noted at upstream and downstream of the discharge point except for the monitoring event on January 29, 2020. The

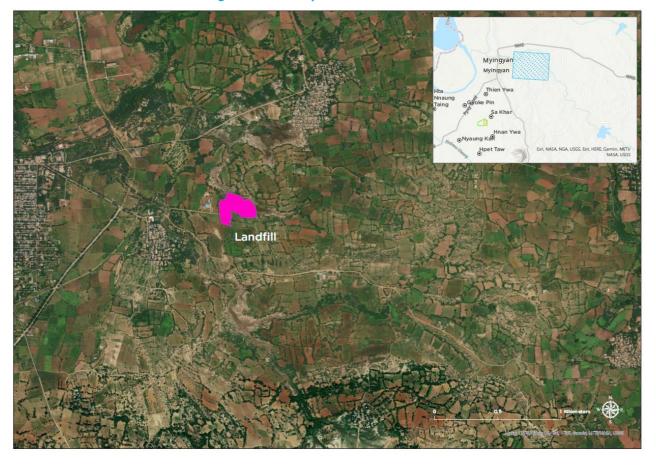
Figure 12: Municipal Waste Landfill Site

OK transports and disposes of the general waste to a landfill site operated by the Myingyan Municipality, located around 4 km east of the centre of Myingyan (**Figure 12**). This facility, which was opened in approximately 2016, is not an engineered landfill. During the IESC's Fourth Monitoring Round (August 2018 visit), the facility was observed to be a poorly controlled and unlined waste dump. It was noted that the waste across much of the site was smoldering / burning and can cause nuisance in Myginyan, with scavengers combing through the waste. Whilst it is understood that the Project's waste stream is small compared to the town as a whole and the SMPC no longer maintains a specially demarcated area at the disposal site specifically for its waste, it is recommended that the landfill is revisited during the next monitoring round to determine whether the Project's waste is disposed of appropriately at the landfill.
